NYC Department of Education
Building Condition Assessment Survey 2023 - 2024

Architectural Inspection

K611

**Asset: THE DOCK STREET EDUCATIONAL COMPLEX - BROOKLYN, 19 DOCK STREET,
 New York, 11201**

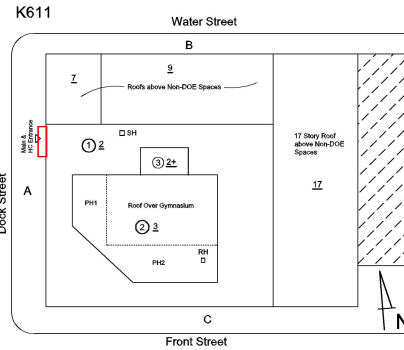
Roof Plan reference

METAL: DETERIORATION/DAMAGED/MISSING PIECES

20

REPLACE

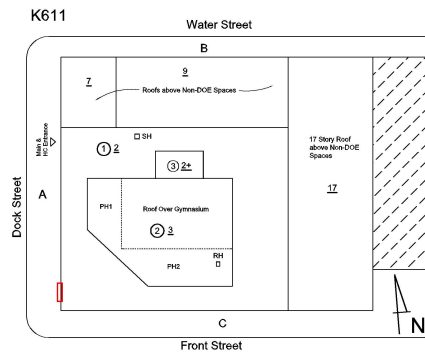
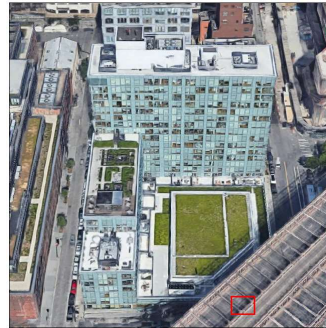
Elevation

Question	Response
EXTERIOR	
AWNINGS AND CANOPIES	
Violations	Facade A No violations recorded.
CHIMNEY	
Material Type(s)	Inspected Metal
Condition	2 - Between Good and Fair
Deficiency	No deficiencies recorded
COPING	
Condition	Inspected 2 - Between Good and Fair
Deficiency	No deficiencies recorded
CORNICE	
	Does not Exist
DOORS	
DOORS AND FRAMES	
Condition	Inspected 2 - Between Good and Fair
Deficiency	No deficiencies recorded
DOOR HARDWARE	
Condition	Inspected 3 - Fair
Deficiency	No deficiencies recorded
LINTELS	
Condition	Inspected 2 - Between Good and Fair
Deficiency	No deficiencies recorded
TRANSOM/SIDE LIGHT	
	Does not Exist
EXTERIOR WALLS	
Material Type(s)	Inspected Steel
Replacement Quantity	6,600
Replacement Uom	S.F.
Instance on All Facades	Inspected
Instance Condition	3 - Fair
Instance Quantity	6,600
Instance Quantity Uom	S.F.
Deficiency	METAL/GLASS CURT WALL: BROKEN GLASS
Roof Plan reference

20

REPLACE

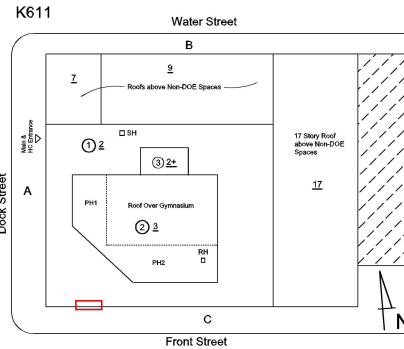
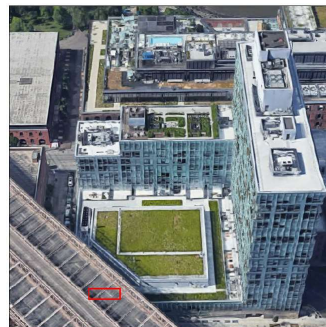
Roof Plan reference

METAL/GLASS CURT WALL: DAMAGED TRIM

10

REPLACE

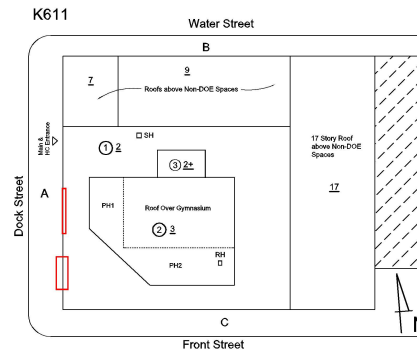
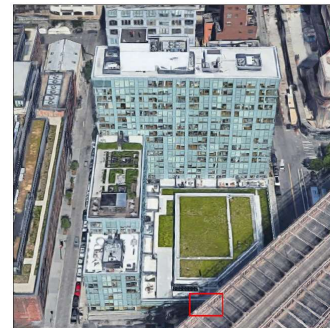
Roof Plan reference

METAL/GLASS CURT WALL: DETERIORATED CONTROL/EXPANSION JOINTS

40
L.F.
MAINTENANCE
PRIORITY 3
LEVEL 2
