NYC Department of Education
Building Condition Assessment Survey 2023 - 2024

Architectural Inspection

Asset: PRE-K CENTER @ 369 93RD STREET - BROOKLYN, 369 93 STREET, 11209

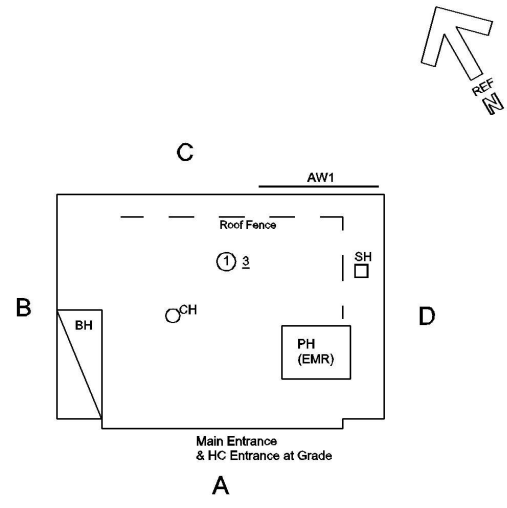
93rd Street

Question	Response
Architectural	
EXTERIOR	Inspected
AREAWAY	Inspected
Instance on AW1	Inspected
Instance Condition	3 - Fair
Instance Quantity	1
Instance Quantity Uom	EACH
Deficiency	AREAWAY SLAB: CRACKS AND SPALLING
Roof Plan reference

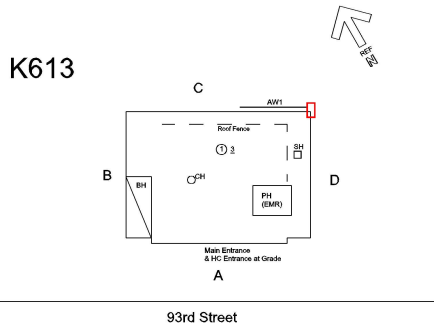
Violations	AW1 No violations recorded.
Deficiency	AREAWAY WALLS: CRACKS AND SPALLING
Roof Plan reference

Deficiency Quantity	10
Quantity Uom	S.F.
Potential Action	REPAIR
Urgency of Action	PRIORITY 3
Purpose of Action	LEVEL 2
Deficiency Photo1
