**NYC Department of Education**  
**Building Condition Assessment Survey 2023 - 2024**

Architectural Inspection

**K615**

**Asset: E NY VOC HS OF TRANSIT TECH.-K, 1 WELLS STREET, New York, 11208**

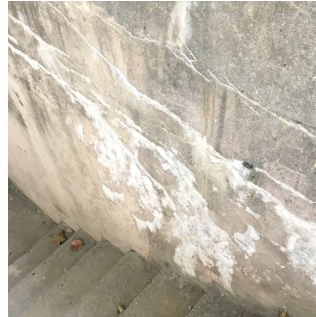
AW8

AREAWAY STAIRS: MISSING RAILINGS

REPLACE

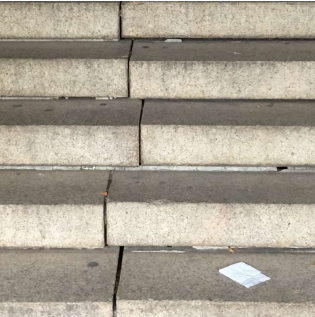
Violations	Facade A No violations recorded.
Deficiency	STONE: DETERIORATED JOINTS

Question	Response
<b>EXTERIOR</b>	
<b>STAIRS/RAMPS: EXTERIOR</b>	
<b>STAIRS/RAMPS</b>	
Rooftop reference

Deficiency Quantity	35
Quantity Uom	L.F.
Potential Action	REPOINT
Urgency of Action	PRIORITY 4
Purpose of Action	LEVEL 2
Deficiency Photo1

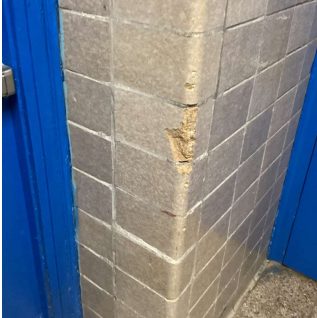
Question	Response
<b>INTERIOR</b>	
<b>CAFETERIA</b>	
<b>Stage</b>	
Instance on Basement	Does not Exist
<b>Walls</b>	
Instance on Basement	Inspected
Condition	2 - Between Good and Fair
Deficiency	GLAZED BLOCK: CRACKS/SPALLING
Deficiency Location/Instance	Exit Vestibule
Deficiency Quantity	10
Quantity Uom	S.F.
Potential Action	REPLACE
Urgency of Action	PRIORITY 3
Purpose of Action	LEVEL 2
Deficiency Photo1

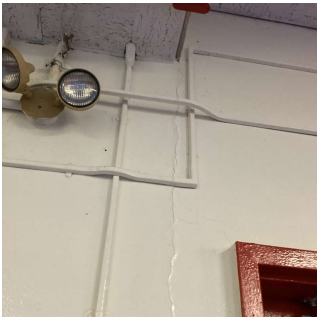
Violations	Exit Vestibule No violations recorded.
Deficiency	PLASTER: CRACKS/SPALLING
Deficiency Location/Instance	Near Men Toilet Room
Deficiency Quantity	10
Quantity Uom	S.F.
Potential Action	REPLACE
Urgency of Action	PRIORITY 3
Purpose of Action	LEVEL 2
Deficiency Photo1

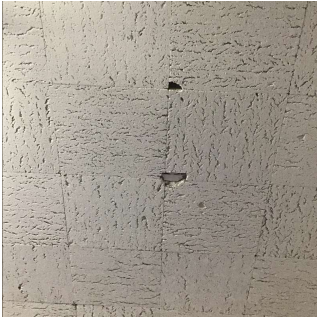
Stair D/Basement Vestibule
Violations	No violations recorded.
Deficiency	ACOUSTIC TILES: DAMAGED/MISSING
Deficiency Location/Instance	Room 210, 125
Deficiency Quantity	40
Quantity Uom	S.F.
Potential Action	REPLACE
Urgency of Action	PRIORITY 3
Purpose of Action	LEVEL 2
Deficiency Photo1

Violations	Near Men Toilet Room No violations recorded.
<b>Window Curtains/Shades/Blinds</b>	
Instance on Basement	Does not Exist
<b>CLASSROOMS/CORRIDORS/ADMIN SPACES</b>	
<b>Ceiling</b>	Inspected
Condition	2 - Between Good and Fair
Deficiency	ACOUSTIC TILES ON PLASTER: DAMAGED/MISSING

Deficiency Location/Instance	Stair D/Basement Vestibule

Question	Response
<b>INTERIOR</b>	
<b>CLASSROOMS/CORRIDORS/ADMIN SPACES</b>	
<b>Ceiling</b>	
Deficiency Quantity	10
Quantity Uom	S.F.
Potential Action	REPLACE
Urgency of Action	PRIORITY 3
Purpose of Action	LEVEL 2
Deficiency Photo1

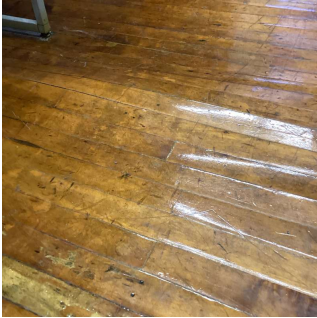
Yes	Tripping Hazard	Severely heaving wood floor is a potential tripping hazard.	INTERIOR   CLASSROOMS /CORRIDORS/ ADMIN SPACES   Floor Finish	Room 303	Joseph Gallucio	Fireman

Question	Response
<b>INTERIOR</b>	
<b>CLASSROOMS/CORRIDORS/ADMIN SPACES</b>	
<b>Door(s)</b>	Inspected
	Room 303
Violations	No violations recorded.
<b>Floor Finish</b>	Inspected
Condition	2 - Between Good and Fair
Deficiency	WOOD: DAMAGED/DETERIORATED
Deficiency Location/Instance	Room 303
Deficiency Quantity	30
Quantity Uom	S.F.
Potential Action	REPLACE
Urgency of Action	PRIORITY 5
Purpose of Action	LEVEL 6
Deficiency Photo1

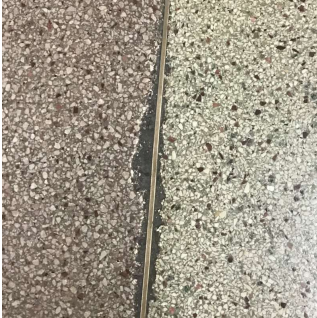
Room 303
Violations	No violations recorded.
Deficiency	TERRAZZO: CRACKS
Deficiency Location/Instance	Main Lobby, Main Entrance
Deficiency Quantity	20
Quantity Uom	S.F.
Potential Action	REPLACE
Urgency of Action	PRIORITY 3
Purpose of Action	LEVEL 2
Deficiency Photo1

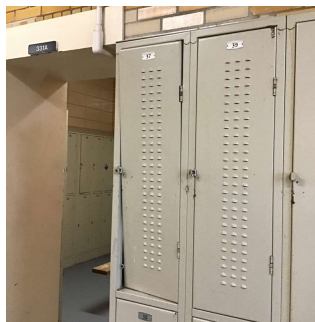
Condition	2 - Between Good and Fair
Deficiency	DAMAGED UNITS
Deficiency Location/Instance	Locker 37
Deficiency Quantity	1
Quantity Uom	EACH
Potential Action	REPLACE
Urgency of Action	PRIORITY 3
Purpose of Action	LEVEL 2
Deficiency Photo1

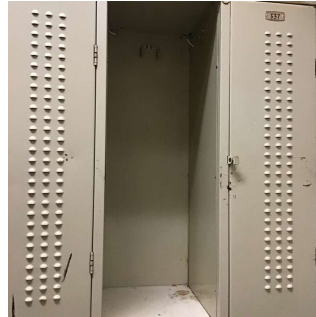
Locker 535

Deficiency	DAMAGED UNITS
Deficiency Location/Instance	Lockers 535, 536, 545, 573, 577, and others
Deficiency Quantity	45
Quantity Uom	EACH
Potential Action	REPLACE
Urgency of Action	PRIORITY 3
Purpose of Action	LEVEL 2
Deficiency Photo1

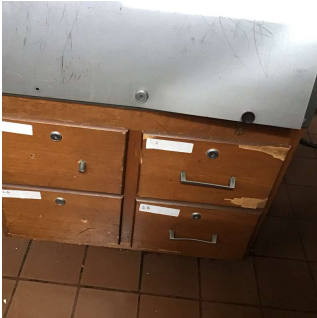
Question	Response
<b>INTERIOR</b>	
<b>SCIENCE LAB</b>	
<b>Fixed Equipment</b>	
Deficiency	CABINETS: MISSING/DAMAGED
Deficiency Location/Instance	Near Entrance
Deficiency Quantity	36
Quantity Uom	L.F.
Potential Action	REPLACE
Urgency of Action	PRIORITY 3
Purpose of Action	LEVEL 2
Deficiency Photo1

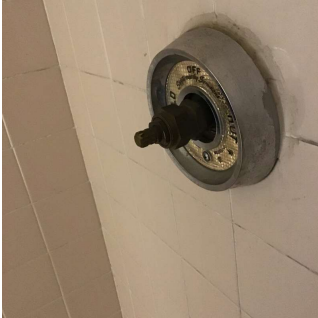
Priority Condition Exist Last Year?	Priority Category	Condition Description	Component Affected	Location Description	Person(s) Notified	Person(s) Title	PhotoImage
No	Protruding Elements	Protruding metal is a potential safety hazard.	INTERIOR   SHOWER ROOM   Walls	Room 348C	Joseph Gallucio	Fireman

Question	Response
<b>INTERIOR</b>	
<b>SHOWER ROOM</b>	
<b>Walls</b>	
Instance on 3rd Floor - Girls	Inspected
Condition	2 - Between Good and Fair
Deficiency	CERAMIC TILE: BROKEN/ MISSING
Deficiency Location/Instance	Room 353A
Deficiency Quantity	10
Quantity Uom	S.F.
Potential Action	REPLACE
Urgency of Action	PRIORITY 5
Purpose of Action	LEVEL 6
Deficiency Photo1

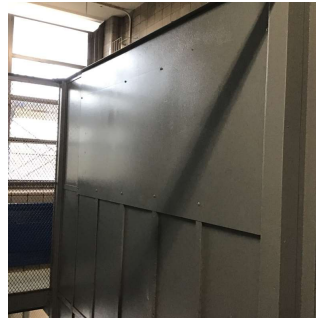
Stair E/3

METAL PANEL: DAMAGED/DETERIORATED

REPLACE

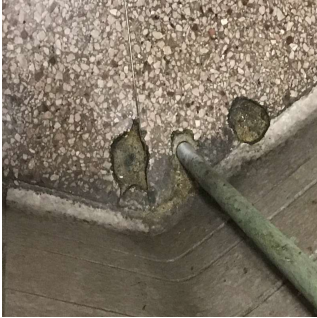
Question	Response
<b>INTERIOR</b>	
<b>STAIRS/RAMPS: INTERIOR</b>	
<b>Railings</b>	Inspected
	Stair E/2
Violations	No violations recorded.
<b>Stairs and Landings</b>	Inspected
Condition	2 - Between Good and Fair
Deficiency	TERRAZZO: CRACKS
Deficiency Location/Instance	Stair F/1 Vestibule
Deficiency Quantity	10
Quantity Uom	S.F.
Potential Action	REPLACE
Urgency of Action	PRIORITY 3
Purpose of Action	LEVEL 2
Deficiency Photo1

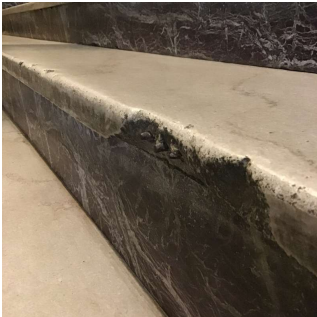
Stair F/1 Vestibule
Violations	No violations recorded.
Deficiency	STONE: BROKEN/MISSING
Deficiency Location/Instance	Main Entrance
Deficiency Quantity	10
Quantity Uom	S.F.
Potential Action	REPLACE
Urgency of Action	PRIORITY 5
Purpose of Action	LEVEL 6
Deficiency Photo1

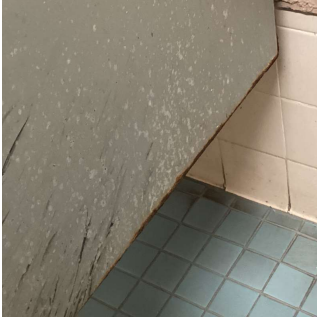
Stair C/1
Violations	No violations recorded.
<b>TOILET ROOMS - STAFF</b>	Inspected
<b>Ceiling</b>	Inspected
Condition	2 - Between Good and Fair
Deficiency	No deficiencies recorded
<b>Door(s)</b>	Inspected
Condition	2 - Between Good and Fair
Deficiency	No deficiencies recorded
<b>Floor Finish</b>	Inspected
Condition	2 - Between Good and Fair
Deficiency	No deficiencies recorded
<b>Stalls</b>	Inspected
Condition	5 - Poor
Deficiency	RUST - MAJOR

Deficiency Location/Instance	Room 226, 152, 153, 147, 102
Deficiency Quantity	5
Quantity Uom	EACH

Question	Response
<b>INTERIOR</b>	
<b>TOILET ROOMS - STAFF</b>	
<b>Stalls</b>	
Potential Action	REPLACE
Urgency of Action	PRIORITY 3
Purpose of Action	LEVEL 2
Deficiency Photo1

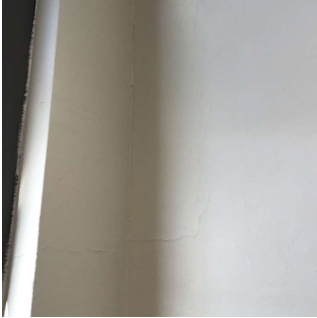
Room 226
Violations	No violations recorded.
<b>Walls</b>	Inspected
Condition	4 - Between Fair and Poor
Deficiency	PLASTER: CRACKS/SPALLING
Deficiency Location/Instance	Room 309, 208, 147
Deficiency Quantity	20
Quantity Uom	S.F.
Potential Action	REPLACE
Urgency of Action	PRIORITY 3
Purpose of Action	LEVEL 2
Deficiency Photo1

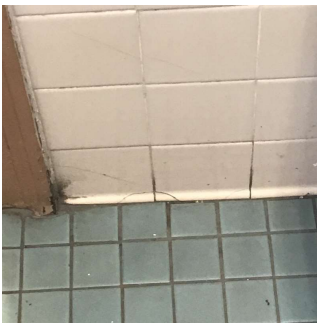
Room 309
Violations	No violations recorded.
Deficiency	CERAMIC TILE: BROKEN/ MISSING
Deficiency Location/Instance	Room 309, 226, 207, 152, 147, and others
Deficiency Quantity	20
Quantity Uom	S.F.
Potential Action	REPLACE
Urgency of Action	PRIORITY 3
Purpose of Action	LEVEL 2

Violations	Room 309 No violations recorded.
<b>TOILET ROOMS - STUDENTS</b>	
<b>Ceiling</b>	Inspected
Condition	2 - Between Good and Fair
Deficiency	ACOUSTIC TILES ON PLASTER: DAMAGED/MISSING
Deficiency Location/Instance	Room B25
Deficiency Quantity	10
Quantity Uom	S.F.
Potential Action	REPLACE
Urgency of Action	PRIORITY 3
Purpose of Action	LEVEL 2
Deficiency Photo1

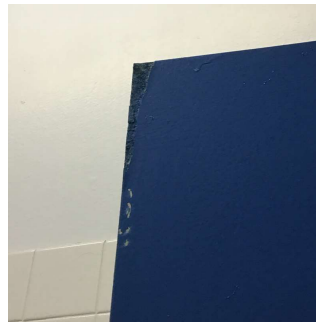
3rd Floor - Boys

Violations	Room B25 No violations recorded.
<b>Door(s)</b>	
Condition	5 - Poor
Deficiency	WOOD: DETERIORATED DOOR
Deficiency Location/Instance	3rd Floor - Boys, Rooms B25, B24
Deficiency Quantity	3
Quantity Uom	EACH
Potential Action	MAINTENANCE
Urgency of Action	PRIORITY 3
Purpose of Action	LEVEL 2

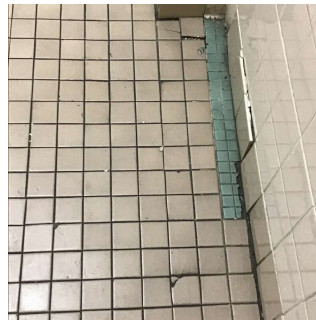
Room B24

CERAMIC TILE: BROKEN/MISSING TILES

REPLACE

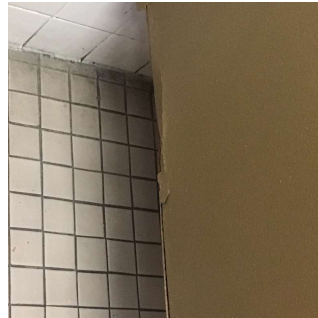
2nd Floor - Girls

RUST - MAJOR

REPLACE

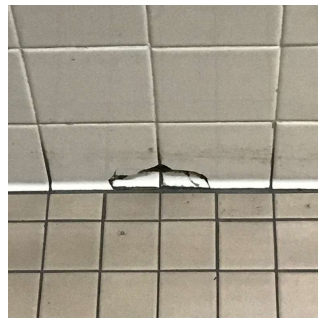
CERAMIC TILE: BROKEN/ MISSING

Question	Response
<b>INTERIOR</b>	
<b>TOILET ROOMS - STUDENTS</b>	
<b>Walls</b>	
Violations	3rd Floor - Girls No violations recorded.
Deficiency	PLASTER: CRACKS/SPALLING
Deficiency Location/Instance	3rd Floor - Boys, Girls, 2nd Floor - Girls, Room B24
Deficiency Quantity	40
Quantity Uom	S.F.
Potential Action	REPLACE
Urgency of Action	PRIORITY 3
Purpose of Action	LEVEL 2
Deficiency Photo1	 
Violations	2nd Floor - Girls No violations recorded.
<b>LIFE SAFETY</b>	Inspected
<b>F.D. HOLDING AREA</b>	Does not Exist
<b>STEEL STAIRS</b>	Does not Exist
<b>SITE</b>	Inspected
<b>CONTAINERIZATION</b>	Inaccessible
<b>Drainage System for Asphalt</b>	Does not Exist
<b>Drainage System for Concrete</b>	Inspected
<b>Catch Basins/Manhole - Surrounded by concrete</b>	Inspected
Condition	3 - Fair
Deficiency	DAMAGED COVER
Deficiency Location/Instance	Between School and Parks Department Athletic Field
Deficiency Quantity	1
Quantity Uom	EACH

REPLACE

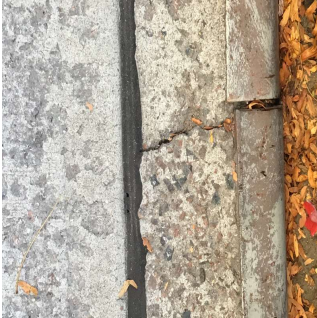
Deficiency	DAMAGED/DETERIORATED/MISSING SECTIONS
Deficiency Location/Instance	Along Wells Street, Fountain Avenue
Deficiency Quantity	175
Quantity Uom	S.F.
Potential Action	REPLACE
Urgency of Action	PRIORITY 3
Purpose of Action	LEVEL 2
Deficiency Photo1	 
Violations	Along Wells Street No violations recorded.
Deficiency	DAMAGED CURBS
Deficiency Location/Instance	Along Wells Street, Fountain Avenue
Deficiency Quantity	25
Quantity Uom	L.F.

Question	Response
<b>SITE</b>	
<b>PAVING</b>	
<b>DOT Sidewalk</b>	
<b>Concrete</b>	
Potential Action	REPLACE
Urgency of Action	PRIORITY 3
Purpose of Action	LEVEL 2
Deficiency Photo1

Violations	Along Wells Street No violations recorded.
<b>Pavers</b>	Does not Exist
<b>PLAYGROUNDS</b>	Does not Exist
<b>PLAYING SURFACE</b>	Does not Exist
<b>RETAINING WALLS</b>	Inspected
Are there any Retaining Walls 6' OR higher facing public street/sidewalk?	No
Condition	2 - Between Good and Fair
Deficiency	No deficiencies recorded
<b>SEATING</b>	Does not Exist
<b>SITE WALLS (NOT RETAINING WALLS)</b>	Does not Exist
<b>STAIRS/RAMPS: EXTERIOR</b>	Inspected
<b>Railings</b>	Inspected
Condition	2 - Between Good and Fair
Deficiency	No deficiencies recorded
<b>Site Cheek/flank Walls</b>	Inspected
Condition	2 - Between Good and Fair
Deficiency	No deficiencies recorded
<b>Stairs/ramps</b>	Inspected
Condition	2 - Between Good and Fair
Deficiency	No deficiencies recorded
