NYC Department of Education
Building Condition Assessment Survey 2023 - 2024

Architectural Inspection

K625

Asset: ROBESON HS COMP&BUS TC (A HML)-K, 150 ALBANY AVENUE, New York, 11213

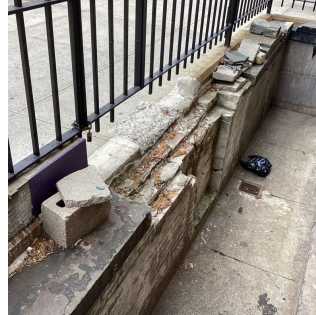
AW3

Question	Response
Architectural	
EXTERIOR	Inspected
AREAWAY	Inspected
Instance on AW1-AW5	Inspected
Instance Condition	4 - Between Fair and Poor
Instance Quantity	5
Instance Quantity Uom	EACH
Deficiency	AREAWAY WALLS: DETERIORATED COPING STONE
Roof Plan reference	
Deficiency Quantity	40
Quantity Uom	S.F.

REPLACE
PRIORITY 5
LEVEL 6

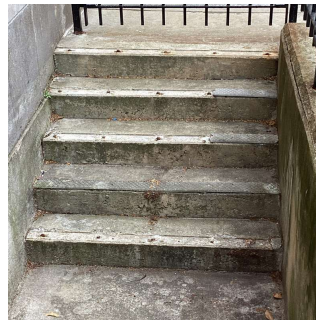
AW4 - Exit 6

AREAWAY STAIRS: DETERIORATED TREADS/RISERS/NOSINGS

20
S.F.
REPLACE
PRIORITY 5
LEVEL 6

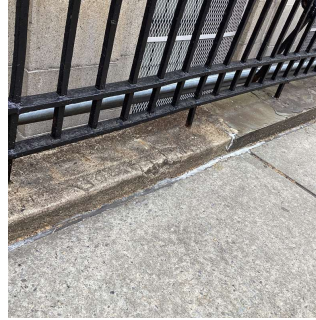
AW5

AREAWAY WALLS: CRACKS AND SPALLING

10
S.F.
REPAIR
PRIORITY 3
LEVEL 2

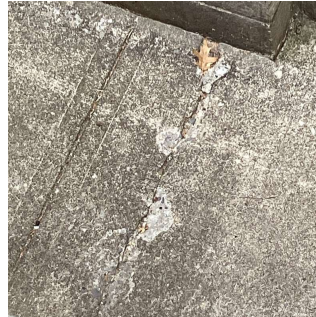
AW5

AREAWAY SLAB: CRACKS AND SPALLING

REPAIR

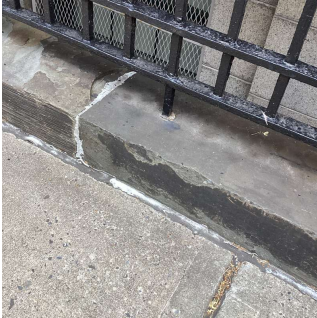
AREAWAY WALLS: DETERIORATED COPING STONE

40
S.F.
REPLACE
PRIORITY 4
LEVEL 2

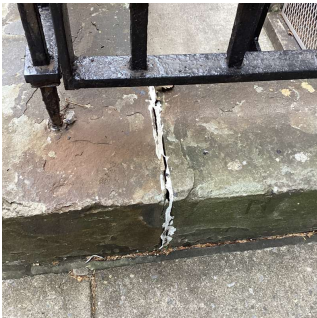
Violations	AW1 No violations recorded.
Deficiency	AREAWAY WALLS: DETERIORATED JOINTS AT COPING STONES
Roof Plan reference

Deficiency Quantity	10
Quantity Uom	L.F.
Potential Action	MAINTENANCE
Urgency of Action	PRIORITY 3
Purpose of Action	LEVEL 2
Deficiency Photo1

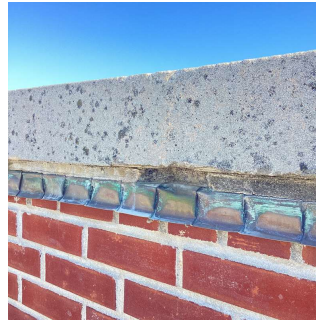
Roof 1 - Facade F

CAST STONE: DETERIORATED BED JOINT

10
L.F.
REPOINT
PRIORITY 3
LEVEL 2

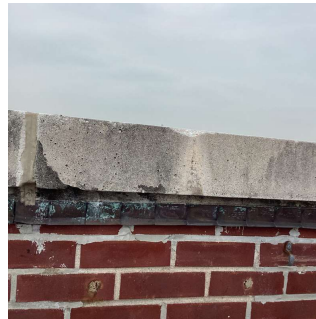
Roof 1 - Near the Bulkhead

CAST STONE: CRACKED/BROKEN PIECES

REPLACE-IN-KIND

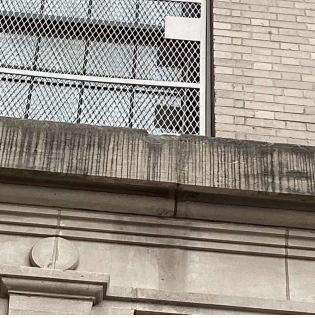
STONE: MINOR CRACKS, SPALLING

Deficiency Quantity	30
Quantity Uom	S.F.
Potential Action	REPAIR
Urgency of Action	PRIORITY 3
Purpose of Action	LEVEL 2
Deficiency Photo1

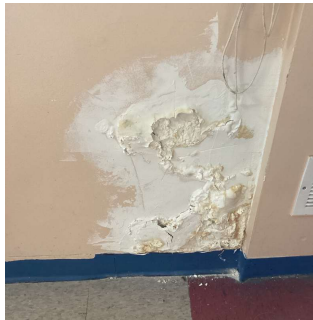
Facade C - Room 417

BRICK: WATER INFILTRATION IN INSTRUCTIONAL SPACE

REPAIR

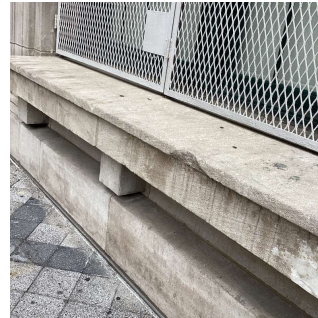
Facade L

STONE: DETERIORATED MASONRY SILLS - MAJOR

REMOVE AND REPLACE

PRIORITY 4
LEVEL 2

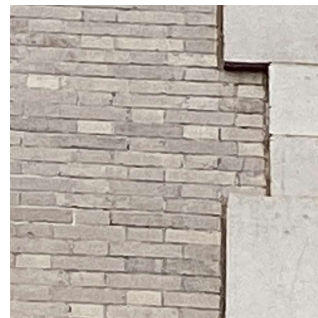
Facade A - Near Main Entrance

BRICK: DETERIORATED JOINTS

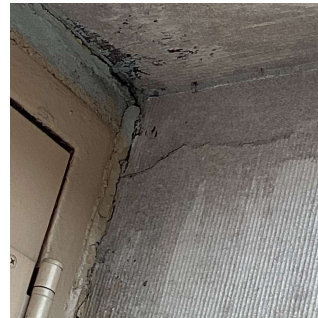
Facade A - Main Entrance

STONE: CHIPPED/SPALLED/BROKEN PIECES - MINOR

REPAIR

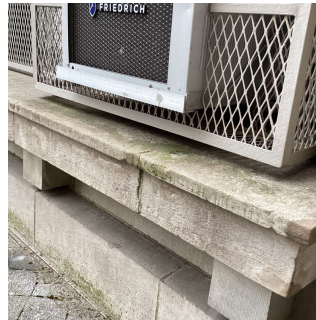
Facade B

STONE: DETERIORATED MASONRY SILLS - MINOR

REPAIR

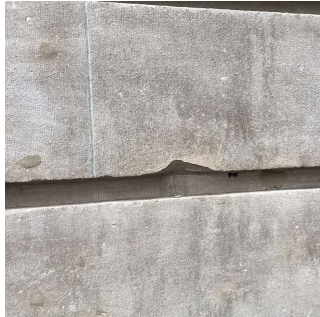
STONE: CHIPPED/SPALLED/BROKEN PIECES - MAJOR

Facade B
Violations	No violations recorded.
EXTERIOR SOFFITS	
Condition	Inspected
	2 - Between Good and Fair
Deficiency	No deficiencies recorded
LOADING DOCK	
	Does not Exist
LOUVER	
Condition	Inspected
	2 - Between Good and Fair
Deficiency	No deficiencies recorded
PARAPETS	
Material Type(s)	Inspected
	Masonry
Replacement Quantity	8,000
Replacement Uom	C.F.
Instance on All Facades	Inspected
Instance Condition	3 - Fair
Instance Quantity	8,000
Instance Quantity Uom	C.F.
Deficiency	BRICK: EFFLORESCENCE
Roof Plan reference

REPLACE

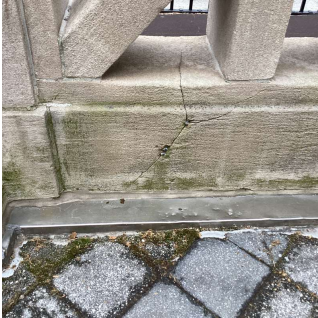
Violations	Roof 1 - Facade L No violations recorded.
Deficiency	STONE: MINOR CRACKS, SPALLING
Roof Plan reference

Deficiency Quantity	10
Quantity Uom	S.F.
Potential Action	REPAIR
Urgency of Action	PRIORITY 3
Purpose of Action	LEVEL 2
Deficiency Photo1

Violations	Plaza Deck - Facade A No violations recorded.
PLAZA DECK	Inspected
Instance on Pavers: Roof 5	Inspected
Instance Condition	3 - Fair
Instance Quantity	5,000
Instance Quantity Uom	S.F.
Installation Year	2000
Source of Installation	Custodial Staff
Deficiency	PAVERS: PAVERS IN POOR CONDITION

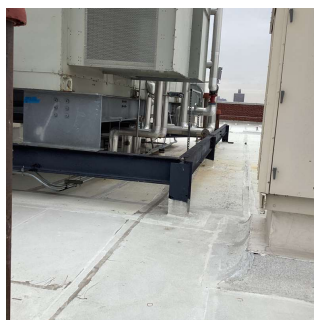
Roof 1
No violations recorded.

Violations	Roof 1 - EMR 2 No violations recorded.
CUPOLA/ SPIRES/ TOWERS	Does not Exist
DORMER	Does not Exist
DUNNAGE STEEL	Inspected
Condition	3 - Fair
Deficiency	HEIGHT LESS THAN 18"

100
L.F.
REPLACE
PRIORITY 3
LEVEL 2

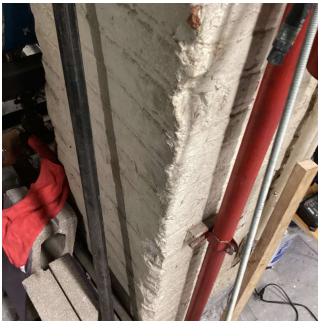
Question	Response
EXTERIOR	
WINDOWS	
EXTERIOR GUARDS	
Deficiency Photo1	 
Violations	Facade A - Near AW5 No violations recorded.
LINTELS	Inspected
Condition	2 - Between Good and Fair
Deficiency	No deficiencies recorded
WINDOWS	Inspected
Material Type(s)	Aluminum
Instance on Aluminum - Double Hung: All Facades	Inspected
Instance Condition	1 - Good
Instance Quantity	16,000
Instance Quantity Uom	S.F.
Are these windows insulated	Yes
Installation Year	2022
Source of Installation	Custodial Staff
Deficiency	No deficiencies recorded
INTERIOR	Inspected
POOLS	Does not Exist
STRUCTURAL	Inspected
COLUMNS/BEAMS/BEARING WALLS	Inspected
Condition	3 - Fair
Deficiency	STEEL COLUMNS/BEAMS: DETERIORATED MASONRY FIREPROOFING
Deficiency Location/Instance	Basement - Boiler Room
Deficiency Quantity	20
Quantity Uom	S.F.
Potential Action	REPLACE
Urgency of Action	PRIORITY 3
Purpose of Action	LEVEL 5
Deficiency Photo1

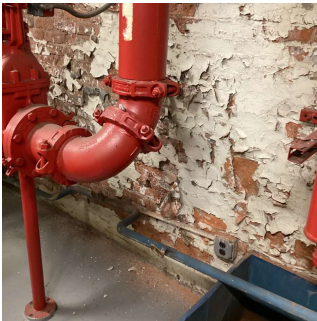
Question	Response
INTERIOR	
STRUCTURAL	
FOUNDATION WALLS	
Deficiency Photo1

Violations	Basement - Boiler Room No violations recorded.
Deficiency	BRICK: WATER INFILTRATION IN NON- INSTRUCTIONAL SPACE
Deficiency Location/Instance	Basement - Boiler Room, Room B10A
Deficiency Quantity	200
Quantity Uom	S.F.
Potential Action	INSTALL WATERPROOFING
Urgency of Action	PRIORITY 5
Purpose of Action	LEVEL 5
Deficiency Photo1	 
Violations	Basement - Boiler Room, Room B10A No violations recorded.
ROOF STRUCTURE	Inspected
Condition	2 - Between Good and Fair
Deficiency	No deficiencies recorded
VAULTS-BUNKERS	Inspected
Foundation Walls	Inspected
Condition	2 - Between Good and Fair
Deficiency	No deficiencies recorded
Slab Structure	Inspected
Condition	3 - Fair
Deficiency	CONCRETE: CRACKS/SPALLED/REINFORCEMENT EXPOSED
Deficiency Location/Instance	Basement - Vault next to the sidewalk elevator
Deficiency Quantity	10
Quantity Uom	S.F.

Potential Action	REPAIR
Urgency of Action	PRIORITY 4
Purpose of Action	LEVEL 5

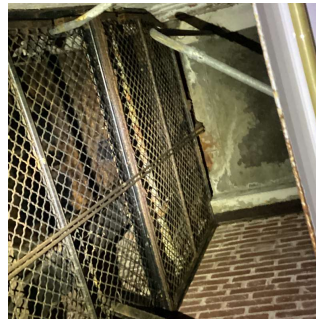
Basement - Sidewalk Elevator

WATER INFILTRATION

REPAIR

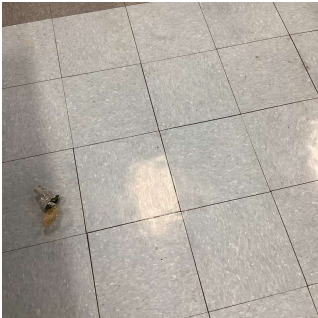
Question	Response
INTERIOR	
STRUCTURAL	
VAULTS-BUNKERS	
Vault/Ash Hoist Doors and Framing	
Deficiency Photo1	 
Violations	Basement - Sidewalk Elevator No violations recorded.
AUDITORIUM	Does not Exist
CAFETERIA	Inspected
Instance on Basement	Inspected
Ceiling	
Instance on Basement	Inspected
Condition	2 - Between Good and Fair
Deficiency	ACOUSTIC TILES ON PLASTER: DAMAGED/MISSING
Deficiency Location/Instance	Near Elevator, Near Ramp
Deficiency Quantity	30
Quantity Uom	S.F.
Potential Action	REPLACE
Urgency of Action	PRIORITY 3
Purpose of Action	LEVEL 2
Deficiency Photo1	 
Violations	Near Elevator No violations recorded.
Door(s)	
Instance on Basement	Inspected
Condition	2 - Between Good and Fair
Deficiency	No deficiencies recorded
Fixed Equipment	
Instance on Basement	Does not Exist
Floor Finish	
Instance on Basement	Inspected
Condition	2 - Between Good and Fair
Deficiency	VINYL TILES: BROKEN/DETERIORATED/MISSING TILES
Deficiency Location/Instance	Center

Question	Response
INTERIOR	
CAFETERIA	
Floor Finish	
Deficiency Quantity	10
Quantity Uom	S.F.
Potential Action	REPLACE
Urgency of Action	PRIORITY 3
Purpose of Action	LEVEL 2
Deficiency Photo1

Center	Center
Violations	No violations recorded.
Sliding-folding Partition	
Instance on Basement	Does not Exist
Stage	
Instance on Basement	Does not Exist
Walls	
Instance on Basement	Inspected
Condition	2 - Between Good and Fair
Deficiency	No deficiencies recorded
Window Curtains/Shades/Blinds	
Instance on Basement	Does not Exist
CLASSROOMS/CORRIDORS/ADMIN SPACES	
Ceiling	
Condition	2 - Between Good and Fair
Deficiency	ACOUSTIC TILES: DAMAGED/MISSING
Deficiency Location/Instance	Rooms 103, 107, 304, 330
Deficiency Quantity	45
Quantity Uom	S.F.
Potential Action	REPLACE
Urgency of Action	PRIORITY 3
Purpose of Action	LEVEL 2
Deficiency Photo1

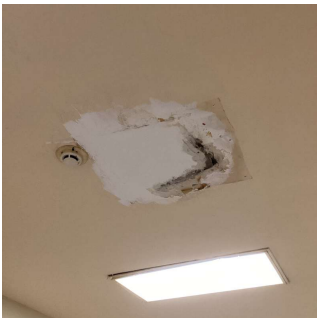
Question	Response
INTERIOR	
CLASSROOMS/CORRIDORS/ADMIN SPACES	
Ceiling	
Deficiency	GYPSUM BOARD: DAMAGED/DETERIORATED - ACTIVE LEAK
Deficiency Location/Instance	Corridor near Room 449
Deficiency Quantity	10
Quantity Uom	S.F.
Potential Action	REPLACE
Urgency of Action	PRIORITY 5
Purpose of Action	LEVEL 2
Deficiency Photo1

Corridor near Room 449
Violations	No violations recorded.
Deficiency	GYPSUM BOARD: DAMAGED/DETERIORATED
Deficiency Location/Instance	Corridor near Rooms B15, 113, 247, 305, 403, and others
Deficiency Quantity	650
Quantity Uom	S.F.
Potential Action	REPLACE
Urgency of Action	PRIORITY 3
Purpose of Action	LEVEL 2
Deficiency Photo1

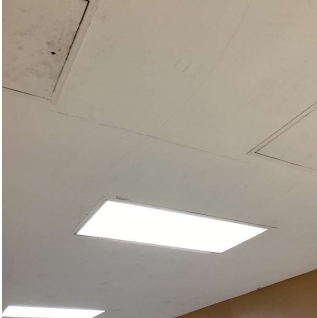
Corridor near Room B15
Violations	No violations recorded.
Door(s)	Inspected
Condition	2 - Between Good and Fair
Deficiency	METAL: DAMAGED LOUVER
Deficiency Location/Instance	Room 237
Deficiency Quantity	1
Quantity Uom	EACH
Potential Action	MAINTENANCE
Urgency of Action	PRIORITY 3

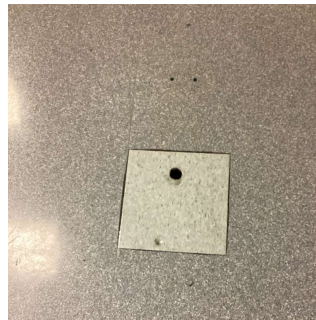
Room 330

VINYL TILES: BROKEN/DETERIORATED/MISSING TILES

REPLACE

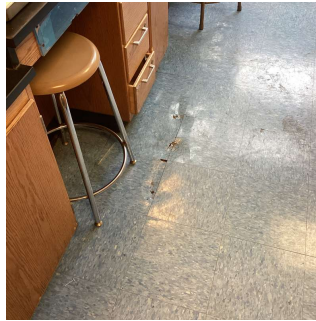
Violations	Main Entrance Vestibule No violations recorded.
Deficiency	VINYL TILES: DETERIORATED SUBSTRATE
Deficiency Location/Instance	Room 402
Deficiency Quantity	50
Quantity Uom	S.F.
Potential Action	REPLACE
Urgency of Action	PRIORITY 5

Purpose of Action	LEVEL 6

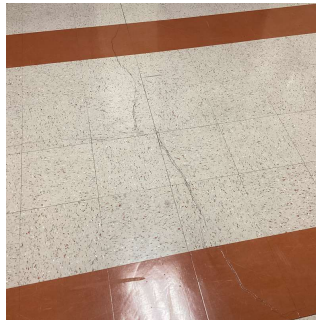
Corridor near Room 424

VINYL TILES: DETERIORATED SUBSTRATE

REPLACE

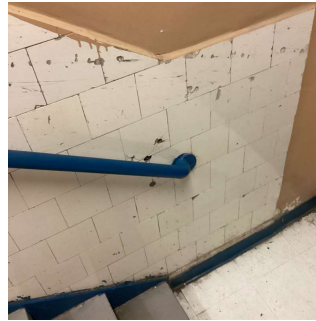
Exit 1 Vestibule

CERAMIC TILE: BROKEN/ MISSING

REPLACE

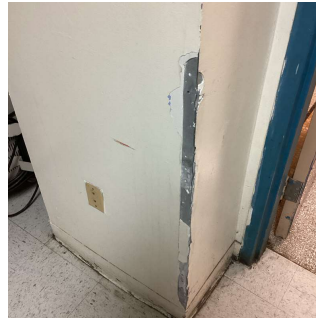
Room 150

GYPSUM BOARD: DETERIORATED

REPLACE

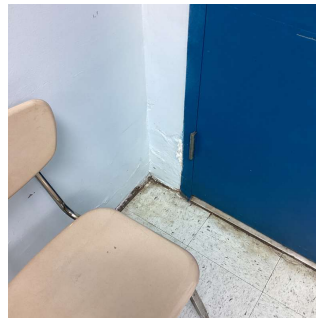
Room B41

PLASTER: CRACKS/SPALLING

REPLACE

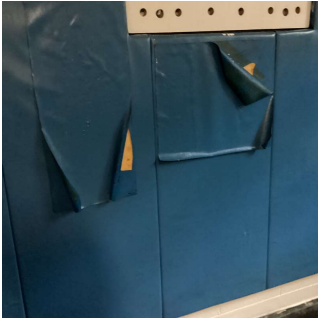
Question	Response
INTERIOR	
CLASSROOMS/CORRIDORS/ADMIN SPACES	
Walls	
Deficiency	WALL PADDING: DETERIORATED
Deficiency Location/Instance	Room B48
Deficiency Quantity	60
Quantity Uom	S.F.
Potential Action	REPLACE
Urgency of Action	PRIORITY 3
Purpose of Action	LEVEL 2
Deficiency Photo1

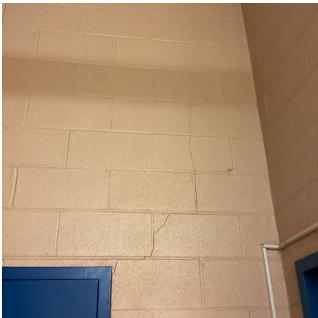
Room B48
Violations	No violations recorded.
Deficiency	MASONRY: CRACKS/SPALLING
Deficiency Location/Instance	Room 203, Corridor near Room B64
Deficiency Quantity	20
Quantity Uom	S.F.
Potential Action	REPLACE
Urgency of Action	PRIORITY 3
Purpose of Action	LEVEL 2
Deficiency Photo1

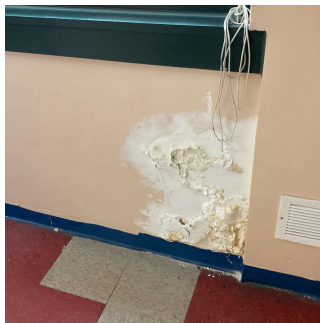
Room 203
Violations	No violations recorded.
Deficiency	PLASTER: CRACKS/SPALLING - ACTIVE LEAK
Deficiency Location/Instance	Room 417
Deficiency Quantity	10
Quantity Uom	S.F.
Potential Action	REPLACE
Urgency of Action	PRIORITY 5
Purpose of Action	LEVEL 2

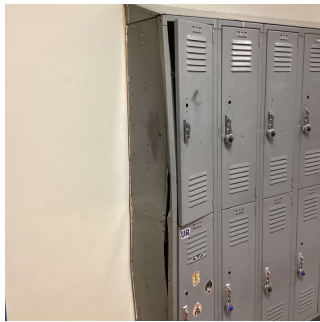
Room 417
Violations	No violations recorded.
Specialties	Inspected
Classroom Locker(s)	Inspected
Condition	2 - Between Good and Fair
Deficiency	DAMAGED UNITS
Deficiency Location/Instance	Corridor near Rooms 204, 249, 441, 449
Deficiency Quantity	6
Quantity Uom	EACH
Potential Action	REPLACE
Urgency of Action	PRIORITY 3
Purpose of Action	LEVEL 2
Deficiency Photo1

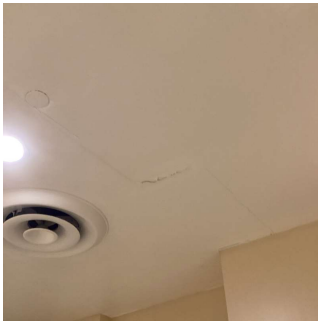
Corridor near Room 449
Violations	No violations recorded.
Fixed Seating	Does not Exist
GYMNASIUM	Inspected
Instance on Basement (Balcony - 191 Seats)	Inspected
Ceiling	Inspected
Instance on Basement (Balcony - 191 Seats)	Inspected
Condition	2 - Between Good and Fair
Deficiency	GYPSUM BOARD: DAMAGED/DETERIORATED
Deficiency Location/Instance	Near Main Entrance
Deficiency Quantity	20
Quantity Uom	S.F.
Potential Action	REPLACE
Urgency of Action	PRIORITY 3
Purpose of Action	LEVEL 2

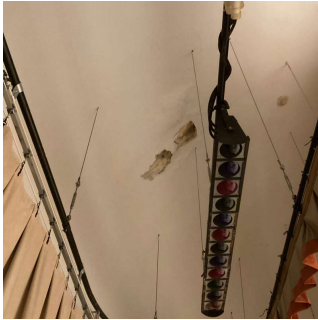
Near Main Entrance No violations recorded.
Deficiency Deficiency Location/Instance Deficiency Quantity Quantity Uom Potential Action Urgency of Action Purpose of Action Deficiency Photo1 Violations	PLASTER: CRACKS/SPALLING Stage 20 S.F. REPLACE PRIORITY 3 LEVEL 2

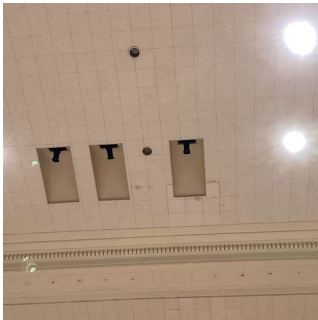
Center No violations recorded.

Stage No violations recorded.
Deficiency Deficiency Location/Instance Deficiency Quantity Quantity Uom Potential Action Urgency of Action Purpose of Action Deficiency Photo1 Violations	ACOUSTIC TILES ON PLASTER: DAMAGED/MISSING Center 10 S.F. REPLACE PRIORITY 3 LEVEL 2

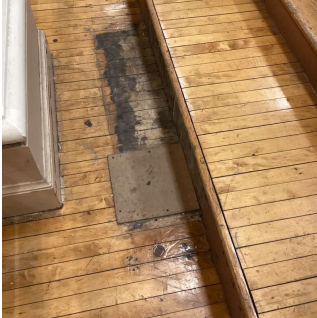
Deficiency	WOOD: DAMAGED/DETERIORATED

Question	Response
INTERIOR	
GYMNASIUM	
Floor Finish	
Deficiency Location/Instance	Balcony
Deficiency Quantity	100
Quantity Uom	S.F.
Potential Action	REPLACE
Urgency of Action	PRIORITY 5
Purpose of Action	LEVEL 6
Deficiency Photo1

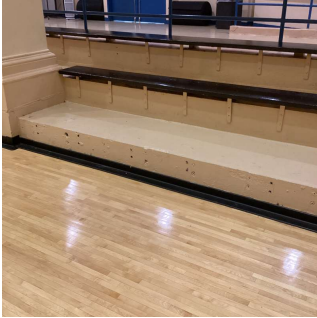
Violations	Balcony No violations recorded.
Seating	
Instance on Basement (Balcony - 191 Seats)	Inspected
Condition	5 - Poor
Deficiency	DAMAGED BLEACHERS
Deficiency Location/Instance	Right Side
Deficiency Quantity	20
Quantity Uom	S.F.
Potential Action	REPLACE
Urgency of Action	PRIORITY 3
Purpose of Action	LEVEL 2
Deficiency Photo1

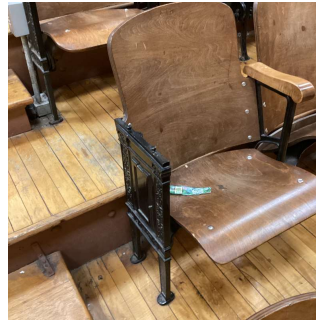
Seat C/28

Violations	Right Side No violations recorded.
Deficiency	DAMAGED FIXED SEATING
Deficiency Location/Instance	Seats C/28, D/5, E/10, 12, 14
Deficiency Quantity	5
Quantity Uom	EACH
Potential Action	REPLACE
Urgency of Action	PRIORITY 5
Purpose of Action	LEVEL 6

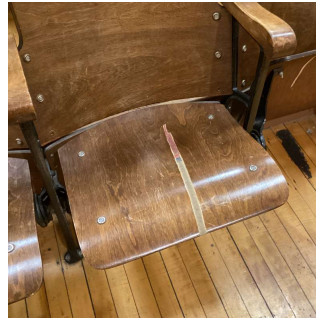
Seat A/23

DAMAGED FIXED SEATING

REPLACE

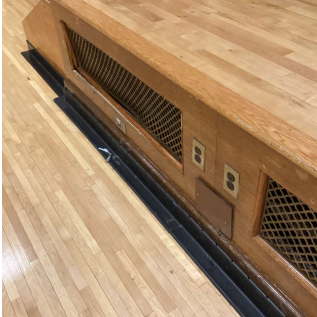
DAMAGED FASCIA

REPLACE

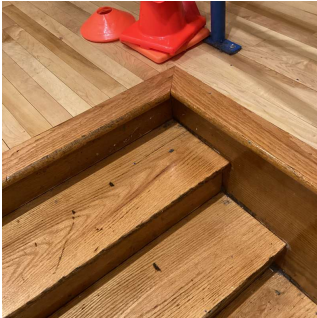
Violations	Right Side No violations recorded.
Deficiency	DAMAGED STEPS
Deficiency Location/Instance	Left Side
Deficiency Quantity	10
Quantity Uom	S.F.
Potential Action	REPLACE
Urgency of Action	PRIORITY 3
Purpose of Action	LEVEL 2
Deficiency Photo1

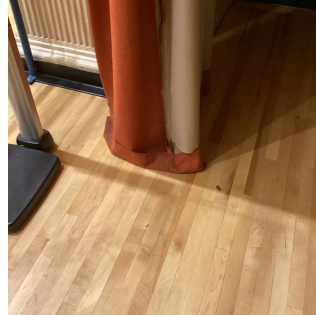
Violations	Left Side No violations recorded.
Stage Curtain Rigging	Inspected
Instance on Basement (Balcony - 191 Seats)	Inspected
Condition	2 - Between Good and Fair
Deficiency	No deficiencies recorded
Stage Curtains	Inspected
Instance on Basement (Balcony - 191 Seats)	Inspected
Condition	3 - Fair
Deficiency	WORN/DETERIORATED
Deficiency Location/Instance	Right Side
Deficiency Quantity	200
Quantity Uom	S.F.
Potential Action	REPLACE
Urgency of Action	PRIORITY 3
Purpose of Action	LEVEL 2

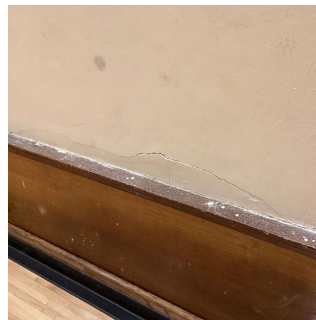
Instance on Basement (Balcony - 191 Seats)	Inspected
Condition	2 - Between Good and Fair
Deficiency	PLASTER: CRACKS/SPALLING
Deficiency Location/Instance	Equipment Closet, Right Side, Left Side of Stage
Deficiency Quantity	30
Quantity Uom	S.F.
Potential Action	REPLACE
Urgency of Action	PRIORITY 3
Purpose of Action	LEVEL 2
Deficiency Photo1

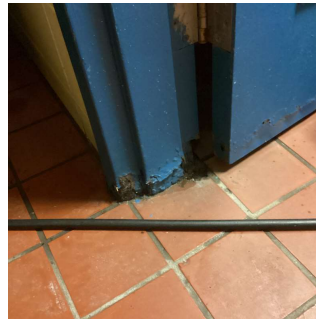
Can Wash Room

Instance on Basement	Inspected
Condition	4 - Between Fair and Poor
Deficiency	METAL: DETERIORATED DOOR AND FRAME
Deficiency Location/Instance	Can Wash Room, Near Locker Rooms
Deficiency Quantity	2
Quantity Uom	EACH
Potential Action	MAINTENANCE
Urgency of Action	PRIORITY 3
Purpose of Action	LEVEL 2
Deficiency Photo1

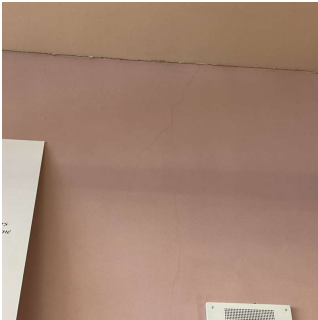
Question	Response
INTERIOR	
LIBRARY	
Walls	
Instance on Room 350	Inspected
Condition	2 - Between Good and Fair
Deficiency	PLASTER: CRACKS/SPALLING
Deficiency Location/Instance	Rear, Near Entrance
Deficiency Quantity	20
Quantity Uom	S.F.
Potential Action	REPLACE
Urgency of Action	PRIORITY 3
Purpose of Action	LEVEL 2
Deficiency Photo1

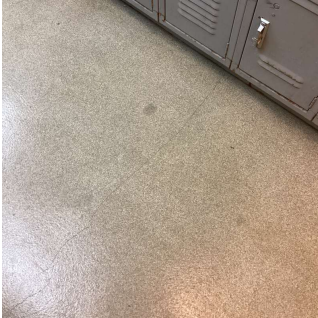
Near Toilet Room
Violations	No violations recorded.

Center
Violations	No violations recorded.
Instance on Basement - Boys (880 Lockers)	Inspected
Condition	2 - Between Good and Fair
Deficiency	EPOXY FLOORING: CRACKS/SPALLING
Deficiency Location/Instance	Near Toilet Room
Deficiency Quantity	15
Quantity Uom	S.F.
Potential Action	REPLACE
Urgency of Action	PRIORITY 3

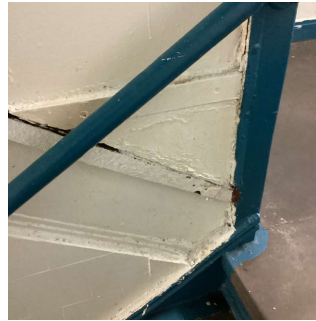
Stair GH/Basement

Stair EF/4
Violations	No violations recorded.
Deficiency	METAL PANEL: DAMAGED/DETERIORATED
Deficiency Location/Instance	Stairs EF/Basement, GH/Basement
Deficiency Quantity	10
Quantity Uom	S.F.
Potential Action	REPLACE
Urgency of Action	PRIORITY 3
Purpose of Action	LEVEL 2

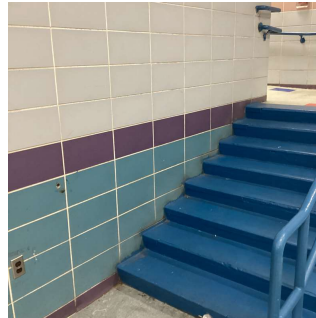
Cafeteria

METAL: MISSING

REPLACE

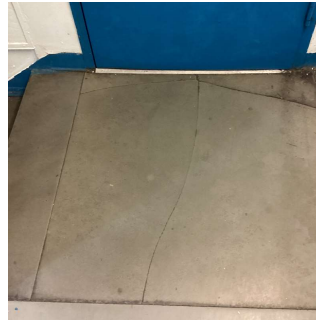
Stair CD/2

STONE: BROKEN/MISSING

REPLACE

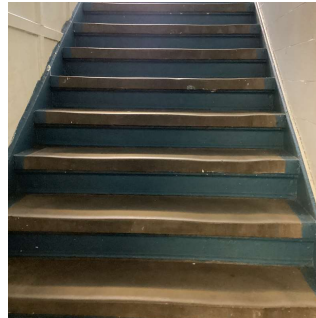
Stair GH/1

STONE: WORN-OUT TREAD/NOSINGS

REPLACE

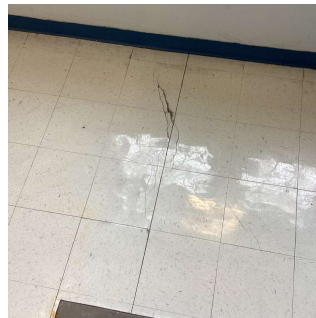
Stair GH/3

VINYL TILES: DETERIORATED SUBSTRATE

REPLACE

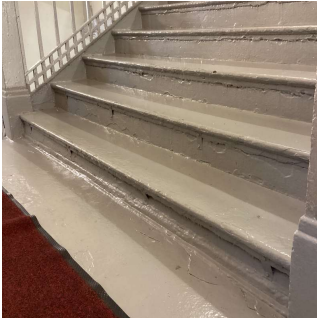
Question	Response
INTERIOR	
STAIRS/RAMPS: INTERIOR	
Stairs and Landings	
Deficiency	METAL: DETERIORATED
Deficiency Location/Instance	Exit 4
Deficiency Quantity	40
Quantity Uom	S.F.
Potential Action	REPLACE
Urgency of Action	PRIORITY 3
Purpose of Action	LEVEL 2
Deficiency Photo1

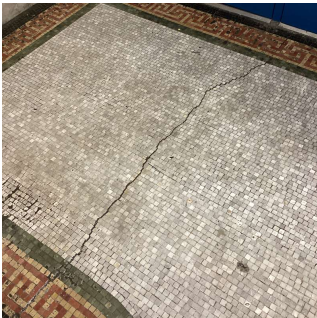
Violations	Exit 4 No violations recorded.
Deficiency	CERAMIC TILE: BROKEN/MISSING
Deficiency Location/Instance	Exit 2, Exit 4
Deficiency Quantity	50
Quantity Uom	S.F.
Potential Action	REPLACE
Urgency of Action	PRIORITY 3
Purpose of Action	LEVEL 2
Deficiency Photo1

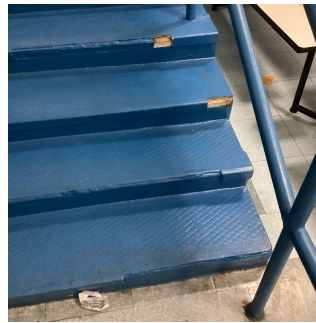
Cafeteria

Violations	Exit 4 No violations recorded.
Deficiency	SHEET VINYL: BROKEN/DETERIORATED
Deficiency Location/Instance	Cafeteria, Gymnasium
Deficiency Quantity	100
Quantity Uom	S.F.
Potential Action	REPLACE
Urgency of Action	PRIORITY 3
Purpose of Action	LEVEL 2

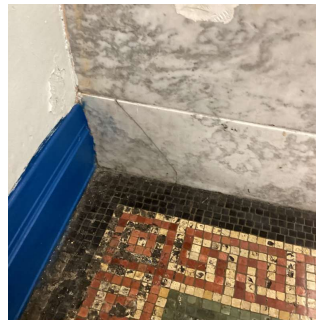
Exit 4

STONE MOLDINGS: CRACKS/SPALLING

REPLACE

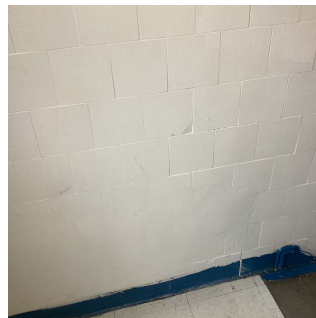
CERAMIC TILE: BROKEN/ MISSING

REPLACE

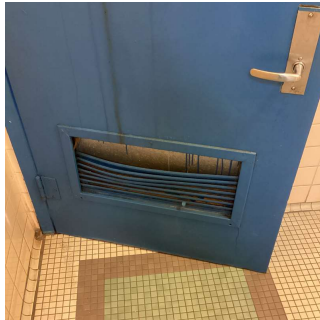
Violations	Room 418 No violations recorded.
Door(s)	
Condition	Inspected 5 - Poor
Deficiency	METAL: DAMAGED LOUVER
Deficiency Location/Instance	Rooms 218, 220, 318, 418, 420, and others
Deficiency Quantity	8
Quantity Uom	EACH
Potential Action	MAINTENANCE
Urgency of Action	PRIORITY 3
Purpose of Action	LEVEL 2
Deficiency Photo1
