NYC Department of Education
Building Condition Assessment Survey 2023 - 2024

Architectural Inspection

K656

Asset: BKLYN HS OF THE ARTS AX (S J HL)-K, 500 PACIFIC STREET, New York, 11217

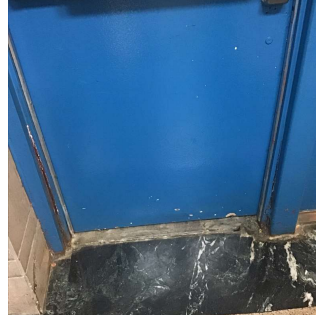
Facade A - Exit 2

PRIORITY 4
LEVEL 2

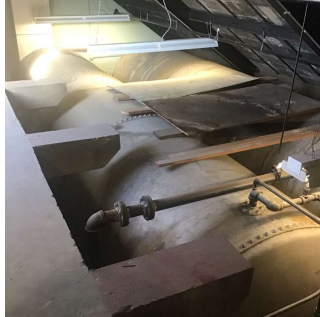
Roof 3
Instance Quantity	1,000
Instance Quantity Uom	S.F.
ROOFING DRAINS	Under Construction
Specialties	Inspected
BULKHEAD/PENTHOUSE	Under Construction
CUPOLA/ SPIRES/ TOWERS	Does not Exist
DORMER	Does not Exist
DUNNAGE STEEL	Does not Exist
SKYLIGHT/ROOF VENT	Does not Exist
ROOF/GRAVITY TANK	Inspected
Condition	3 - Fair
Deficiency	TANK: NOT IN USE - MINOR DETERIORATION
Roof Plan reference	K656

Deficiency Quantity	2
Quantity Uom	EACH
Potential Action	NO ACTION
Urgency of Action	PRIORITY 1
Purpose of Action	LEVEL 1

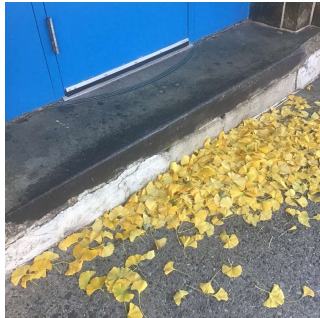
Violations	Room 450 No violations recorded.
STAIRS/RAMPS: EXTERIOR	Inspected
BUILDING CHEEK/FLANK WALLS	Does not Exist
RAILINGS	Does not Exist
STAIRS/RAMPS	Inspected
Condition	5 - Poor
Deficiency	CONCRETE: CRACKS/SPALLING - MAJOR
Roof Plan reference	K656
Deficiency Quantity	30
Quantity Uom	S.F.
Potential Action	REPLACE
Urgency of Action	PRIORITY 4
Purpose of Action	LEVEL 2
Deficiency Photo1

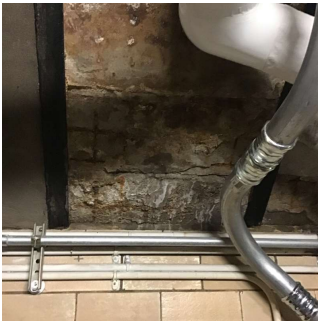
Question	Response
INTERIOR	
STRUCTURAL	
FOUNDATION WALLS	
Purpose of Action	LEVEL 5
Deficiency Photo1	 
	Boiler Room
Violations	No violations recorded.
ROOF STRUCTURE	
Condition	Inspected
Deficiency	3 - Fair
Deficiency Location/Instance	CONCRETE: CRACKED/SPALLED/REINFORCEMENT EXPOSED
Deficiency Quantity	Room 458
Quantity Uom	50
Potential Action	S.F.
Urgency of Action	REPAIR
Purpose of Action	PRIORITY 3
Deficiency Photo1	LEVEL 5

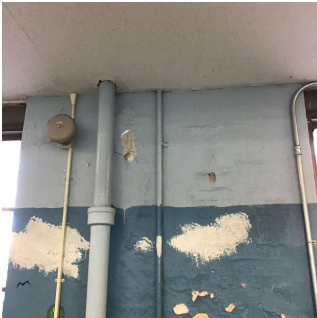
Question	Response
INTERIOR	
CAFETERIA	
Ceiling	
Deficiency Photo1	 
Violations	Near Main Entrance No violations recorded.
Door(s)	
Instance on 3rd Floor	Inspected
Condition	2 - Between Good and Fair
Deficiency	No deficiencies recorded
Fixed Equipment	
Instance on 3rd Floor	Does not Exist
Floor Finish	
Instance on 3rd Floor	Inspected
Condition	2 - Between Good and Fair
Deficiency	VINYL TILES: BROKEN/DETERIORATED/MISSING TILES
Deficiency Location/Instance	Right and Center Side, Near Servery
Deficiency Quantity	50
Quantity Uom	S.F.
Potential Action	REPLACE
Urgency of Action	PRIORITY 3
Purpose of Action	LEVEL 2
Deficiency Photo1	 
Violations	Right Side No violations recorded.
Sliding-folding Partition	
Instance on 3rd Floor	Does not Exist
Stage	
Instance on 3rd Floor	Does not Exist
Walls	
Instance on 3rd Floor	Inspected
Condition	2 - Between Good and Fair
Deficiency	PLASTER: CRACKS/SPALLING
Deficiency Location/Instance	Right and Left Side Windows

Question	Response
INTERIOR	
CAFETERIA	
Walls	
Deficiency Quantity	20
Quantity Uom	S.F.
Potential Action	REPLACE
Urgency of Action	PRIORITY 3
Purpose of Action	LEVEL 2
Deficiency Photo1

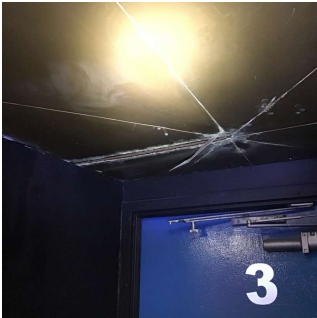
Violations	Left Side Windows No violations recorded.
Window Curtains/Shades/Blinds	
Instance on 3rd Floor	Does not Exist
CLASSROOMS/CORRIDORS/ADMIN SPACES	
Ceiling	
Condition	Inspected
Deficiency	4 - Between Fair and Poor
Deficiency Location/Instance	GYPSUM BOARD: DAMAGED/DETERIORATED - ACTIVE LEAK
Deficiency Quantity	Room 168
Quantity Uom	10
Potential Action	S.F.
Urgency of Action	REPLACE
Purpose of Action	PRIORITY 5
Deficiency Photo1	LEVEL 2
Violations

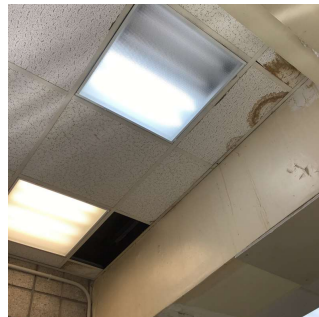
Room 168 No violations recorded.
Deficiency	ACOUSTIC TILES: DAMAGED/MISSING
Deficiency Location/Instance	Room 356,167,162, Main Entrance Lobby, Corridor near Rooms M54 and others
Deficiency Quantity	950
Quantity Uom	S.F.
Potential Action	REPLACE
Urgency of Action	PRIORITY 3

Question	Response
INTERIOR	
CLASSROOMS/CORRIDORS/ADMIN SPACES	
Ceiling	
Purpose of Action	LEVEL 2
Deficiency Photo1

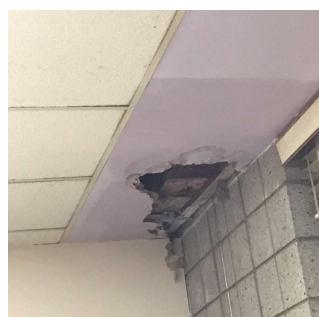
Violations	Main Entrance Lobby
Violations	No violations recorded.
Deficiency	GYPSUM BOARD: DAMAGED/DETERIORATED
Deficiency Location/Instance	Room 162, Main Entrance Lobby, Corridor near Girls Lockers Room - Basement
Deficiency Quantity	60
Quantity Uom	S.F.
Potential Action	REPLACE
Urgency of Action	PRIORITY 3
Purpose of Action	LEVEL 2
Deficiency Photo1

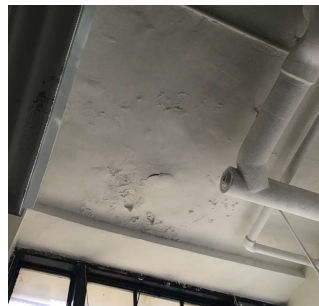
Violations	Room 162
Violations	No violations recorded.
Deficiency	PLASTER: CRACKS/SPALLING
Deficiency Location/Instance	Corridor near Room 454, In Room 155, Rooms 167,271,459 and others
Deficiency Quantity	200
Quantity Uom	S.F.
Potential Action	REPLACE
Urgency of Action	PRIORITY 3
Purpose of Action	LEVEL 2
Deficiency Photo1

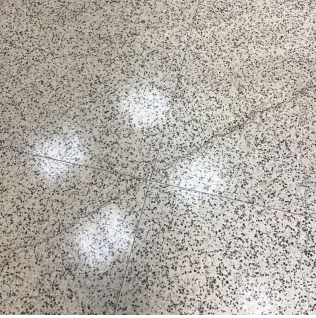
Room 459
Violations	No violations recorded.
Floor Finish	Inspected
Condition	2 - Between Good and Fair
Deficiency	TERRAZZO: CRACKS
Deficiency Location/Instance	Main Entrance Lobby
Deficiency Quantity	50
Quantity Uom	S.F.
Potential Action	REPLACE

Question	Response
INTERIOR	
CLASSROOMS/CORRIDORS/ADMIN SPACES	
Floor Finish	
Urgency of Action	PRIORITY 3
Purpose of Action	LEVEL 2
Deficiency Photo1

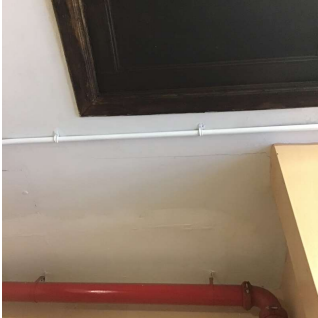
Question	Response
INTERIOR	
STAIRS/RAMPS: INTERIOR	
Ceiling	Inspected
Condition	2 - Between Good and Fair
Deficiency	PLASTER: CRACKS/SPALLING
Deficiency Location/Instance	Stair F/3
Deficiency Quantity	10
Quantity Uom	S.F.
Potential Action	REPLACE
Urgency of Action	PRIORITY 3
Purpose of Action	LEVEL 2
Deficiency Photo1

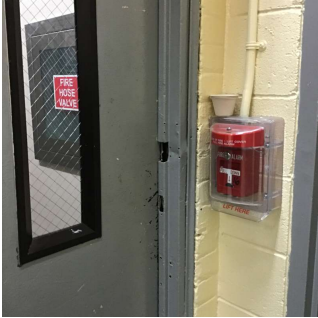
Violations	Stair F/3 No violations recorded.
Door(s)	Inspected
Condition	3 - Fair
Deficiency	METAL: DETERIORATED DOOR AND FRAME
Deficiency Location/Instance	Stair G/3
Deficiency Quantity	1
Quantity Uom	EACH
Potential Action	MAINTENANCE
Urgency of Action	PRIORITY 3
Purpose of Action	LEVEL 2
Deficiency Photo1

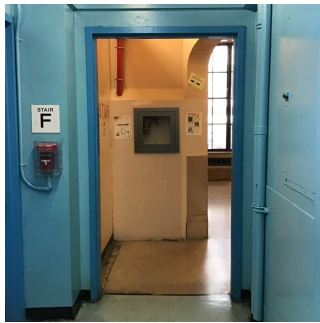
Violations	Stair G/3 No violations recorded.
Deficiency	METAL: MISSING DOOR
Deficiency Location/Instance	Stair F/2
Deficiency Quantity	1
Quantity Uom	EACH
Potential Action	MAINTENANCE
Urgency of Action	PRIORITY 5
Purpose of Action	LEVEL 6

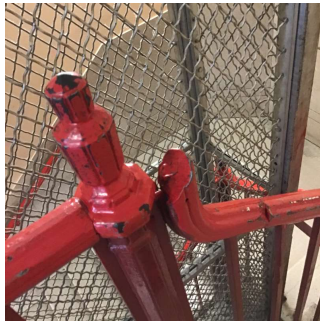
Violations	Stair F/2 35671707Z
Partition	Does not Exist
Railings	Inspected
Condition	5 - Poor
Deficiency	METAL: DAMAGED
Deficiency Location/Instance	Stair F/3
Deficiency Quantity	10
Quantity Uom	L.F.
Potential Action	REPLACE
Urgency of Action	PRIORITY 3
Purpose of Action	LEVEL 2
Deficiency Photo1

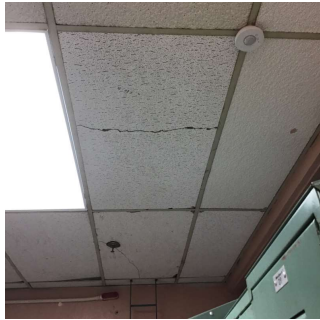
Violations	Stair G/1 No violations recorded.
TOILET ROOMS - STAFF	Inspected
Ceiling	Inspected
Condition	5 - Poor
Deficiency	ACOUSTIC TILES: DAMAGED/MISSING
Deficiency Location/Instance	Rooms 361,360
Deficiency Quantity	60
Quantity Uom	S.F.
Potential Action	REPLACE
Urgency of Action	PRIORITY 3
Purpose of Action	LEVEL 2
Deficiency Photo1

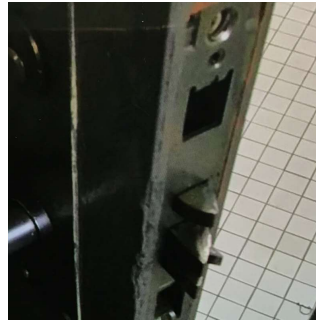
Violations	Women Kitchen Locker Room No violations recorded.
Door(s)	Inspected
Condition	5 - Poor
Deficiency	WOOD: DETERIORATED DOOR
Deficiency Location/Instance	Room M63
Deficiency Quantity	1
Quantity Uom	EACH
Potential Action	MAINTENANCE
Urgency of Action	PRIORITY 3
Purpose of Action	LEVEL 2

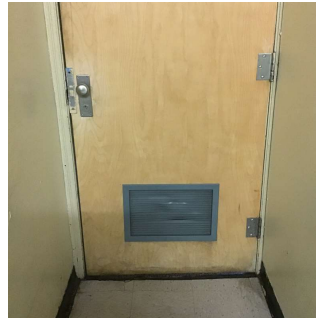
Room 155

WOOD: DAMAGED LOUVER

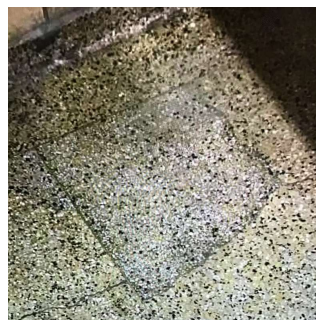
TERRAZZO: CRACKS

REPLACE

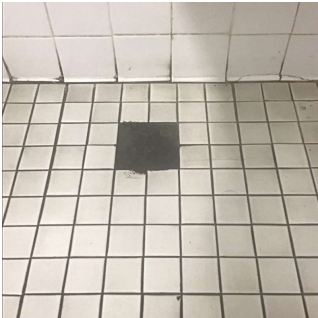
Question	Response
INTERIOR	
TOILET ROOMS - STAFF	
Floor Finish	
Violations	Room 156 No violations recorded.
Deficiency	CERAMIC TILE: BROKEN/MISSING TILES
Deficiency Location/Instance	Rooms 269,360
Deficiency Quantity	30
Quantity Uom	S.F.
Potential Action	REPLACE
Urgency of Action	PRIORITY 3
Purpose of Action	LEVEL 2
Deficiency Photo1

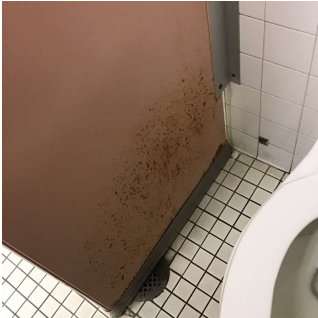
Violations	Room 269 No violations recorded.
Stalls	Inspected
Condition	5 - Poor
Deficiency	RUST - MAJOR
Deficiency Location/Instance	Rooms 361,360
Deficiency Quantity	2
Quantity Uom	EACH
Potential Action	REPLACE
Urgency of Action	PRIORITY 3
Purpose of Action	LEVEL 2
Deficiency Photo1

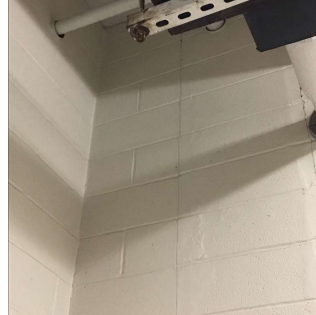
Room 267

Violations	Room 361 No violations recorded.
Walls	Inspected
Condition	3 - Fair
Deficiency	MASONRY: CRACKS/SPALLING
Deficiency Location/Instance	Rooms 267,269
Deficiency Quantity	40
Quantity Uom	S.F.
Potential Action	REPLACE

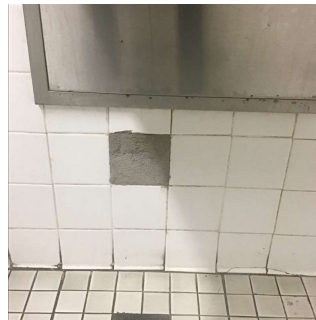
Room 269

CERAMIC TILE: BROKEN/ MISSING
Rooms 267,269,361
30
S.F.
REPLACE
PRIORITY 3
LEVEL 2

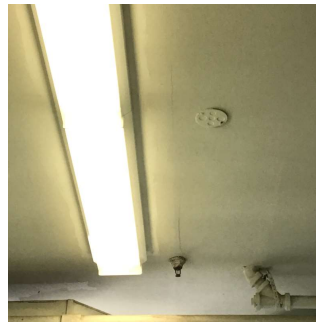
PLASTER: CRACKS/SPALLING
Room 278
10
S.F.
REPLACE
PRIORITY 3
LEVEL 2

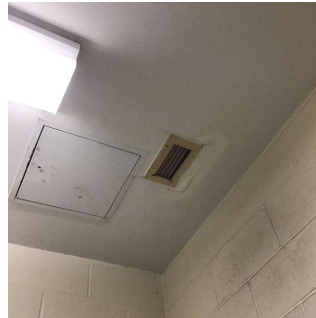
Room 351A

GYPSUM BOARD: DAMAGED/DETERIORATED

REPLACE

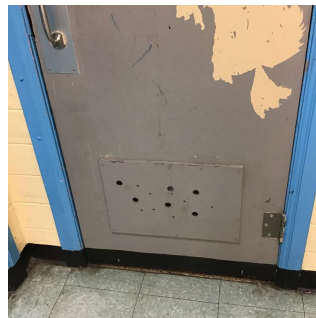
WOOD: DAMAGED LOUVER

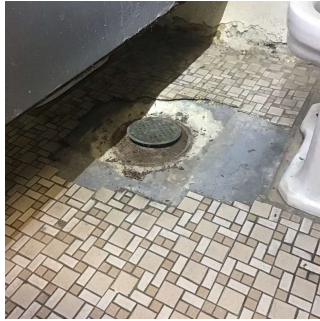
Question	Response
INTERIOR	
TOILET ROOMS - STUDENTS	
Door(s)	
Violations	Room 151 No violations recorded.
Deficiency	METAL: DETERIORATED DOOR
Deficiency Location/Instance	Girls Toilet Room - 4th Floor
Deficiency Quantity	1
Quantity Uom	EACH
Potential Action	MAINTENANCE
Urgency of Action	PRIORITY 3
Purpose of Action	LEVEL 2
Deficiency Photo1	 
Violations	Girls Toilet Room - 4th Floor No violations recorded.
Deficiency	METAL: DAMAGED LOUVER
Deficiency Location/Instance	Girls Toilet Room - 3rd Floor, Boys Toilet Room - 3rd Floor
Deficiency Quantity	2
Quantity Uom	EACH
Potential Action	MAINTENANCE
Urgency of Action	PRIORITY 3
Purpose of Action	LEVEL 2
Deficiency Photo1	 
Violations	Girls Toilet Room - 3rd Floor No violations recorded.
Floor Finish	Inspected
Condition	3 - Fair
Deficiency	CERAMIC TILE: BROKEN/MISSING TILES
Deficiency Location/Instance	Rooms 278,277, Boys Toilet Room - 4th Floor, Girls Toilet Room - 4th Floor

Deficiency Quantity	70
Quantity Uom	S.F.
Potential Action	REPLACE
Urgency of Action	PRIORITY 3

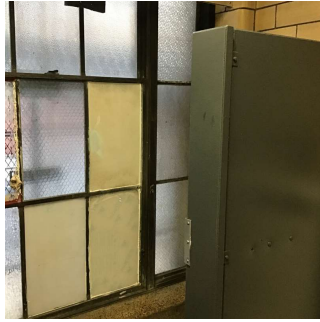
Violations	Boys Toilet Room - 4th Floor No violations recorded.
Stalls	
Condition	Inspected 5 - Poor
Deficiency	BROKEN/MISSING
Deficiency Location/Instance	Boys Toilet Room - 4th Floor, Room 151
Deficiency Quantity	2
Quantity Uom	EACH
Potential Action	REPLACE
Urgency of Action	PRIORITY 3
Purpose of Action	LEVEL 2
Deficiency Photo1

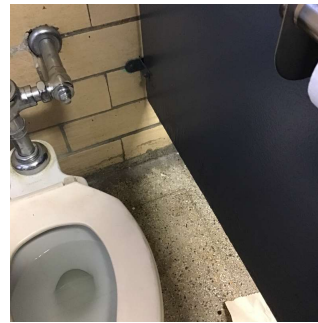
Violations	Room 151 No violations recorded.
Deficiency	RUST - MAJOR
Deficiency Location/Instance	Rooms 151,462,463
Deficiency Quantity	3
Quantity Uom	EACH
Potential Action	REPLACE
Urgency of Action	PRIORITY 3
Purpose of Action	LEVEL 2

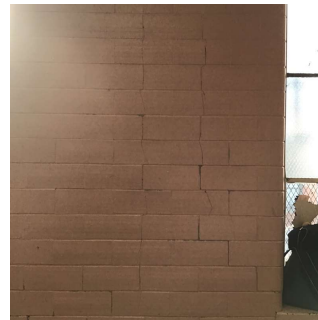
Room 277

MASONRY: CRACKS/SPALLING

REPLACE

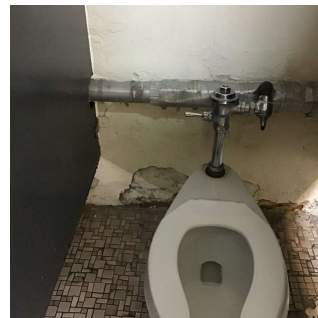
PLASTER: CRACKS/SPALLING

REPLACE

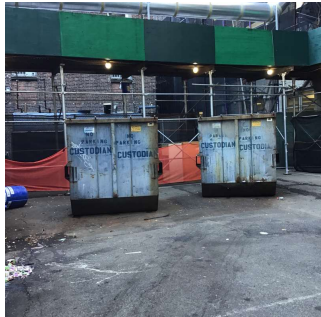
Question	Response
INTERIOR	Inspected
TOILET ROOMS - STUDENTS	Inspected
Walls	Inspected
Violations	Boys Toilet Room - 4th Floor No violations recorded.
LIFE SAFETY	Inspected
F.D. HOLDING AREA	Does not Exist
STEEL STAIRS	Does not Exist
SITE	Inspected
CONTAINERIZATION	Inspected
Condition	5 - Poor
Deficiency	CONTAINER DAMAGED
Deficiency Location/Instance	Pacific Street
Deficiency Quantity	2
Quantity Uom	EACH
Potential Action	REPLACE
Urgency of Action	PRIORITY 3
Purpose of Action	LEVEL 2
Deficiency Photo1

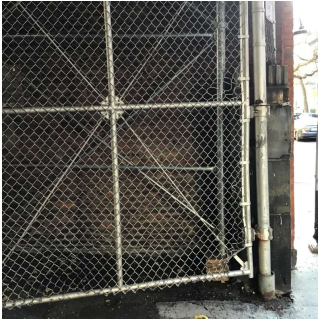
Violations	Pacific Street No violations recorded.
Drainage System for Asphalt	Inspected
Catch Basins/Manhole - Surrounded by asphalt	Inspected
Condition	2 - Between Good and Fair
Deficiency	No deficiencies recorded
Culverts - Asphalt Covering	Does not Exist
Drainage System for Concrete	Does not Exist
Drainage System for Soil	Does not Exist
DRINKING FOUNTAINS	Does not Exist
FENCES	Inspected
Condition	3 - Fair
Deficiency	CHAIN LINK: DAMAGED/DETERIORATED

Deficiency Location/Instance	Dean Street, Parking Lot
Deficiency Quantity	100
Quantity Uom	S.F.
Potential Action	REPLACE
Urgency of Action	PRIORITY 3
Purpose of Action	LEVEL 2

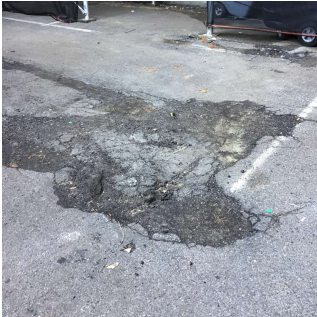
Violations	Parking Lot No violations recorded.
Deficiency	CRACKS - MAJOR
Deficiency Location/Instance	Parking Lot
Deficiency Quantity	600
Quantity Uom	S.F.
Potential Action	REPLACE
Urgency of Action	PRIORITY 5
Purpose of Action	LEVEL 6

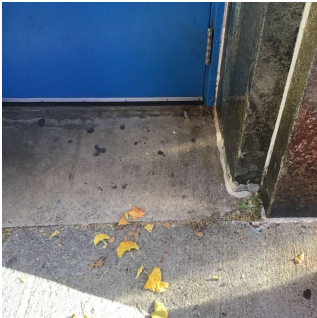
Pacific Street
Violations	No violations recorded.
Concrete	Does not Exist
Pavers	Does not Exist
Student Use	Does not Exist
Site Sidewalks & Walkways	Inspected
Asphalt	Does not Exist
Concrete	Inspected
Condition	3 - Fair
Deficiency	DAMAGED/DETERIORATED/MISSING SECTIONS
Deficiency Location/Instance	Dean Street, Pacific Street
Deficiency Quantity	100
Quantity Uom	S.F.
Potential Action	REPLACE
Urgency of Action	PRIORITY 3
Purpose of Action	LEVEL 2
Deficiency Photo1

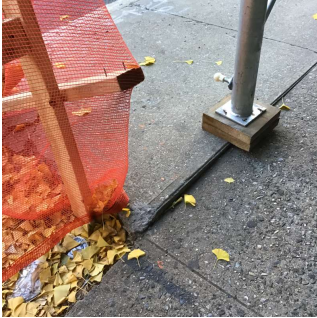
Dean Street
Violations	No violations recorded.
Pavers	Does not Exist
DOT Sidewalk	Inspected
Asphalt	Does not Exist
Concrete	Inspected
Condition	4 - Between Fair and Poor
Deficiency	HEAVING
Deficiency Location/Instance	3rd Avenue
Deficiency Quantity	100
Quantity Uom	S.F.

Question	Response
SITE	
PAVING	
DOT Sidewalk	
Concrete	
Potential Action	REPLACE
Urgency of Action	PRIORITY 4
Purpose of Action	LEVEL 4
Deficiency Photo1

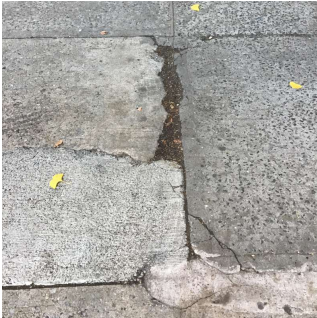
Violations	3rd Avenue 68717
Deficiency	DAMAGED/DETERIORATED/MISSING SECTIONS
Deficiency Location/Instance	3rd Avenue, Dean Street, Pacific Street
Deficiency Quantity	1,900
Quantity Uom	S.F.
Potential Action	REPLACE
Urgency of Action	PRIORITY 4
Purpose of Action	LEVEL 4
Deficiency Photo1

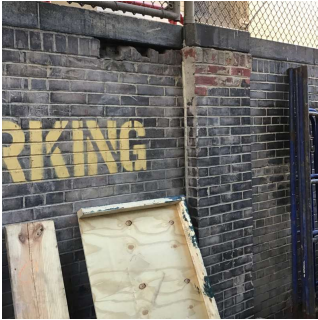
Question	Response
SITE	
PAVING	
DOT Sidewalk	
Concrete	Inspected
Deficiency Photo1	 
	3rd Avenue 68717
Violations	
Pavers	Does not Exist
PLAYGROUNDS	Does not Exist
PLAYING SURFACE	Does not Exist
RETAINING WALLS	Inspected
Are there any Retaining Walls 6' OR higher facing public street/sidewalk?	No
Condition	3 - Fair
Deficiency	BRICK: DETERIORATED COPING STONE
Deficiency Location/Instance	North East of Building
Deficiency Quantity	10
Quantity Uom	S.F.
Potential Action	REPLACE
Urgency of Action	PRIORITY 3
Purpose of Action	LEVEL 2
Deficiency Photo1	 
	North East of Building
Violations	No violations recorded.
Deficiency	BRICK: CRACKS/SPALLING - MAJOR
Deficiency Location/Instance	North East of Building
Deficiency Quantity	30
Quantity Uom	S.F.
Potential Action	REPLACE
Urgency of Action	PRIORITY 3
Purpose of Action	LEVEL 2

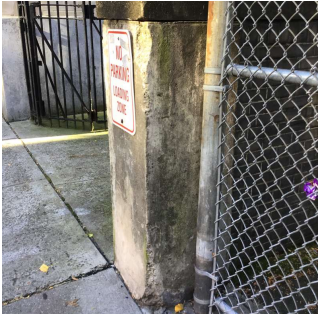
Violations	North East of Building No violations recorded.
Deficiency	CAST IN PLACE CONCRETE: CRACKS/SPALLING - MAJOR
Deficiency Location/Instance	Pacific Street
Deficiency Quantity	20
Quantity Uom	S.F.
Potential Action	REPLACE
Urgency of Action	PRIORITY 3
Purpose of Action	LEVEL 2
Deficiency Photo1

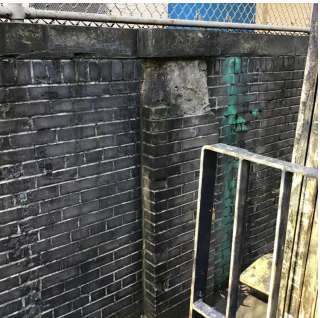
Question	Response
SITE	
SITE WALLS (NOT RETAINING WALLS)	
Violations	Pacific Street No violations recorded.
Deficiency	BRICK: CRACKS/SPALLING - MAJOR
Deficiency Location/Instance	North East Side of the Building
Deficiency Quantity	30
Quantity Uom	S.F.
Potential Action	REPLACE
Urgency of Action	PRIORITY 3
Purpose of Action	LEVEL 2
Deficiency Photo1
