NYC Department of Education
Building Condition Assessment Survey 2023 - 2024

Architectural Inspection

K660

Asset: WILLIAM MAXWELL CTE HS - K, 145 PENNSYLVANIA AVENUE, New York, 11207

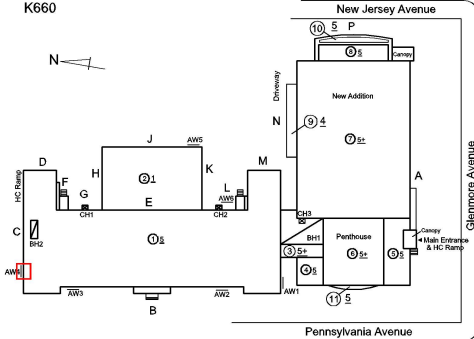
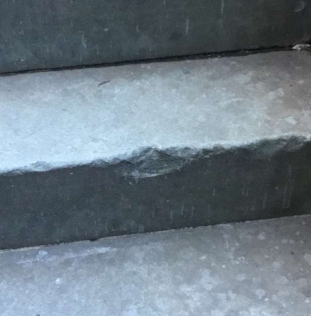
Question	Response
Architectural	
EXTERIOR	Inspected
AREAWAY	Inspected
Instance on AW1-AW6	Inspected
Instance Condition	3 - Fair
Instance Quantity	6
Instance Quantity Uom	EACH
Deficiency	AREAWAY STAIRS: DETERIORATED TREADS/RISERS/NOSINGS
Roof Plan reference

Deficiency Quantity	10
Quantity Uom	S.F.
Potential Action	REPAIR
Urgency of Action	PRIORITY 3
Purpose of Action	LEVEL 2
Deficiency Photo1

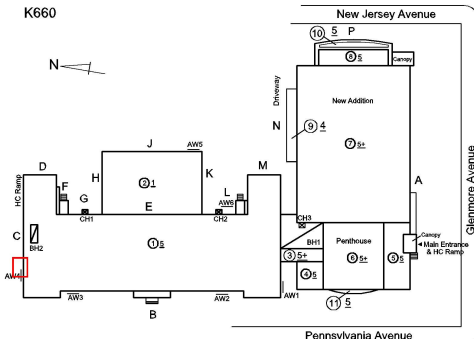
Violations	No violations recorded.
Deficiency	AREAWAY STAIRS: DETERIORATED TREADS/RISERS/NOSINGS
Roof Plan reference

Deficiency Quantity	15
Quantity Uom	S.F.
Potential Action	REPLACE
Urgency of Action	PRIORITY 5

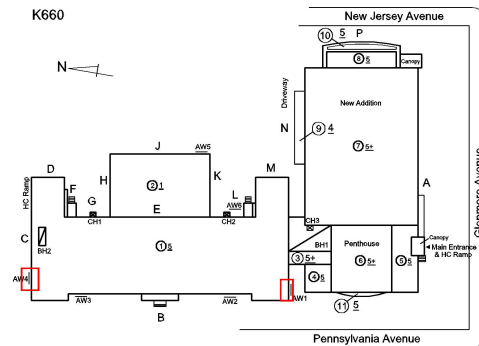
AREAWAY WALLS: CRACKS AND SPALLING

30
S.F.
REPLACE
PRIORITY 4
LEVEL 2

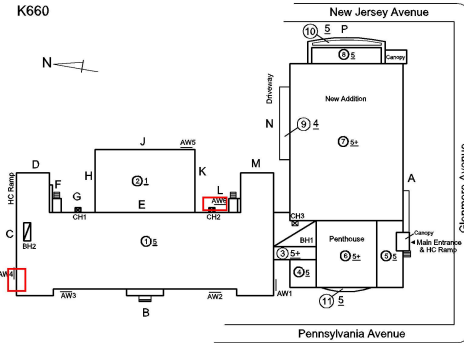
AREAWAY WALLS: DETERIORATED COPING STONE

40

REPLACE

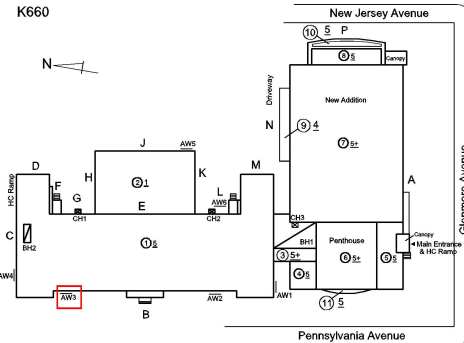
AREAWAY WALLS: CRACKS AND SPALLING

35

REPAIR

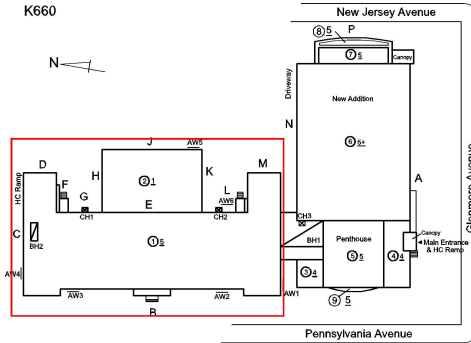
AW3
Violations	No violations recorded.
AWNINGS AND CANOPIES	
Condition	Inspected
Deficiency	2 - Between Good and Fair
	No deficiencies recorded
CHIMNEY	
Material Type(s)	Inspected
Condition	Masonry
	2 - Between Good and Fair
Deficiency	BRICK: DETERIORATED JOINTS
Roof Plan reference	 
Deficiency Quantity	10
Quantity Uom	S.F.
Potential Action	REPOINT
Urgency of Action	PRIORITY 3
Purpose of Action	LEVEL 2
Deficiency Photo1	 
	CH2
Violations	No violations recorded.
COPING	
Condition	Inspected
Deficiency	3 - Fair
	CAST STONE: DETERIORATED TRANSVERSE JOINTS

150
L.F.
MAINTENANCE
PRIORITY 3
LEVEL 2

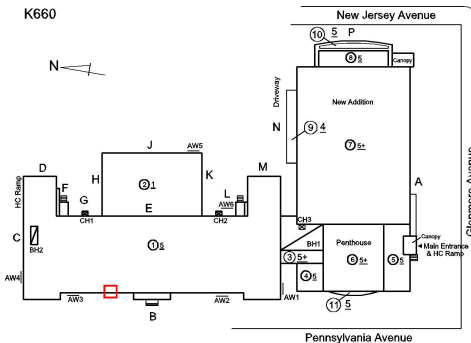
STONE: MINOR CRACKS, SPALLING

10
S.F.
REPAIR
PRIORITY 3
LEVEL 2

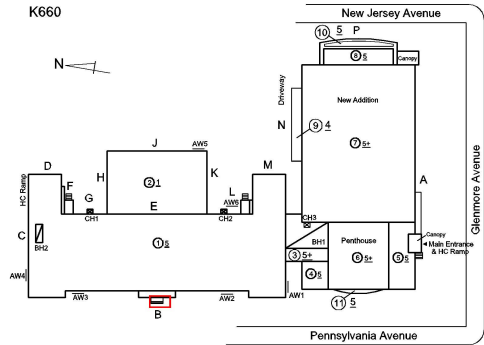
Violations	Facade A No violations recorded.
DOORS	Inspected
DOORS AND FRAMES	Inspected
Condition	4 - Between Fair and Poor
Deficiency	METAL: DETERIORATED DOOR - MINOR DETERIORATION
Roof Plan reference	<p>K660</p>

Deficiency Quantity	1
Quantity Uom	EACH
Potential Action	MAINTENANCE
Urgency of Action	PRIORITY 3
Purpose of Action	LEVEL 2
Deficiency Photo1

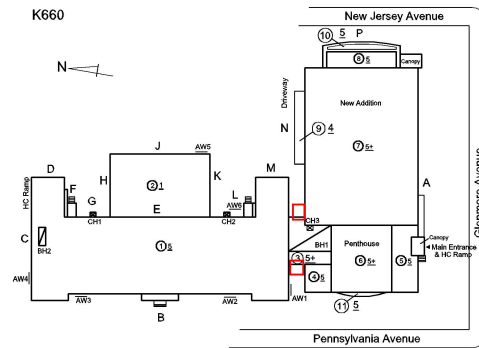
Violations	Facade A No violations recorded.
Deficiency	METAL: DETERIORATED DOOR AND FRAME - MAJOR DETERIORATION

4
 EACH
 REPLACE
 PRIORITY 4
 LEVEL 2

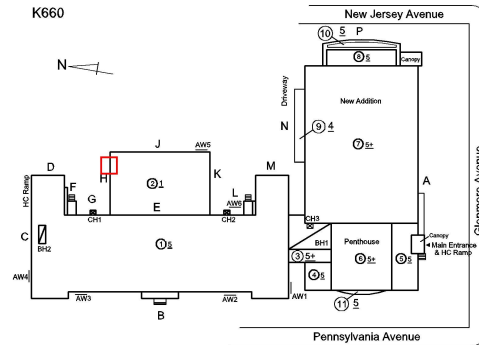
METAL: DETERIORATED DOOR AND FRAME - MINOR DETERIORATION

2
 EACH
 MAINTENANCE
 PRIORITY 3
 LEVEL 2

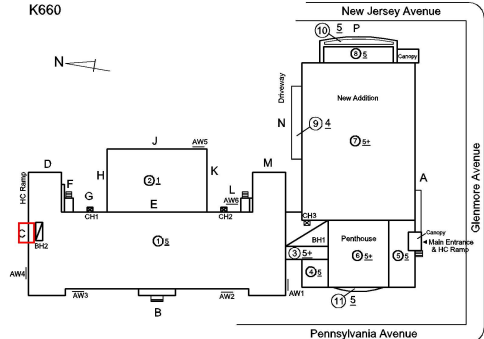
Violations	Facade H - Exit 11 No violations recorded.
DOOR HARDWARE	Inspected
Condition	3 - Fair
Deficiency	No deficiencies recorded
LINTELS	Inspected
Condition	2 - Between Good and Fair
Deficiency	STONE: CHIPPED/SPALLED/BROKEN PIECES
Roof Plan reference

Deficiency Quantity	20
Quantity Uom	S.F.
Potential Action	REPAIR
Urgency of Action	PRIORITY 3
Purpose of Action	LEVEL 2
Deficiency Photo1

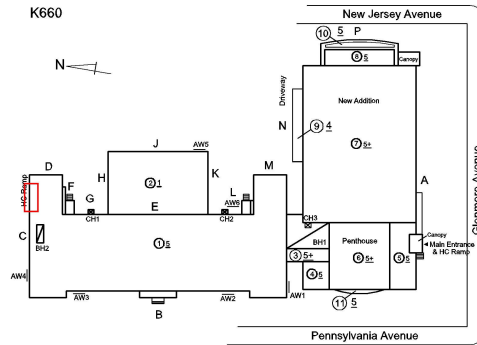
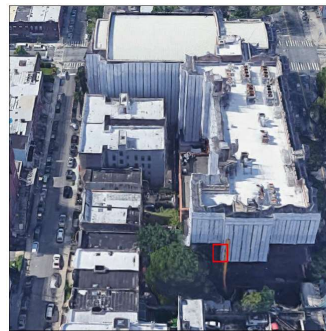
Question	Response
EXTERIOR	
EXTERIOR WALLS	
Material Type(s)	Masonry, Steel
Replacement Quantity	65,000
Replacement Uom	S.F.
Instance on All Facades	Inspected
Instance Condition	3 - Fair
Instance Quantity	65,000
Instance Quantity Uom	S.F.
Deficiency	BRICK: DETERIORATED CONTROL/EXPANSION JOINTS
Roof Plan reference	 
Elevation	 
Deficiency Quantity	15
Quantity Uom	L.F.
Potential Action	MAINTENANCE
Urgency of Action	PRIORITY 3
Purpose of Action	LEVEL 2
Deficiency Photo1	 
Violations	Facade P No violations recorded.
Deficiency	BRICK: DETERIORATED MASONRY SILLS - MINOR

20

REPAIR

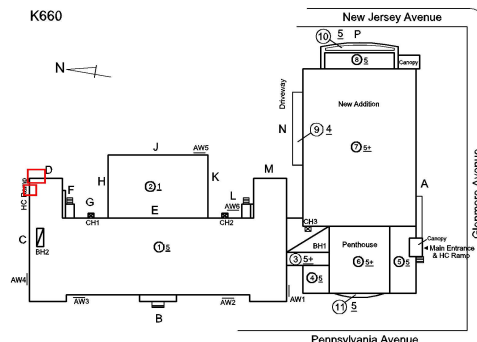
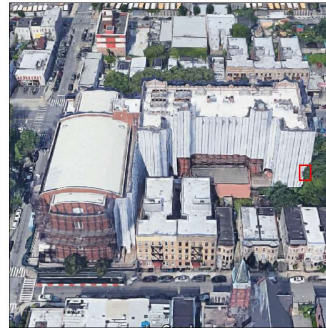
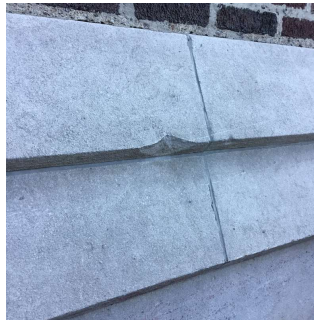
Facade C

STONE: CHIPPED/SPALLED/BROKEN PIECES - MINOR

25

REPAIR

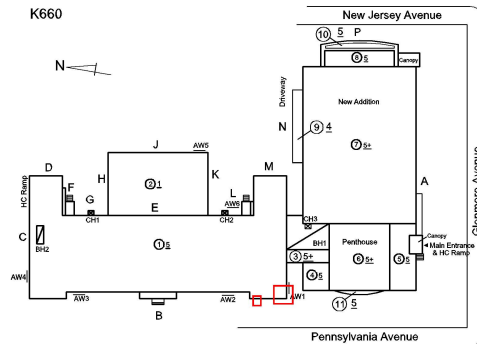
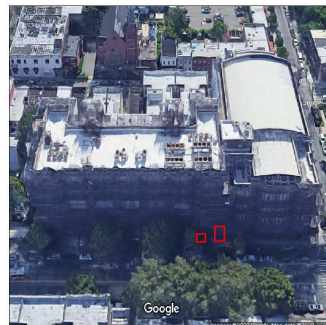
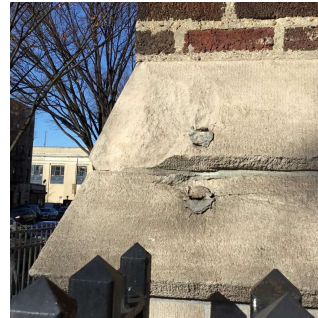
Facade A

STONE: CHIPPED/SPALLED/BROKEN PIECES - MAJOR

20

REPLACE

PRIORITY 4
LEVEL 2

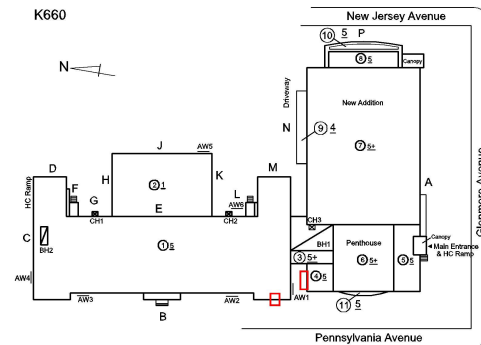
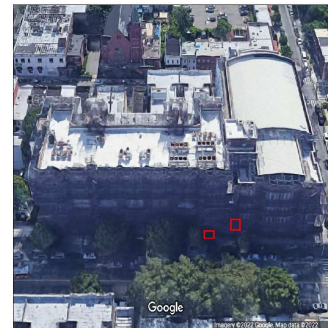
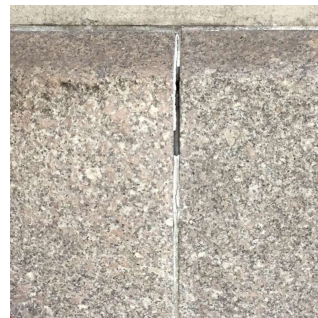
Facade A

STONE: DETERIORATED JOINTS

20

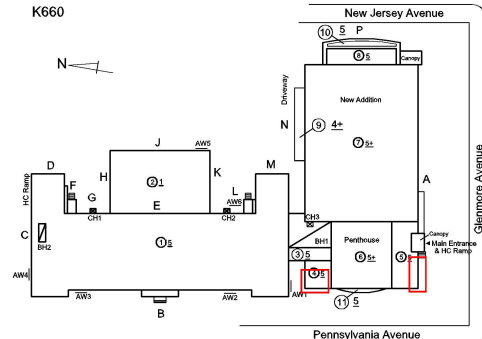
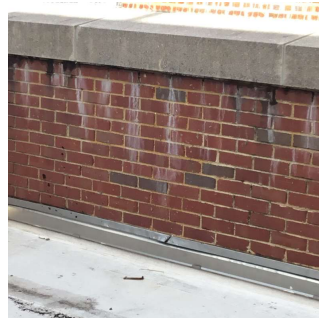
Question	Response
EXTERIOR	
PARAPETS	
Instance Condition	3 - Fair
Instance Quantity	1,000
Instance Quantity Uom	C.F.
Deficiency	BRICK: EFFLORESCENCE
Roof Plan reference

Deficiency Quantity	40
Quantity Uom	S.F.
Potential Action	MAINTENANCE
Urgency of Action	PRIORITY 1
Purpose of Action	LEVEL 1
Deficiency Photo 1

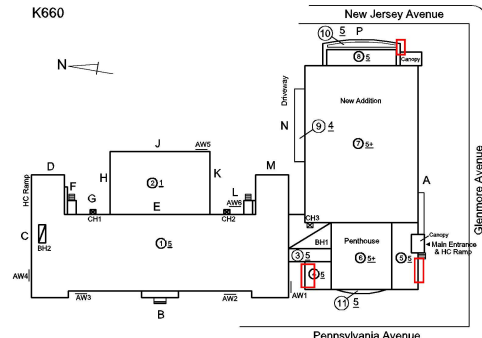
Violations	Roof 4 No violations recorded.
Deficiency	BRICK: DETERIORATED JOINTS
Roof Plan reference

Deficiency Quantity	80
Quantity Uom	S.F.
Potential Action	REPOINT
Urgency of Action	PRIORITY 3
Purpose of Action	LEVEL 2

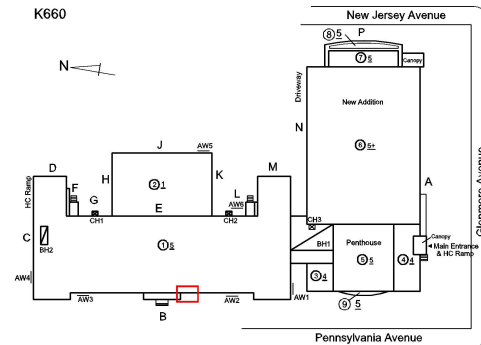
BRICK: MINOR CRACKS, SPALLING

15

REPAIR

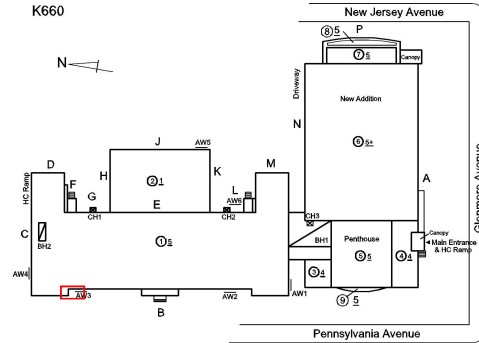
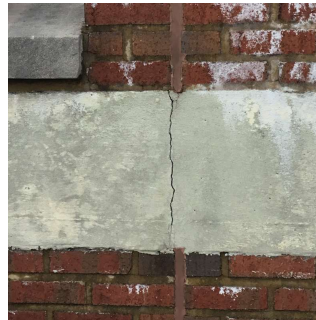
Roof 1

CONCRETE: MAJOR DETERIORATION/CRACKS

10

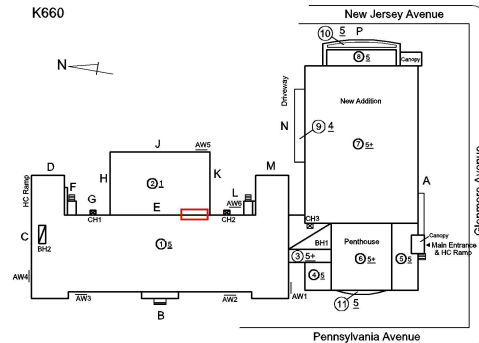
Installation Year	1998
Source of Installation	Inspector Estimate
Deficiency	IRMA: FLASHING: CAP FLASHING DAMAGED

20
L.F.
REPLACE
PRIORITY 4
LEVEL 2

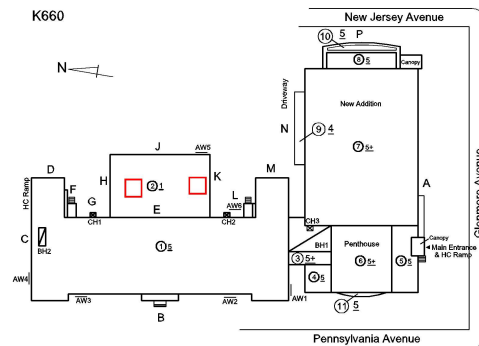
IRMA: ROOFING: MAJOR ACTIVE ROOF LEAKS IN INSTRUCTIONAL SPACE

200
S.F.
REPLACE ROOFING WITH MAJOR EQUIPMENT REMOVAL
PRIORITY 5
LEVEL 2

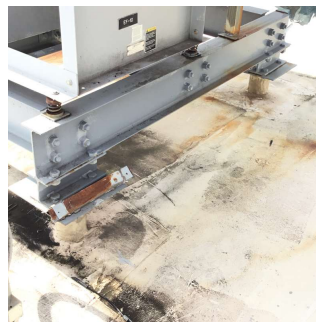
DUNNAGE STEEL

180
L.F.
REPLACE
PRIORITY 3
LEVEL 2

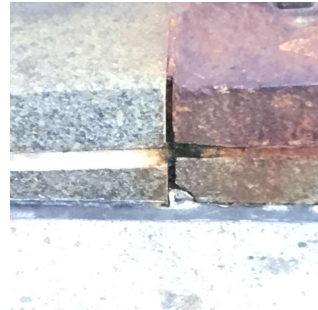
STONE: DETERIORATED JOINTS

20
S.F.
REPOINT
PRIORITY 4

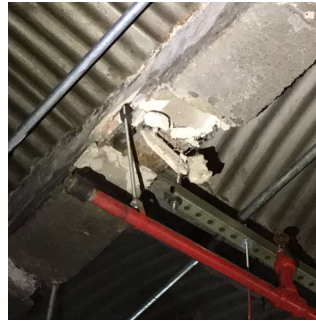
Custodian Shop

STEEL COLUMNS/BEAMS: DETERIORATED/MISSING SPRAY-ON FIREPROOFING

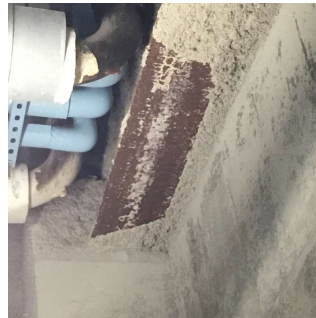
Room B65 (Rooms B43, B60, B61 similar)

CINDER CONCRETE ARCH: METAL PAN DETERIORATED, SPALLED

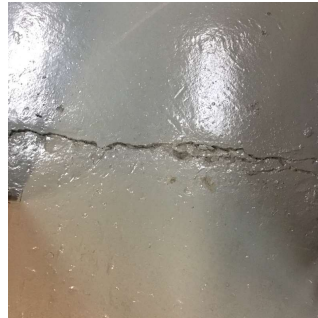
Room B64 (Room B43, Basement Corridor, Custodian Shop similar)

CONCRETE SLAB ON GRADE: THRU CRACKS

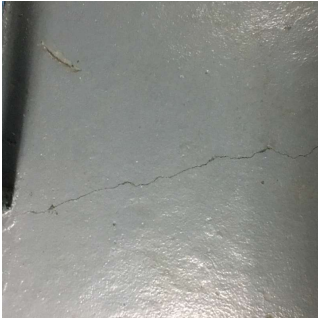
Question	Response
INTERIOR	
STRUCTURAL	
FLOOR STRUCTURE	
Violations	Basement Corridor (Rooms B31, B35, B39, B43, B60, B61, B65, Stairwell F/Basement, Electrical Panel Room, Custodian Shop similar) No violations recorded.
Deficiency	CONCRETE: CRACKS/SPALLED/REINFORCEMENT EXPOSED
Deficiency Location/Instance	PH
Deficiency Quantity	40
Quantity Uom	S.F.
Potential Action	REPAIR
Urgency of Action	PRIORITY 3
Purpose of Action	LEVEL 5
Deficiency Photo1

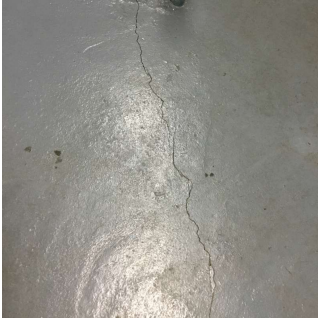
Violations	PH (Gymnasium PH similar) No violations recorded.
Deficiency	CONCRETE: CRACKS/SPALLED/REINFORCEMENT EXPOSED
Deficiency Location/Instance	PH
Deficiency Quantity	25
Quantity Uom	S.F.
Potential Action	REPAIR
Urgency of Action	PRIORITY 4
Purpose of Action	LEVEL 5
Deficiency Photo1

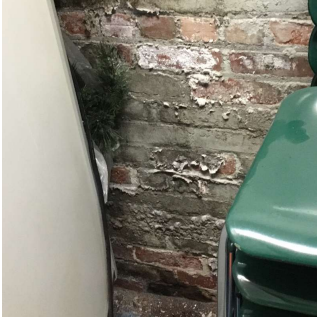
Violations	PH No violations recorded.
FOUNDATION WALLS	
Material Type(s)	Inspected Concrete, Masonry
Condition	3 - Fair
Deficiency	BRICK: CRACKED/SPALLED
Deficiency Location/Instance	Basement

Question	Response
INTERIOR	
STRUCTURAL	
FOUNDATION WALLS	
Potential Action	RESTITCH
Urgency of Action	PRIORITY 3
Purpose of Action	LEVEL 5
Deficiency Photo1

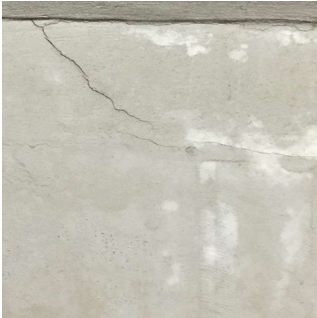
Book Storage Room (Basement Storage Room similar)
Violations	No violations recorded.
Deficiency	CONCRETE: CRACKED/SPALLED/REINFORCEMENT EXPOSED
Deficiency Location/Instance	Basement
Deficiency Quantity	70
Quantity Uom	S.F.
Potential Action	REPAIR
Urgency of Action	PRIORITY 3
Purpose of Action	LEVEL 5
Deficiency Photo1

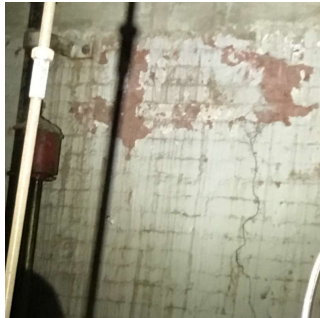
Oil Tank Room (Room B35, Facade N similar)
Violations	No violations recorded.
ROOF STRUCTURE	
Condition	Inspected
Deficiency	2 - Between Good and Fair
	No deficiencies recorded
VAULTS-BUNKERS	
Foundation Walls	
Condition	Inspected
Deficiency	2 - Between Good and Fair
Deficiency Location/Instance	CRACKS, SPALLING
Deficiency Quantity	Vault
Quantity Uom	20
Potential Action	S.F.
Urgency of Action	REPAIR
Purpose of Action	PRIORITY 3
	LEVEL 5

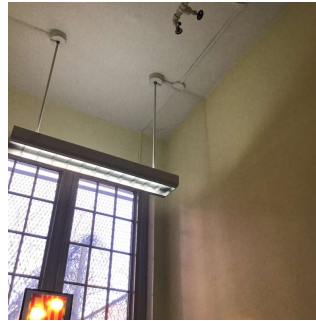
Vestibule Exit 11

Violations	Right Side No violations recorded.
Deficiency	PLASTER: CRACKS/SPALLING
Deficiency Location/Instance	Exit 11 Vestibule
Deficiency Quantity	15
Quantity Uom	S.F.
Potential Action	REPLACE
Urgency of Action	PRIORITY 3
Purpose of Action	LEVEL 2

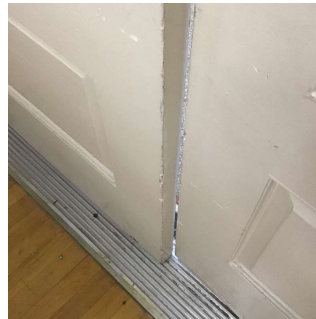
Right side of Stage

Instance on 1st Floor (460 Seats)	Inspected
Condition	5 - Poor
Deficiency	WOOD: DETERIORATED DOOR
Deficiency Location/Instance	Right and Left side of Stage ,Center Entrance
Deficiency Quantity	4
Quantity Uom	EACH
Potential Action	MAINTENANCE
Urgency of Action	PRIORITY 3
Purpose of Action	LEVEL 2
Deficiency Photo1

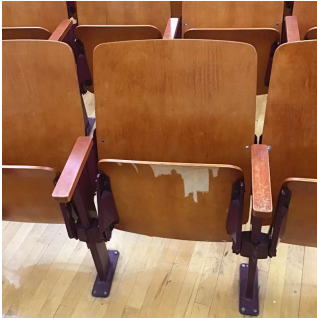
Question	Response
INTERIOR	
AUDITORIUM	
Fixed Seating	
Deficiency	DAMAGED/BROKEN/INOPERABLE
Deficiency Location/Instance	Seats A/2,4,10, B/2,D/2
Deficiency Quantity	26
Quantity Uom	EACH
Potential Action	REPLACE
Urgency of Action	PRIORITY 3
Purpose of Action	LEVEL 2
Deficiency Photo1

Seat A/4
Violations	No violations recorded.
Floor Finish	
Instance on 1st Floor (460 Seats)	Inspected
Condition	2 - Between Good and Fair
Deficiency	No deficiencies recorded
Sliding-folding Partition	
Instance on 1st Floor (460 Seats)	Does not Exist
Stage	
Instance on 1st Floor (460 Seats)	Inspected
Stage	
Instance on 1st Floor (460 Seats)	Inspected
Condition	3 - Fair
Deficiency	DAMAGED FLOOR
Deficiency Location/Instance	Center
Deficiency Quantity	25
Quantity Uom	S.F.
Potential Action	REPLACE
Urgency of Action	PRIORITY 3
Purpose of Action	LEVEL 2
Deficiency Photo1

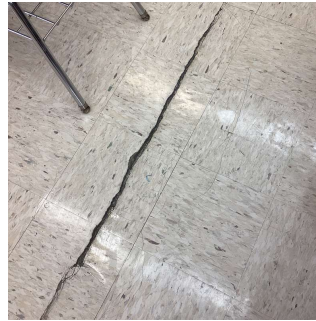
Room 417B

VINYL TILES: TRIPPING HAZARD - ELECTRICAL OUTLET

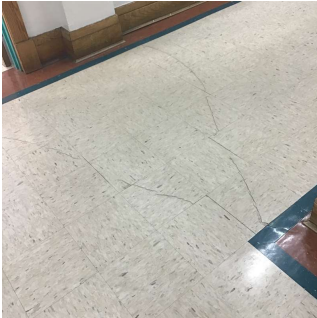
Question	Response
INTERIOR	
CLASSROOMS/CORRIDORS/ADMIN SPACES	
Floor Finish	
Deficiency	VINYL TILES: DETERIORATED SUBSTRATE
Deficiency Location/Instance	Corridor near room 525, Rooms 529, 525,524,520 and others
Deficiency Quantity	3,000
Quantity Uom	S.F.
Potential Action	REPLACE
Urgency of Action	PRIORITY 3
Purpose of Action	LEVEL 2
Deficiency Photo1

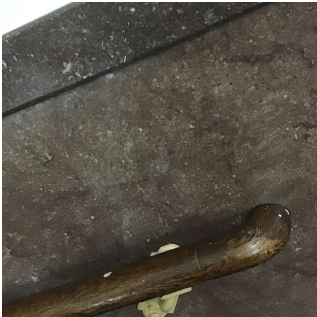
Violations	Corridor near room 525 No violations recorded.
Walls	
Condition	Inspected
Deficiency	2 - Between Good and Fair
Deficiency	STONE: CRACKS/SPALLING
Deficiency Location/Instance	Auditorium Lobby
Deficiency Quantity	30
Quantity Uom	S.F.
Potential Action	REPLACE
Urgency of Action	PRIORITY 3
Purpose of Action	LEVEL 2
Deficiency Photo1

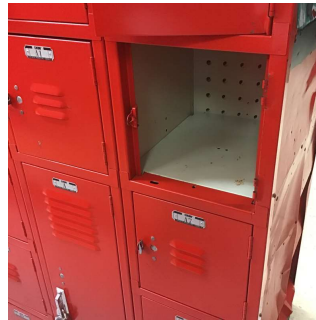
Locker A/6

Deficiency	DAMAGED UNITS
------------	---------------

Deficiency Location/Instance	Locker A/6,7 I/12,13,15 and others
------------------------------	------------------------------------

Potential Action	REPLACE
------------------	---------

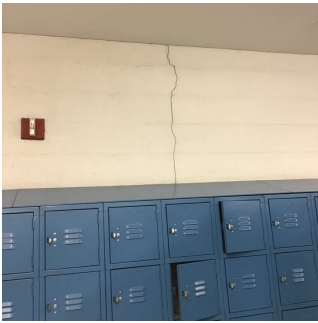
Deficiency	MASONRY: CRACKS/SPALLING
------------	--------------------------

Potential Action	REPLACE
------------------	---------

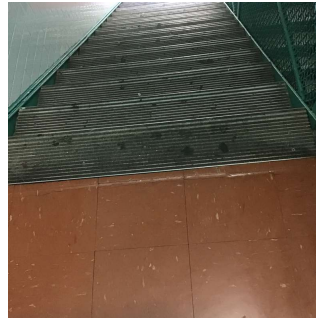
Stair C/5

CERAMIC TILE: BROKEN/ MISSING

REPLACE

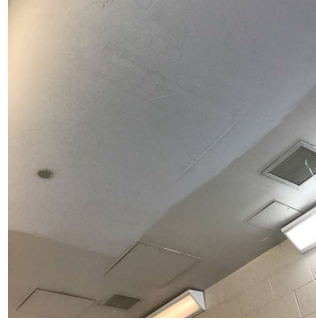
Question	Response
INTERIOR	
TOILET ROOMS - STAFF	Inspected
Stalls	Inspected
Condition	2 - Between Good and Fair
Deficiency	No deficiencies recorded
Walls	Inspected
Condition	2 - Between Good and Fair
Deficiency	GYPSON BOARD: DETERIORATED
Deficiency Location/Instance	Nurse Room 104, 106, 108
Deficiency Quantity	40
Quantity Uom	S.F.
Potential Action	REPLACE
Urgency of Action	PRIORITY 3
Purpose of Action	LEVEL 2
Deficiency Photo1	 
Violations	Nurse No violations recorded.
Deficiency	CERAMIC TILE: BROKEN/ MISSING
Deficiency Location/Instance	Room 238
Deficiency Quantity	10
Quantity Uom	S.F.
Potential Action	REPLACE
Urgency of Action	PRIORITY 3
Purpose of Action	LEVEL 2
Deficiency Photo1	 
Violations	Room 238 No violations recorded.
TOILET ROOMS - STUDENTS	Inspected
Ceiling	Inspected
Condition	2 - Between Good and Fair
Deficiency	GYPSON BOARD: DAMAGED/DETERIORATED
Deficiency Location/Instance	Room 345
Deficiency Quantity	15

Potential Action	REPLACE
Urgency of Action	PRIORITY 3
Purpose of Action	LEVEL 2
Deficiency Photo1

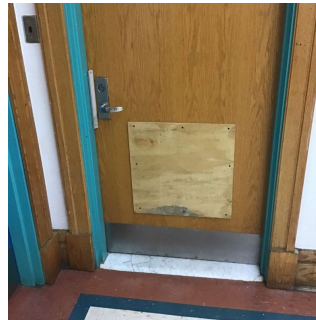
4th Floor Boys

Deficiency	WOOD: DAMAGED LOUVER
Deficiency Location/Instance	4th Floor Boys,
Deficiency Quantity	1
Quantity Uom	EACH
Potential Action	MAINTENANCE
Urgency of Action	PRIORITY 3
Purpose of Action	LEVEL 2
Deficiency Photo1

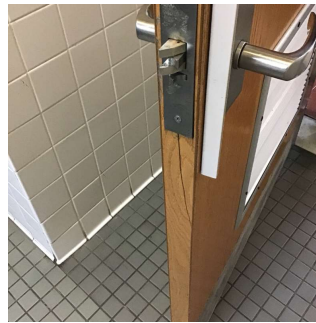
Room 426

Deficiency	WOOD: DETERIORATED DOOR
Deficiency Location/Instance	Rooms 426, 302, 202
Deficiency Quantity	3
Quantity Uom	EACH
Potential Action	MAINTENANCE
Urgency of Action	PRIORITY 3
Purpose of Action	LEVEL 2

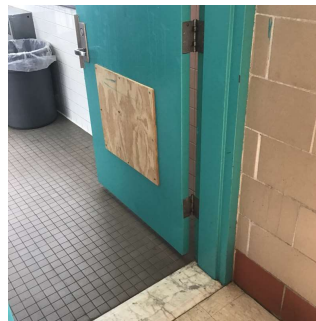
Boy Gymnasium

CERAMIC TILE: DETERIORATED SUBSTRATE

REPLACE

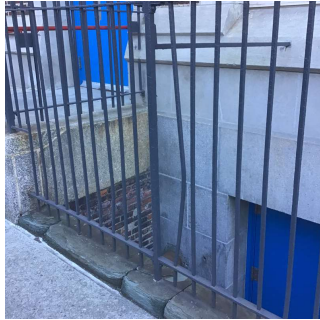
Question	Response
SITE	
Drainage System for Soil	Inspected
Catch Basins/Manhole - Surrounded by Soil	Inspected
Condition	2 - Between Good and Fair
Deficiency	No deficiencies recorded
Culverts - Soil Covering	Does not Exist
DRINKING FOUNTAINS	Does not Exist
FENCES	Inspected
Condition	3 - Fair
Deficiency	WROUGHT IRON: DAMAGED/DETERIORATED
Deficiency Location/Instance	Near Exit 13, Pennsylvania Avenue
Deficiency Quantity	120
Quantity Uom	S.F.
Potential Action	REPLACE
Urgency of Action	PRIORITY 3
Purpose of Action	LEVEL 2
Deficiency Photo1

Violations	Near Exit 13 No violations recorded.
Deficiency	CONCRETE CURB: DAMAGED/DETERIORATED
Deficiency Location/Instance	New Jersey Avenue, Glenmore Avenue, Pennsylvania Avenue
Deficiency Quantity	200
Quantity Uom	S.F.
Potential Action	REPLACE
Urgency of Action	PRIORITY 3
Purpose of Action	LEVEL 2
Deficiency Photo1

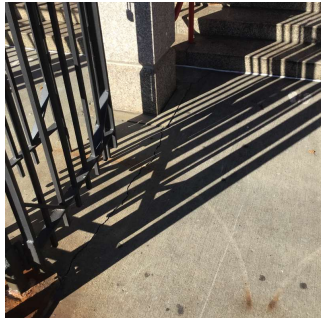
Violations	Near Exit 5 No violations recorded.
Pavers	Does not Exist
DOT Sidewalk	Inspected
Asphalt	Does not Exist
Concrete	Inspected
Condition	4 - Between Fair and Poor
Deficiency	DAMAGED CURBS
Deficiency Location/Instance	Pennsylvania Avenue, Glenmore Avenue
Deficiency Quantity	90
Quantity Uom	L.F.
Potential Action	REPLACE
Urgency of Action	PRIORITY 4
Purpose of Action	LEVEL 4
Deficiency Photo1

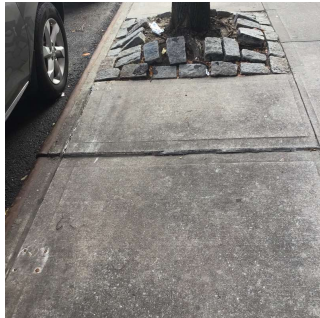
Violations	Pennsylvania Avenue, Glenmore Avenue 94334
Deficiency	HEAVING
Deficiency Location/Instance	New Jersey Avenue
Deficiency Quantity	25
Quantity Uom	S.F.
Potential Action	REPLACE
Urgency of Action	PRIORITY 4
Purpose of Action	LEVEL 4

Violations	New Jersey Avenue 94334
Deficiency	DAMAGED/DETERIORATED/MISSING SECTIONS
Deficiency Location/Instance	Glemore Avenue, New Jersey Avenue, Pennsylvania Avenue
Deficiency Quantity	425
Quantity Uom	S.F.
Potential Action	REPLACE
Urgency of Action	PRIORITY 4
Purpose of Action	LEVEL 4
Deficiency Photo1

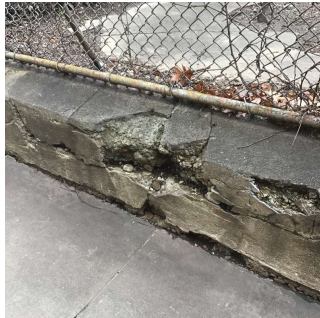
Near Exit 11
Violations	No violations recorded.
STAIRS/RAMPS: EXTERIOR	Does not Exist
ARTWORK	Inspected
Instance	Interior - Cafeteria - 20036
Instance Photo

Question	Response
SITE	
SITE WALLS (NOT RETAINING WALLS)	Inspected
Condition	3 - Fair
Deficiency	CAST IN PLACE CONCRETE: CRACKS/SPALLING - MAJOR
Deficiency Location/Instance	Near Exit 11
Deficiency Quantity	100
Quantity Uom	S.F.
Potential Action	REPLACE
Urgency of Action	PRIORITY 3
Purpose of Action	LEVEL 2
Deficiency Photo1
