NYC Department of Education
Building Condition Assessment Survey 2023 - 2024

Architectural Inspection

Asset: **PRE-K CENTER @ 219 25TH STREET - BROOKLYN, 219 25TH STREET, New York, 11232**

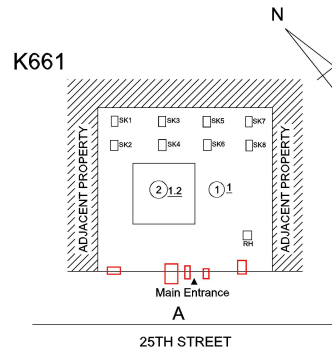
Question	Response
Architectural	
EXTERIOR	Inspected
AREAWAY	Does not Exist
AWNINGS AND CANOPIES	Does not Exist
CHIMNEY	Does not Exist
COPING	Inspected
Condition	3 - Fair
Deficiency	CAST STONE: CRACKED/BROKEN PIECES
Roof Plan reference

Deficiency Quantity
Quantity Uom
Potential Action
Urgency of Action
Purpose of Action

30
L.F.
REPLACE-IN-KIND
PRIORITY 4
LEVEL 2

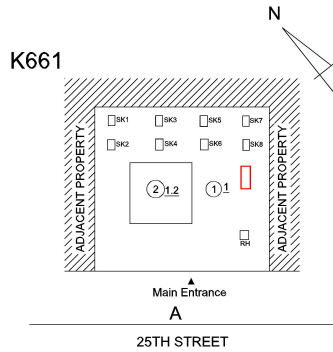
Roof Plan reference

Deficiency	MODIFIED BITUMEN: ROOFING: DELAMINATION
------------	---

Deficiency Quantity	60
---------------------	----

Quantity Uom	S.F.
--------------	------

Potential Action	REPLACE ROOFING WITHOUT MAJOR EQUIPMENT REMOVAL
------------------	---
