**NYC Department of Education
Building Condition Assessment Survey 2023 - 2024**

Architectural Inspection

K662

Asset: PRE-K CENTER @ 385 AVENUE W - BROOKLYN, 385 AVENUE W, New York, 11223

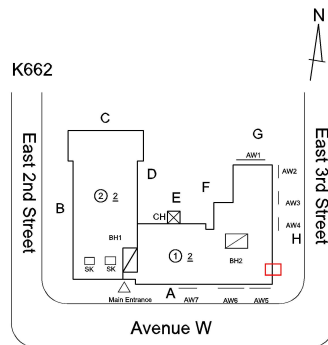
Question	Response
Architectural	
EXTERIOR	Inspected
AREAWAY	Not Required
AWNINGS AND CANOPIES	Inspected
Condition	3 - Fair
Deficiency	METAL: DETERIORATION/DAMAGED/MISSING PIECES
Roof Plan reference

25
S.F.
REPLACE
PRIORITY 4
LEVEL 2

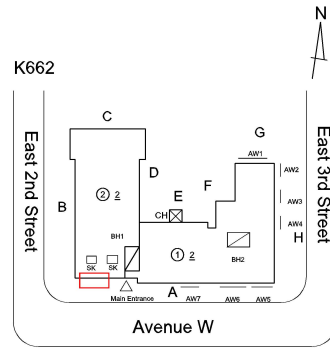
METAL: DETERIORATION/DAMAGED/MISSING PIECES

REPAIR

PRIORITY 3

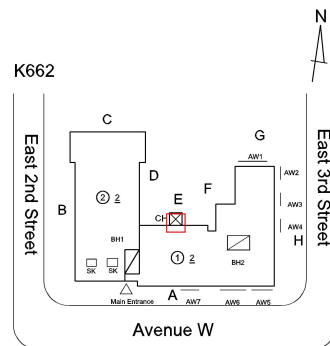
BRICK: DETERIORATED JOINTS

REPOINT

PRIORITY 3

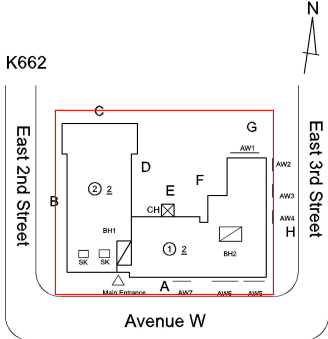
Violations	Chimney No violations recorded.
COPING	
Condition	Inspected 3 - Fair
Deficiency	CAST STONE: DETERIORATED TRANSVERSE JOINTS
Roof Plan reference

Deficiency Quantity	100
Quantity Uom	L.F.
Potential Action	MAINTENANCE
Urgency of Action	PRIORITY 3
Purpose of Action	LEVEL 2
Deficiency Photo1

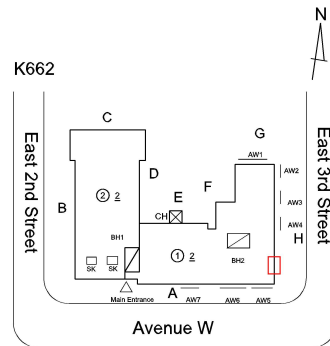
Violations	Roof 1 No violations recorded.
CORNICE	
Does not Exist	
DOORS	
Inspected	
DOORS AND FRAMES	
Inspected	
Condition	4 - Between Fair and Poor
Deficiency	WOOD: DETERIORATED DOOR AND FRAME - MAJOR DETERIORATION

2
EACH
REPLACE
PRIORITY 4
LEVEL 2

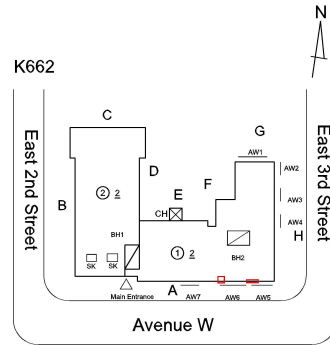
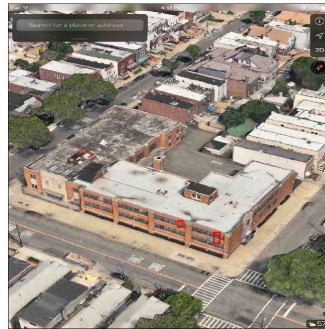
BRICK: MASONRY SILLS - DETERIORATED JOINTS

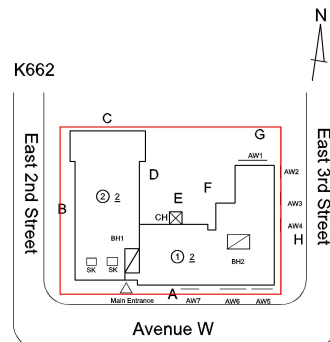
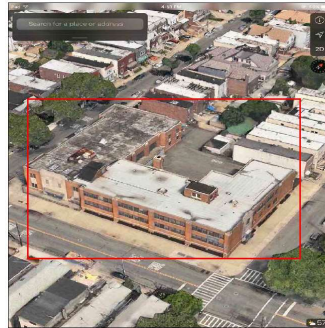
BRICK: DETERIORATED JOINTS

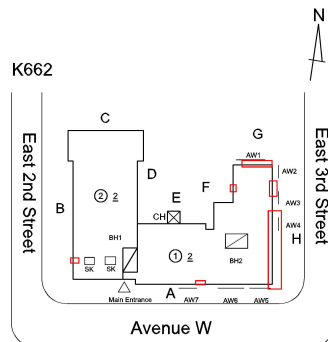
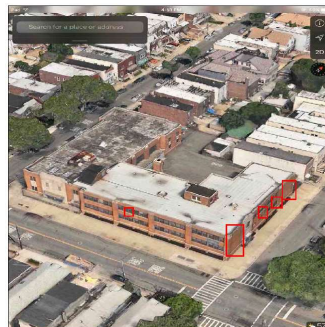
BRICK: DETERIORATED JOINTS

Question	Response
EXTERIOR	
EXTERIOR WALLS	
Urgency of Action	PRIORITY 4
Purpose of Action	LEVEL 2
Deficiency Photo1

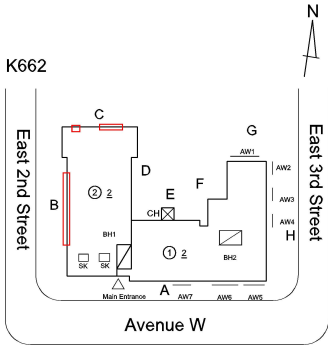
Violations	Facade H No violations recorded.
EXTERIOR SOFFITS	Does not Exist
LOADING DOCK	Does not Exist
LOUVER	Does not Exist
PARAPETS	Inspected
Material Type(s)	Masonry
Replacement Quantity	1,750
Replacement Uom	C.F.
Instance on All Roofs	Inspected
Instance Condition	5 - Poor
Instance Quantity	1,750
Instance Quantity Uom	C.F.
Deficiency	BRICK: MINOR CRACKS, SPALLING
Roof Plan reference

Deficiency Quantity	70
Quantity Uom	S.F.
Potential Action	REPAIR
Urgency of Action	PRIORITY 3
Purpose of Action	LEVEL 2

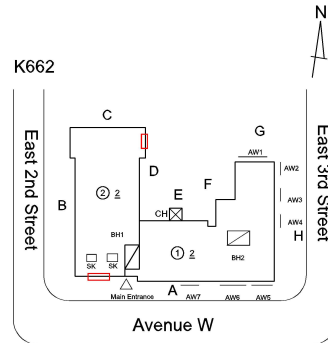
BRICK: MAJOR DETERIORATION/CRACKS

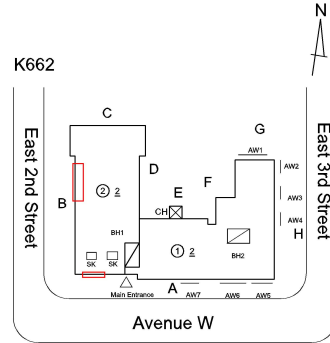
BRICK: DETERIORATED JOINTS

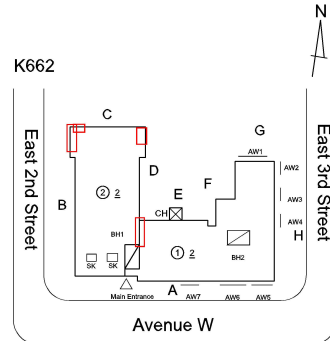
BRICK: DETERIORATED JOINTS

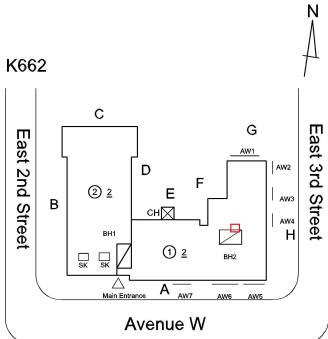
Violations	Roof 1 No violations recorded.
PLAZA DECK	Does not Exist
ROOF	Inspected
Roofing	Inspected
Replacement Quantity	24,000
Replacement Uom	S.F.
ROOF HATCH/SMOKE HATCH	Does not Exist
LEADERS, GUTTERS, DOWNSPOUTS, SCUPPERS	Inspected
Condition	3 - Fair
Deficiency	DAMAGED/MISSING
Roof Plan reference

Deficiency Quantity	10
Quantity Uom	L.F.
Potential Action	REPLACE
Urgency of Action	PRIORITY 4
Purpose of Action	LEVEL 2
Deficiency Photo1

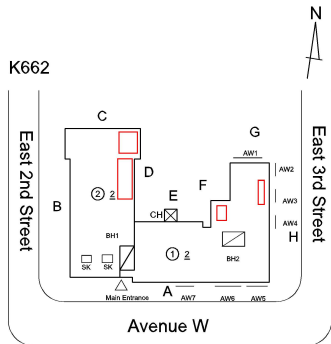
Roof 1
Instance Quantity	24,000
Instance Quantity Uom	S.F.
Does the roof have major mechanical equipment sitting on Dunnage Steel less than 18" above the Roofing?	Yes
Does this roof instance have a Sustainable Roof System?	No
Do solar panels exist on these roofs?	No
Is/Are the roof(s) suitable for Solar Panel installation?	Yes
Installation Year	1990
Source of Installation	Custodial Staff
Deficiency	MODIFIED BITUMEN: ROOFING: DELAMINATION
Roof Plan reference

Deficiency Quantity	170
Quantity Uom	S.F.
Potential Action	REPLACE ROOFING WITH MAJOR EQUIPMENT REMOVAL
Urgency of Action	PRIORITY 4
Purpose of Action	LEVEL 2
Deficiency Photo1

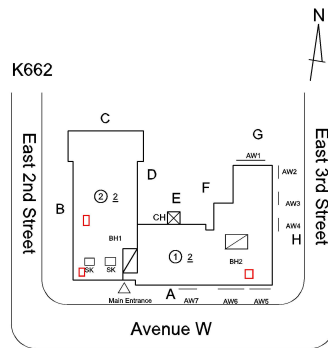
Condition	5 - Poor
-----------	----------

Deficiency	DETERIORATED
Roof Plan reference

3
EACH
REPLACE
PRIORITY 4
LEVEL 2

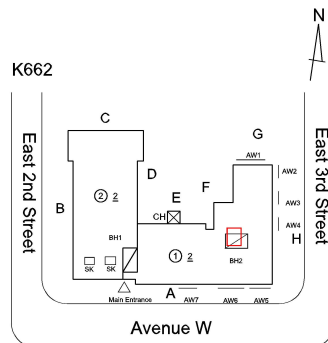
Condition	4 - Between Fair and Poor
-----------	---------------------------

Deficiency	BULKHEAD/PENTHOUSE WINDOWS: DAMAGED, DETERIORATED WINDOWS
------------	---

30
S.F.
REPLACE
PRIORITY 4

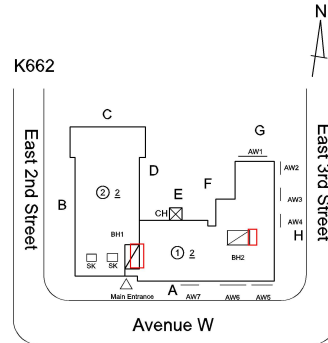
BULKHEAD/PENTHOUSE DOORS: DETERIORATED DOOR

REPLACE DOOR

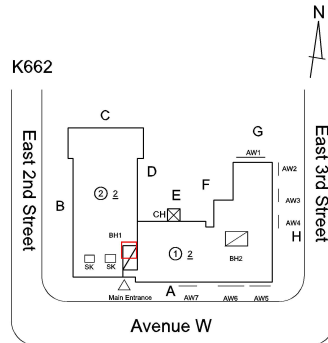
**BULKHEAD/PENTHOUSE WALLS/INTERIOR: GLAZED BLOCK
CRACKS/SPALLING**

10
S.F.
REPLACE
PRIORITY 4
LEVEL 2

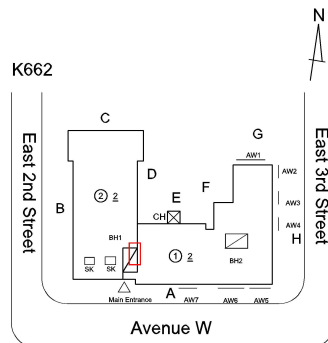
BULKHEAD/PENTHOUSE CEILING: PLASTER DAMAGED/DETERIORATED

15
S.F.
REPLACE
PRIORITY 3
LEVEL 2

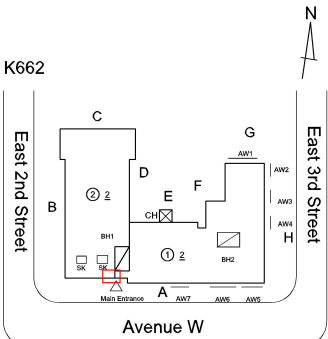
Question	Response
EXTERIOR	
ROOF	Inspected
Specialties	Inspected
ROOF/GRAVITY TANK	Does not Exist
STAIRS/RAMPS: EXTERIOR	Inspected
BUILDING CHEEK/FLANK WALLS	Does not Exist
RAILINGS	Does not Exist
STAIRS/RAMPS	Inspected
Condition	3 - Fair
Deficiency	STONE: DETERIORATED JOINTS
Roof Plan reference

Deficiency Quantity	10
Quantity Uom	L.F.
Potential Action	REPOINT
Urgency of Action	PRIORITY 4
Purpose of Action	LEVEL 2
Deficiency Photo1

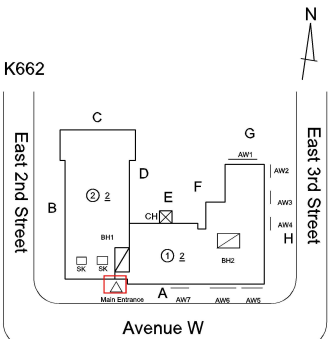
Violations	Facade A No violations recorded.
Deficiency	STONE: DETERIORATED JOINTS
Roof Plan reference

Deficiency Quantity	10
Quantity Uom	L.F.
Potential Action	REPOINT

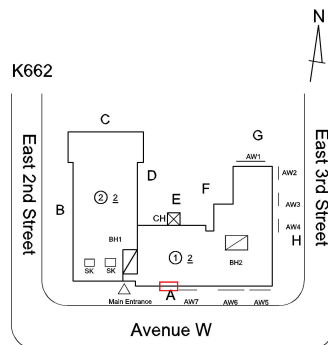
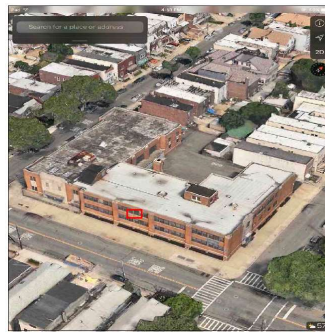
Question	Response
EXTERIOR	
STAIRS/RAMPS: EXTERIOR	Inspected
STAIRS/RAMPS	
Urgency of Action	PRIORITY 3
Purpose of Action	LEVEL 2
Deficiency Photo1	 
	Facade A
Violations	No violations recorded.
WINDOWS	Inspected
Replacement Quantity	4,000
Replacement Uom	S.F.
EXTERIOR GUARDS	Inspected
Condition	2 - Between Good and Fair
Deficiency	No deficiencies recorded
LINTELS	Inspected
Condition	2 - Between Good and Fair
Deficiency	No deficiencies recorded
WINDOWS	Inspected
Material Type(s)	Aluminum
Instance on Aluminum - Double Hung: All Facades	Inspected
Instance Condition	3 - Fair
Instance Quantity	2,500
Instance Quantity Uom	S.F.
Are these windows insulated	No
Installation Year	1951
Source of Installation	Custodial Staff
Deficiency	ALUMINUM - DOUBLE HUNG: BROKEN PANE
Roof Plan reference

30
S.F.
MAINTENANCE
PRIORITY 3
LEVEL 2

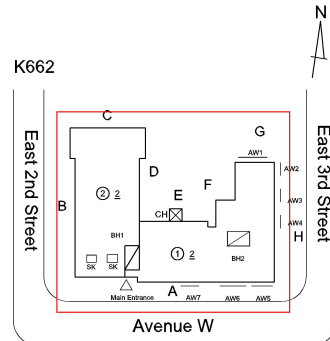
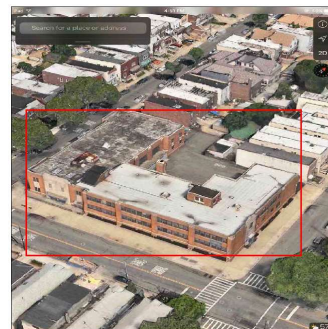
ALUMINUM - DOUBLE HUNG: INOPERABLE BALANCE

REPLACE BALANCES
PRIORITY 3
LEVEL 2
No photo recorded
No violations recorded.

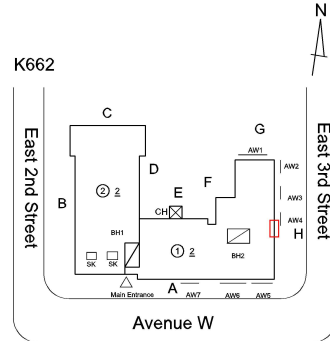
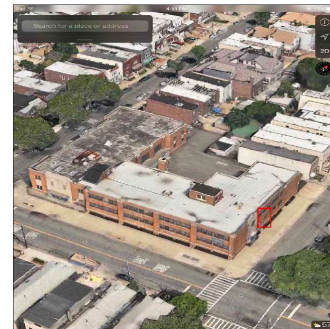
ALUMINUM - DOUBLE HUNG: AIR/WATER INFILTRATION

30
L.F.
REPLACE TRIM, SILLS OR WEATHERSTRIPPING
PRIORITY 5
LEVEL 2

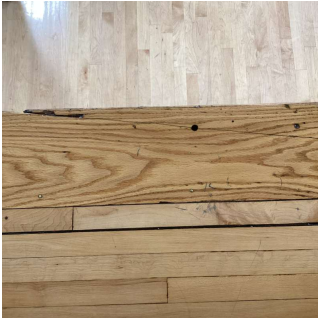
Front
Violations	No violations recorded.
Stage Curtain Rigging	
Instance on 1st Floor	Inspected
Condition	2 - Between Good and Fair
Deficiency	No deficiencies recorded
Stage Curtains	
Instance on 1st Floor	Inspected
Condition	2 - Between Good and Fair
Deficiency	No deficiencies recorded

Question	Response
INTERIOR	
GYMNASIUM	
Fixed Equipment	
Instance on 1st Floor	Inspected
Condition	2 - Between Good and Fair
Deficiency	No deficiencies recorded
Floor Finish	
Instance on 1st Floor	Inspected
Condition	1 - Good
Deficiency	No deficiencies recorded
Seating	
Instance on 1st Floor	Does not Exist
Sliding-folding Partition	
Instance on 1st Floor	Does not Exist
Stage	
Instance on 1st Floor	Inspected
Stage	
Instance on 1st Floor	Inspected
Condition	3 - Fair
Deficiency	DAMAGED FLOOR
Deficiency Location/Instance	Front
Deficiency Quantity	25
Quantity Uom	S.F.
Potential Action	REPLACE
Urgency of Action	PRIORITY 3
Purpose of Action	LEVEL 2
Deficiency Photo1

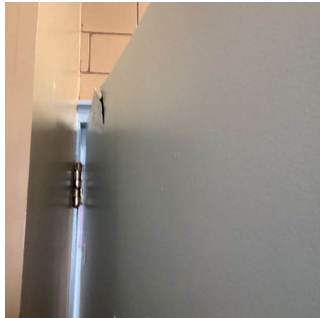
Question	Response
INTERIOR	
SCIENCE PREP ROOM	Does not Exist
SHOWER ROOM	Does not Exist
STAIRS/RAMPS: INTERIOR	Inspected
Do Letter Stair Signs Exist?	No
Ceiling	Inspected
Condition	2 - Between Good and Fair
Deficiency	No deficiencies recorded
Door(s)	Inspected
Condition	5 - Poor
Deficiency	METAL: DETERIORATED DOOR
Deficiency Location/Instance	2nd Floor
Deficiency Quantity	1
Quantity Uom	EACH
Potential Action	MAINTENANCE
Urgency of Action	PRIORITY 3
Purpose of Action	LEVEL 2
Deficiency Photo1

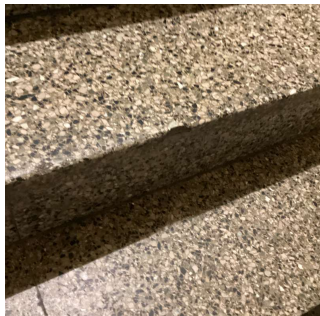
Violations	2nd Floor No violations recorded.
Partition	Does not Exist
Railings	Inspected
Condition	2 - Between Good and Fair
Deficiency	No deficiencies recorded
Stairs and Landings	Inspected
Condition	3 - Fair
Deficiency	TERRAZZO: CRACKS
Deficiency Location/Instance	2nd Floor Vestibule, Main Stair
Deficiency Quantity	25
Quantity Uom	S.F.
Potential Action	REPLACE
Urgency of Action	PRIORITY 3
Purpose of Action	LEVEL 2
Deficiency Photo1

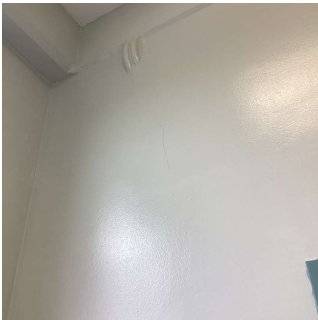
Question	Response
INTERIOR	
TOILET ROOMS - STAFF	
Floor Finish	Inspected
Condition	2 - Between Good and Fair
Deficiency	No deficiencies recorded
Stalls	Does not Exist
Walls	Inspected
Condition	2 - Between Good and Fair
Deficiency	PLASTER: CRACKS/SPALLING
Deficiency Location/Instance	Room 15B
Deficiency Quantity	10
Quantity Uom	S.F.
Potential Action	REPLACE
Urgency of Action	PRIORITY 3
Purpose of Action	LEVEL 2
Deficiency Photo1

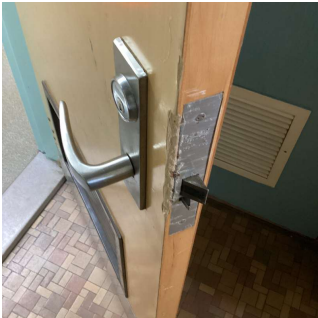
Room 11T
Violations	No violations recorded.

Room 15B
Violations	No violations recorded.
TOILET ROOMS - STUDENTS	
	Inspected
Ceiling	Inspected
Condition	2 - Between Good and Fair
Deficiency	No deficiencies recorded
Door(s)	Inspected
Condition	5 - Poor
Deficiency	WOOD: DETERIORATED DOOR
Deficiency Location/Instance	Room 11T
Deficiency Quantity	1
Quantity Uom	EACH
Potential Action	MAINTENANCE
Urgency of Action	PRIORITY 3
Purpose of Action	LEVEL 2
Deficiency Photo1

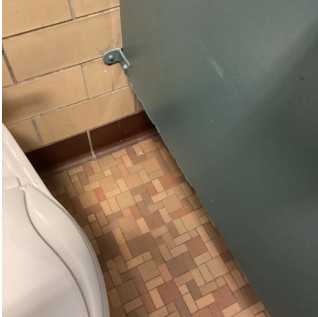
Violations	Room 11T No violations recorded.
Walls	Inspected
Condition	2 - Between Good and Fair
Deficiency	No deficiencies recorded
LIFE SAFETY	Inspected
F.D. HOLDING AREA	Does not Exist
STEEL STAIRS	Does not Exist
SITE	Does not Exist
ARTWORK	Does not Exist

Question	Response
INTERIOR	
TOILET ROOMS - STUDENTS	
Floor Finish	Inspected
Condition	2 - Between Good and Fair
Deficiency	No deficiencies recorded
Stalls	Inspected
Condition	5 - Poor
Deficiency	RUST - MAJOR
Deficiency Location/Instance	Room 11T, 17T
Deficiency Quantity	8
Quantity Uom	EACH
Potential Action	REPLACE
Urgency of Action	PRIORITY 3
Purpose of Action	LEVEL 2
Deficiency Photo1
