NYC Department of Education
Building Condition Assessment Survey 2023 - 2024

Architectural Inspection

K664

Asset: **PRE-K CENTER @ 140A 58TH STREET - BROOKLYN, 140A 58 STREET, New York, 11220**

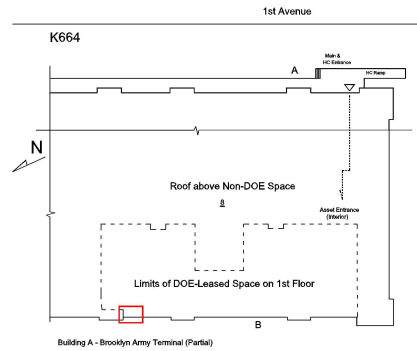
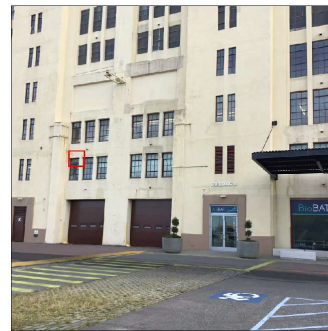
Question	Response
Architectural	
EXTERIOR	Inspected
AREAWAY	Does not Exist
AWNINGS AND CANOPIES	Not Required
CHIMNEY	Not Required
COPING	Not Required
CORNICE	Does not Exist
DOORS	Inspected
DOORS AND FRAMES	Inspected
Condition	2 - Between Good and Fair
Deficiency	No deficiencies recorded
DOOR HARDWARE	Inspected
Condition	2 - Between Good and Fair
Deficiency	No deficiencies recorded
LINTELS	Does not Exist
TRANSOM/SIDE LIGHT	Inspected
Condition	2 - Between Good and Fair
Deficiency	No deficiencies recorded
EXTERIOR WALLS	Inspected
Material Type(s)	Concrete, Masonry
Replacement Quantity	1,400
Replacement Uom	S.F.
Instance on Facade B	Inspected
Instance Condition	3 - Fair
Instance Quantity	1,400
Instance Quantity Uom	S.F.
Deficiency	CAST IN PLACE / PRE-CAST CONCRETE: MAJOR CRACKS/SPALLING

REPLACE

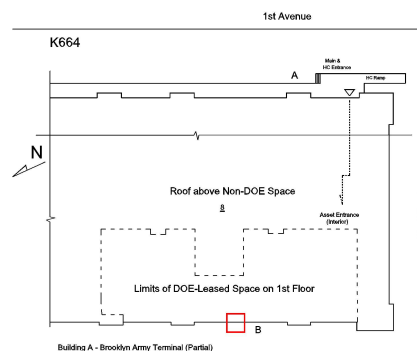
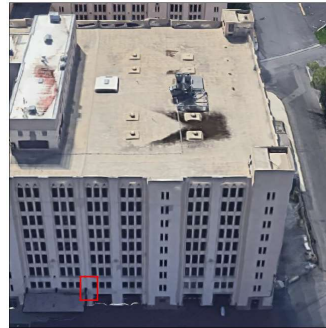
CAST IN PLACE / PRE-CAST CONCRETE: DETERIORATED CONTROL/EXPANSION JOINTS

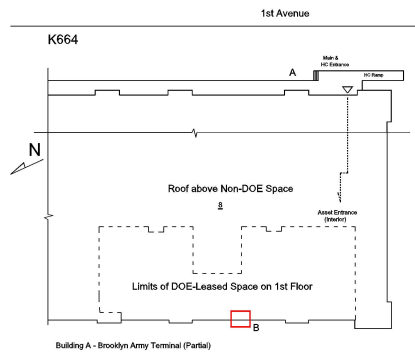
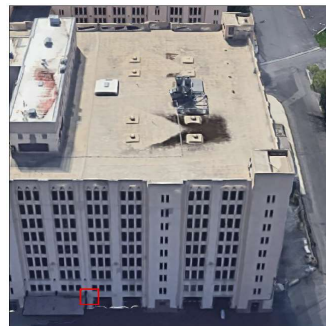
CAST IN PLACE / PRE-CAST CONCRETE: MINOR
CRACKS/SPALLING

Question	Response
EXTERIOR	
EXTERIOR WALLS	
Potential Action	REPAIR
Urgency of Action	PRIORITY 3
Purpose of Action	LEVEL 2
Deficiency Photo1

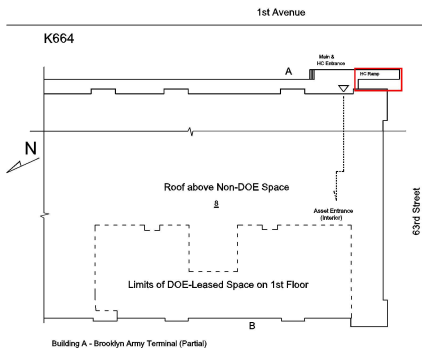
Violations	Facade B No violations recorded.
EXTERIOR SOFFITS	Does not Exist
LOADING DOCK	Not Required
LOUVER	Not Required
PARAPETS	Not Required
PLAZA DECK	Does not Exist
ROOF	Inspected
Roofing	Not Required
Specialties	Inspected
BULKHEAD/PENTHOUSE	Not Required
CUPOLA/ SPIRES/ TOWERS	Does not Exist
DORMER	Does not Exist
DUNNAGE STEEL	Not Required
SKYLIGHT/ROOF VENT	Not Required
ROOF/GRAVITY TANK	Not Required
STAIRS/RAMPS: EXTERIOR	Inspected
BUILDING CHEEK/FLANK WALLS	Inspected
Condition	4 - Between Fair and Poor
Deficiency	CAST IN PLACE CONCRETE: CRACKS/SPALLING - MINOR
Roof Plan reference

Deficiency Quantity	40
Quantity Uom	S.F.
Potential Action	REPAIR
Urgency of Action	PRIORITY 3
Purpose of Action	LEVEL 2

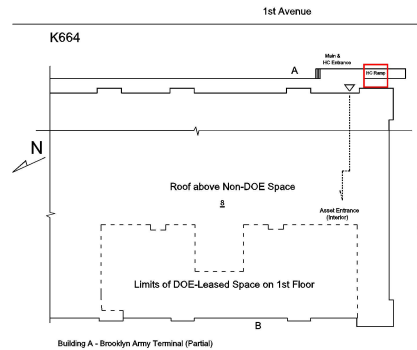
CAST IN PLACE CONCRETE: CRACKS/SPALLING - MAJOR

REPLACE

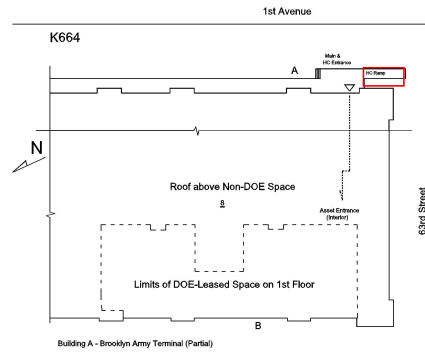
RUST - MAJOR

25
L.F.
REPLACE
PRIORITY 4
LEVEL 2

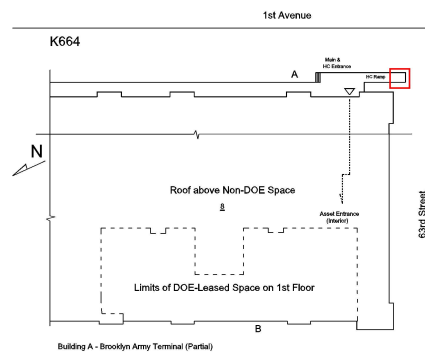
DAMAGED

10
L.F.
REPLACE
PRIORITY 4
LEVEL 2

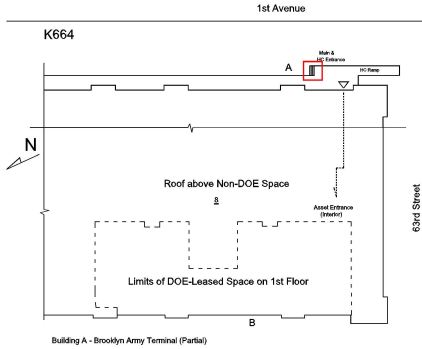
Question	Response
EXTERIOR	
STAIRS/RAMPS: EXTERIOR	
RAILINGS	
Deficiency Photo1	 
Violations	Facade A - HC Ramp No violations recorded.
STAIRS/RAMPS	
Condition	Inspected 5 - Poor
Deficiency	METAL: RUST - MAJOR
Roof Plan reference

Deficiency Quantity	50
Quantity Uom	S.F.
Potential Action	REPLACE
Urgency of Action	PRIORITY 4
Purpose of Action	LEVEL 2
Deficiency Photo1	 
Violations	Facade A No violations recorded.
Deficiency	CONCRETE: CRACKS/SPALLING - MINOR

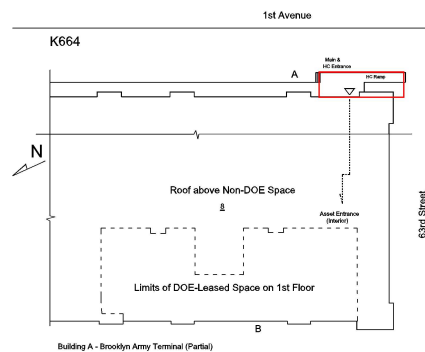
CONCRETE: CRACKS/SPALLING - MAJOR

50
S.F.
REPLACE
PRIORITY 4
LEVEL 2

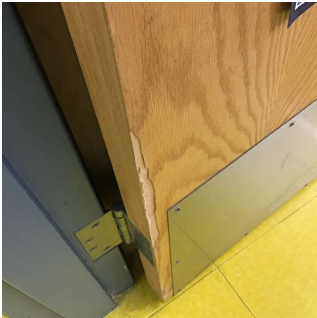
Question	Response
INTERIOR	
STRUCTURAL	
FLOOR STRUCTURE	Inspected
Violations	1st Floor - Telecom Room No violations recorded.
FOUNDATION WALLS	Inaccessible
ROOF STRUCTURE	Not Required
VAULTS-BUNKERS	Does not Exist
AUDITORIUM	Does not Exist
CAFETERIA	Does not Exist
CLASSROOMS/CORRIDORS/ADMIN SPACES	Inspected
Ceiling	Inspected
Condition	2 - Between Good and Fair
Deficiency	No deficiencies recorded
Door(s)	Inspected
Condition	5 - Poor
Deficiency	WOOD: MISSING DOOR
Deficiency Location/Instance	Room 102
Deficiency Quantity	1
Quantity Uom	EACH
Potential Action	MAINTENANCE
Urgency of Action	PRIORITY 3
Purpose of Action	LEVEL 2
Deficiency Photo1
