NYC Department of Education
Building Condition Assessment Survey 2023 - 2024

Architectural Inspection

K672

Asset: PRE-K CENTER @ 1223 CONEY ISLAND AVENUE - BROOKLYN, 1223 CONEY ISLAND AVENUE, New York, 11230

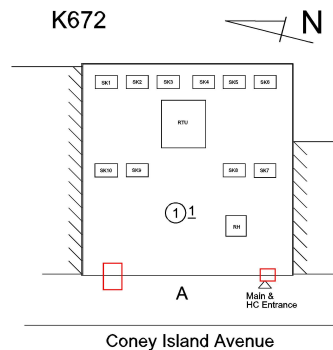
Question	Response
Architectural	
EXTERIOR	Inspected
AREAWAY	Does not Exist
AWNINGS AND CANOPIES	Does not Exist
CHIMNEY	Inspected
Material Type(s)	Masonry
Condition	2 - Between Good and Fair
Deficiency	No deficiencies recorded
COPING	Inspected
Condition	2 - Between Good and Fair
Deficiency	No deficiencies recorded
CORNICE	Does not Exist
DOORS	Inspected
DOORS AND FRAMES	Inspected
Condition	3 - Fair
Deficiency	METAL: DETERIORATED DOOR AND FRAME - MINOR DETERIORATION
Roof Plan reference

Deficiency Quantity
Quantity Uom
Potential Action
Urgency of Action

3
EACH
MAINTENANCE
PRIORITY 3

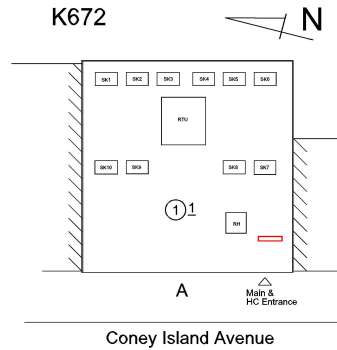
Roof 1
No violations recorded.

Question	Response
EXTERIOR	
ROOF	
Roofing	
ROOFING	
Instance Photo	 
	Roof 1
Instance Quantity	10,000
Instance Quantity Uom	S.F.
Does the roof have major mechanical equipment sitting on Dunnage Steel less than 18" above the Roofing?	No
Does this roof instance have a Sustainable Roof System?	Yes
Sustainable Roof Type	White Roof
Sustainable Roof Location (Roof Number)	Roof 1
Do solar panels exist on these roofs?	No
Is/Are the roof(s) suitable for Solar Panel installation?	Yes
Installation Year	2016
Source of Installation	Custodial Staff
Deficiency	MODIFIED BITUMEN: FLASHING: BASE FLASHING DETERIORATED
Roof Plan reference	<p align="center">K672</p>   <p align="center">Coney Island Avenue</p>
Deficiency Quantity	10
Quantity Uom	S.F.
Potential Action	REPLACE
Urgency of Action	PRIORITY 4
Purpose of Action	LEVEL 2
Deficiency Photo1	 
	Roof 1
Violations	No violations recorded.
Deficiency	MODIFIED BITUMEN: ROOFING: DELAMINATION

10
S.F.
REPLACE ROOFING WITHOUT MAJOR EQUIPMENT
REMOVAL
PRIORITY 4
LEVEL 2

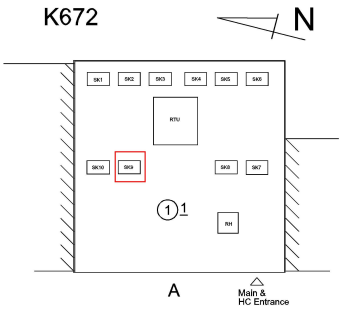
WATER INFILTRATION

Question	Response
EXTERIOR	
ROOF	
Specialties	
SKYLIGHT/ROOF VENT	
Roof Plan reference

Deficiency Quantity	50
Quantity Uom	S.F.
Potential Action	MAINTENANCE
Urgency of Action	PRIORITY 3
Purpose of Action	LEVEL 2
Deficiency Photo1
