NYC Department of Education
Building Condition Assessment Survey 2023 - 2024

Architectural Inspection

Asset: P.S. 677 - BROOKLYN, 139 MENAHAN STREET, New York, 11221

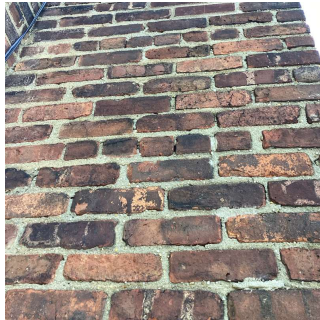
Violations	CH No violations recorded.
Deficiency	BRICK: DETERIORATED JOINTS
Roof Plan reference

Deficiency Quantity	50
Quantity Uom	S.F.
Potential Action	REPOINT
Urgency of Action	PRIORITY 3
Purpose of Action	LEVEL 2
Deficiency Photo1

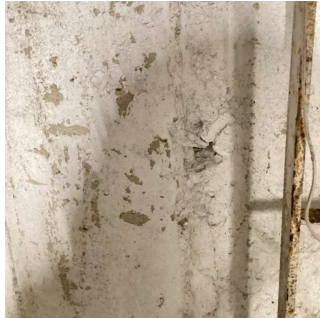
Violations	Basement - Vault No violations recorded.
Deficiency	CRACKS, SPALLING
Deficiency Location/Instance	Basement - Vault
Deficiency Quantity	20
Quantity Uom	S.F.
Potential Action	REPAIR
Urgency of Action	PRIORITY 3
Purpose of Action	LEVEL 5
Deficiency Photo1

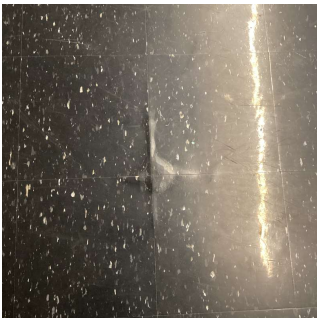
Question	Response
INTERIOR	
MULTI-PURPOSE ROOM	
Ceiling	
Deficiency Quantity	10
Quantity Uom	S.F.
Potential Action	REPLACE
Urgency of Action	PRIORITY 3
Purpose of Action	LEVEL 2
Deficiency Photo1	 
	Near Students Toilets Room
Violations	No violations recorded.
Door(s)	
Instance on Basement	Inspected
Condition	2 - Between Good and Fair
Deficiency	No deficiencies recorded
Fixed Equipment	
Instance on Basement	Does not Exist
Floor Finish	
Instance on Basement	Inspected
Condition	2 - Between Good and Fair
Deficiency	VINYL TILES: BROKEN/DETERIORATED/MISSING TILES
Deficiency Location/Instance	Right and Left Side
Deficiency Quantity	30
Quantity Uom	S.F.
Potential Action	REPLACE
Urgency of Action	PRIORITY 3
Purpose of Action	LEVEL 2
Deficiency Photo1

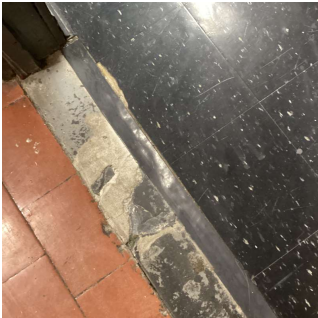
Question	Response
INTERIOR	
STAIRS/RAMPS: INTERIOR	
Stairs and Landings	
Violations	Stair A/Basement No violations recorded.
Deficiency	CONCRETE: CRACKS/SPALLING - MAJOR
Deficiency Location/Instance	Stair C/Basement
Deficiency Quantity	10
Quantity Uom	S.F.
Potential Action	REPLACE
Urgency of Action	PRIORITY 3
Purpose of Action	LEVEL 2
Deficiency Photo1

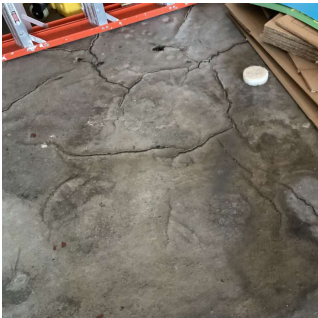
Violations	Stair C/Basement No violations recorded.
Deficiency	ROLLED ASPHALT: CRACKS
Deficiency Location/Instance	Stair A/Bulkhead
Deficiency Quantity	250
Quantity Uom	S.F.
Potential Action	REPLACE
Urgency of Action	PRIORITY 3
Purpose of Action	LEVEL 2
Deficiency Photo1

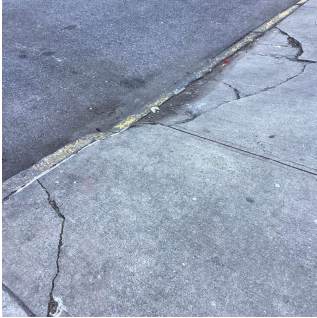
Question	Response
SITE	
PAVING	
DOT Sidewalk	
Concrete	
Urgency of Action	PRIORITY 3
Purpose of Action	LEVEL 2
Deficiency Photo1

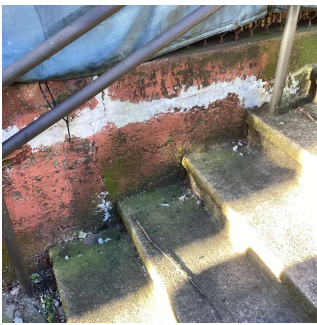
Question	Response
SITE	
STAIRS/RAMPS: EXTERIOR	
Site Cheek/flank Walls	
Deficiency Photo1
