**NYC Department of Education**  
**Building Condition Assessment Survey 2023 - 2024**

Architectural Inspection

**K682**

**Asset:** P.S. @ 736 48TH STREET - BROOKLYN, 736 48TH STREET, New York, 11220

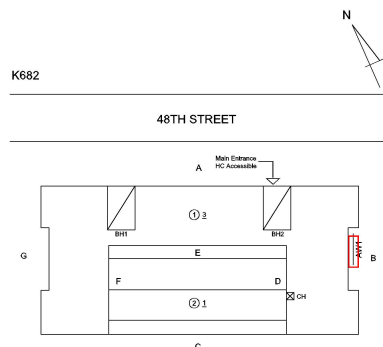
Question	Response
<b>Architectural</b>	
<b>EXTERIOR</b>	Inspected
<b>AREAWAY</b>	Inspected
Instance on AW1	Inspected
Instance Condition	3 - Fair
Instance Quantity	1
Instance Quantity Uom	EACH
Deficiency	AREAWAY STAIRS: DETERIORATED MATERIAL SLIDE
Roof Plan reference	
Deficiency Quantity	20
Quantity Uom	S.F.
Potential Action	REPLACE

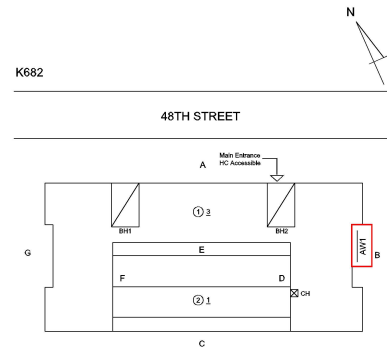
AREAWAY SLAB: CRACKS AND SPALLING

10  
S.F.  
REPLACE  
PRIORITY 4  
LEVEL 2

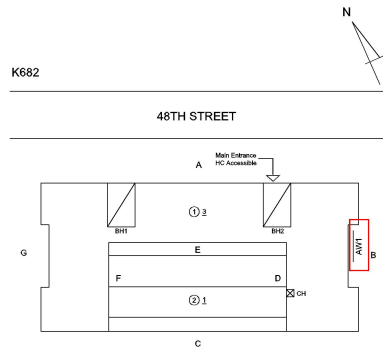
AREAWAY WALLS: CRACKS AND SPALLING

20  
S.F.  
REPAIR  
PRIORITY 3  
LEVEL 2

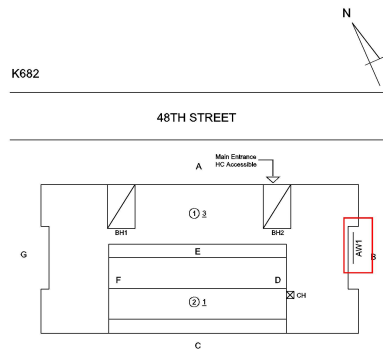
AREAWAY WALLS: DETERIORATED JOINTS

30  
S.F.  
REPAIR  
PRIORITY 4  
LEVEL 2

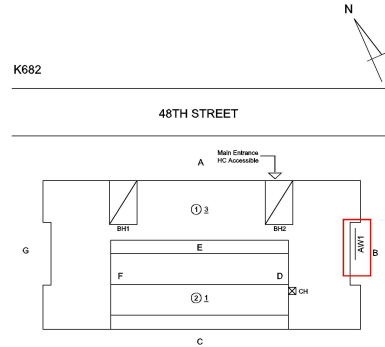
AREAWAY STAIRS: DETERIORATED  
TREADS/RISERS/NOSINGS

REPAIR

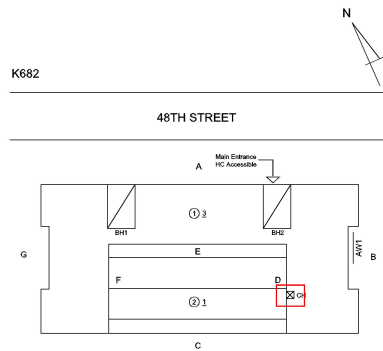
BRICK: MAJOR / THRU CRACKS

20  
 S.F.  
 REMOVE AND REBUILD  
 PRIORITY 4  
 LEVEL 2

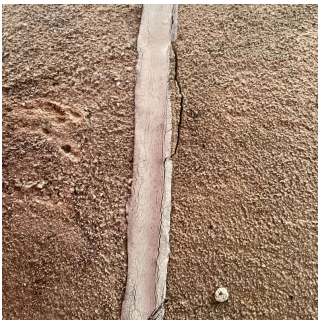
Violations	CH No violations recorded.
<b>COPING</b>	
Condition	Inspected
Deficiency	3 - Fair
Roof Plan reference	CAST STONE: DETERIORATED TRANSVERSE JOINTS
Deficiency Quantity	80
Quantity Uom	L.F.
Potential Action	MAINTENANCE
Urgency of Action	PRIORITY 3
Purpose of Action	LEVEL 2
Deficiency Photo1

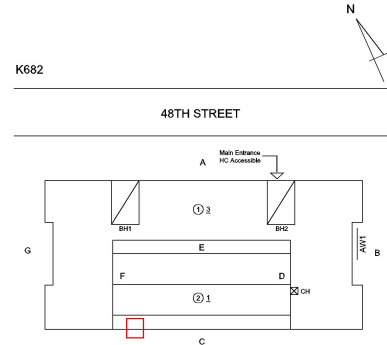
METAL: BROKEN GLASS

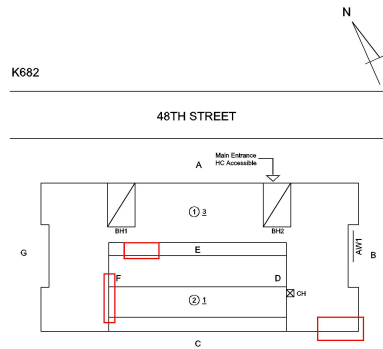
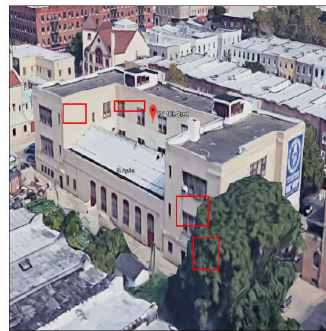
BRICK: MAJOR / THRU CRACKS

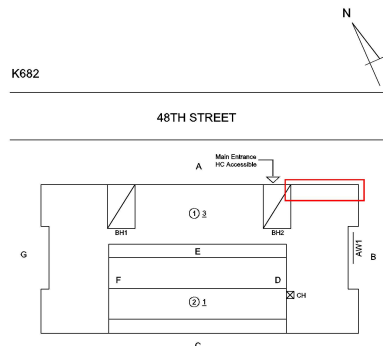
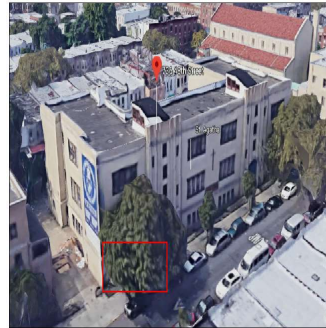
BRICK: DETERIORATED JOINTS

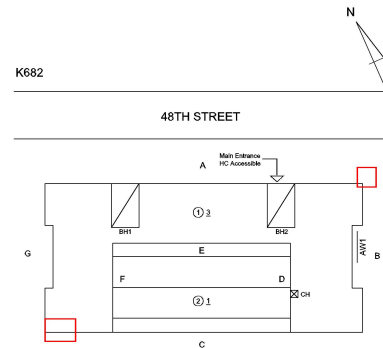
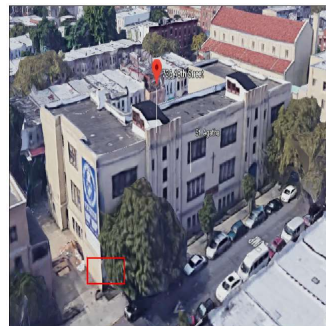
BRICK: CRACKS/DISPLACED/SPALLED BRICK AT BUILDING CORNERS

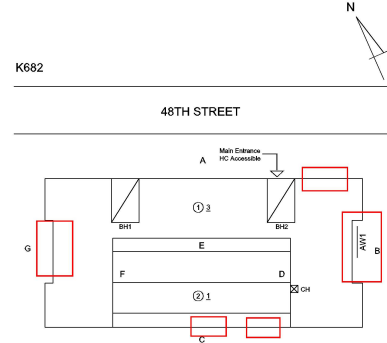
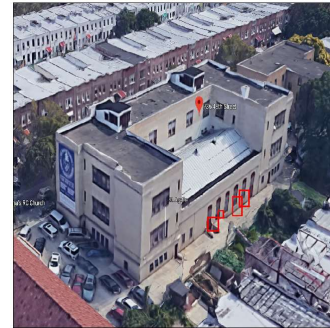
BRICK: DETERIORATED MASONRY SILLS - MAJOR

60  
L.F.  
REMOVE AND REPLACE  
PRIORITY 4  
LEVEL 2

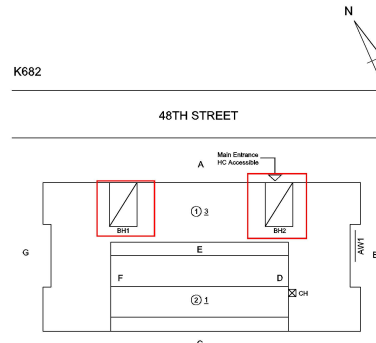
Condition	3 - Fair
Deficiency	BULKHEAD/PENTHOUSE WALLS/INTERIOR: GLAZED BLOCK CRACKS/SPALLING

Question	Response
<b>EXTERIOR</b>	
<b>ROOF</b>	
<b>Specialties</b>	
<b>BULKHEAD/PENTHOUSE</b>	
Deficiency Quantity	40
Quantity Uom	S.F.
Potential Action	REPLACE
Urgency of Action	PRIORITY 4
Purpose of Action	LEVEL 2
Deficiency Photo1

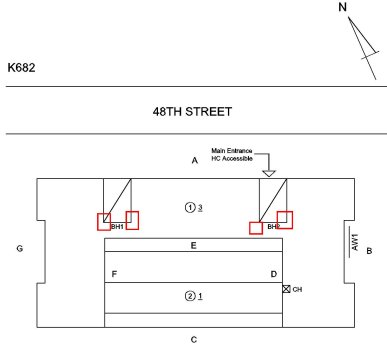
Violations	BH2 No violations recorded.
Deficiency	BULKHEAD/PENTHOUSE WALLS/EXTERIOR: CRACKS/SPALLING - MAJOR
Roof Plan reference

Deficiency Quantity	40
Quantity Uom	S.F.
Potential Action	REPLACE
Urgency of Action	PRIORITY 4
Purpose of Action	LEVEL 2
Deficiency Photo1

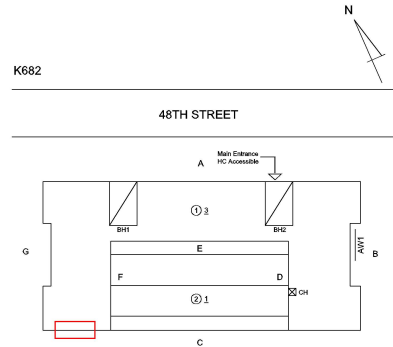
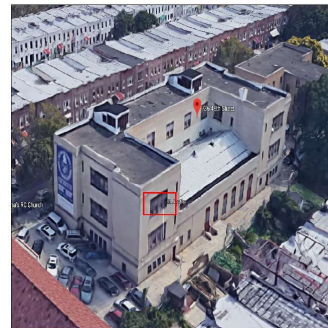
ALUMINUM - DOUBLE HUNG: BROKEN PANE

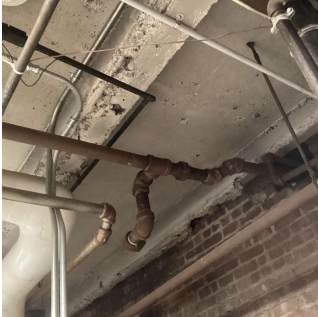
Question	Response
<b>INTERIOR</b>	
<b>POOLS</b>	Does not Exist
<b>STRUCTURAL</b>	Inspected
<b>COLUMNS/BEAMS/BEARING WALLS</b>	Inspected
Condition	3 - Fair
Deficiency	CONCRETE COLUMNS/BEAMS: CRACKED/SPALLED/REINFORCEMENT EXPOSED
Deficiency Location/Instance	Basement - Electrical Panel Room, Boiler Room
Deficiency Quantity	40
Quantity Uom	S.F.
Potential Action	REPLACE
Urgency of Action	PRIORITY 4
Purpose of Action	LEVEL 5
Deficiency Photo1

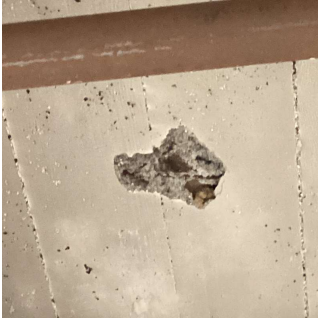
Basement - Boiler Room
Violations	No violations recorded.
<b>FLOOR STRUCTURE</b>	Inspected
Condition	4 - Between Fair and Poor
Deficiency	CONCRETE: CRACKS/SPALLED/REINFORCEMENT EXPOSED
Deficiency Location/Instance	Basement - Boiler Room
Deficiency Quantity	30
Quantity Uom	S.F.
Potential Action	REPAIR
Urgency of Action	PRIORITY 4
Purpose of Action	LEVEL 5
Deficiency Photo1

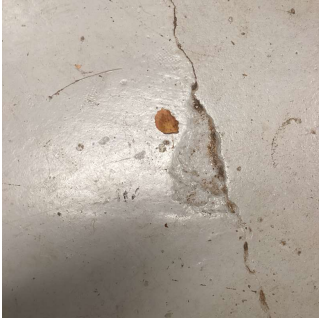
Basement - Boiler Room
Violations	No violations recorded.
Deficiency	CONCRETE SLAB ON GRADE: THRU CRACKS

Deficiency Location/Instance	Basement - Boiler Room, Electrical Room, Water Main Room, Gas Meter Room
Deficiency Quantity	80
Quantity Uom	S.F.
Potential Action	REPLACE

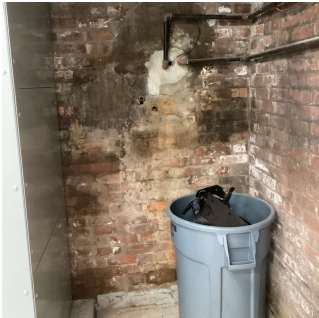
Basement - Water Main Room
Violations	No violations recorded.
<b>FOUNDATION WALLS</b>	
Material Type(s)	Inspected Concrete, Masonry
Condition	4 - Between Fair and Poor
Deficiency	BRICK: WATER INFILTRATION IN ELECTRICAL PANEL ROOM
Deficiency Location/Instance	Basement - Electrical Room
Deficiency Quantity	100
Quantity Uom	S.F.
Potential Action	INSTALL WATERPROOFING
Urgency of Action	PRIORITY 5
Purpose of Action	LEVEL 6
Deficiency Photo1

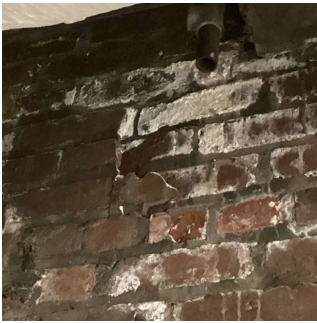
Basement - Electrical Room
Violations	No violations recorded.
Deficiency	BRICK: CRACKED/SPALLED
Deficiency Location/Instance	Basement - Water Main Room, Electrical Room, Boiler Room, Basement - Gas Meter Room
Deficiency Quantity	90
Quantity Uom	S.F.
Potential Action	RESTITCH
Urgency of Action	PRIORITY 4
Purpose of Action	LEVEL 5

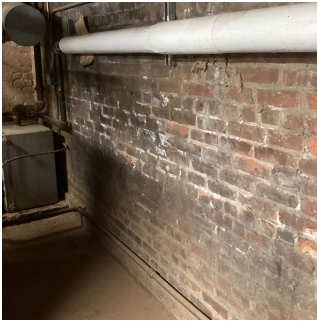
Violations	Basement - Gas Meter Room No violations recorded.
Deficiency	CONCRETE: WATER INFILTRATION IN NON- INSTRUCTIONAL SPACE
Deficiency Location/Instance	Basement - Boiler Room
Deficiency Quantity	100
Quantity Uom	S.F.
Potential Action	INSTALL WATERPROOFING
Urgency of Action	PRIORITY 5
Purpose of Action	LEVEL 5
Deficiency Photo1

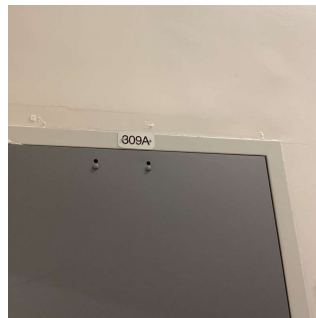
GYP SUM BOARD: DETERIORATED

REPLACE

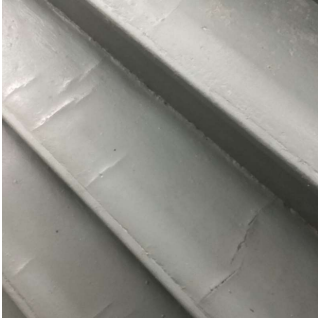
Question	Response
<b>INTERIOR</b>	
<b>LOCKER ROOM</b>	Does not Exist
<b>MULTI-PURPOSE ROOM</b>	Does not Exist
<b>SCIENCE DEMO ROOM</b>	Does not Exist
<b>SCIENCE LAB</b>	Does not Exist
<b>SCIENCE PREP ROOM</b>	Does not Exist
<b>SHOWER ROOM</b>	Does not Exist
<b>STAIRS/RAMPS: INTERIOR</b>	Inspected
Do Letter Stair Signs Exist?	Yes
<b>Ceiling</b>	Inspected
Condition	2 - Between Good and Fair
Deficiency	No deficiencies recorded
<b>Door(s)</b>	Inspected
Condition	2 - Between Good and Fair
Deficiency	No deficiencies recorded
<b>Partition</b>	Does not Exist
<b>Railings</b>	Inspected
Condition	2 - Between Good and Fair
Deficiency	No deficiencies recorded
<b>Stairs and Landings</b>	Inspected
Condition	3 - Fair
Deficiency	ROLLED ASPHALT: CRACKS
Deficiency Location/Instance	Stairs B/Bulkhead, 3
Deficiency Quantity	50
Quantity Uom	S.F.
Potential Action	REPLACE
Urgency of Action	PRIORITY 3
Purpose of Action	LEVEL 2
Deficiency Photo1

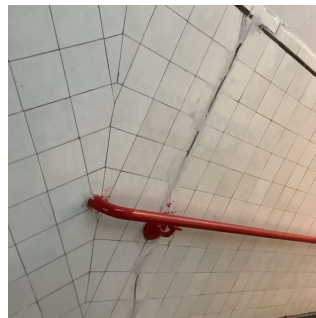
CERAMIC TILE: BROKEN/ MISSING

REPLACE

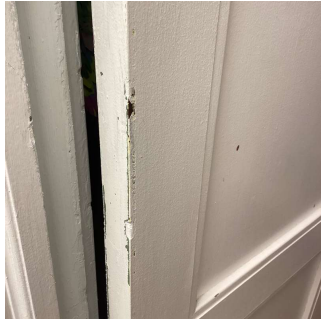
Question	Response
<b>INTERIOR</b>	
<b>STAIRS/RAMPS: INTERIOR</b>	Inspected
<b>Walls</b>	Inspected
Violations	Stair B/3 No violations recorded.
<b>TOILET ROOMS - STAFF</b>	Inspected
<b>Ceiling</b>	Inspected
Condition	2 - Between Good and Fair
Deficiency	No deficiencies recorded
<b>Door(s)</b>	Inspected
Condition	5 - Poor
Deficiency	WOOD: DETERIORATED DOOR
Deficiency Location/Instance	Room 305A
Deficiency Quantity	1
Quantity Uom	EACH
Potential Action	MAINTENANCE
Urgency of Action	PRIORITY 3
Purpose of Action	LEVEL 2
Deficiency Photo1

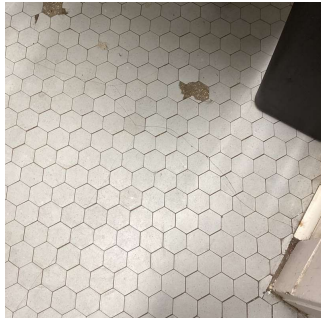
Violations	Room 305A No violations recorded.
<b>Floor Finish</b>	Inspected
Condition	3 - Fair
Deficiency	CERAMIC TILE: DETERIORATED SUBSTRATE
Deficiency Location/Instance	Room 305A
Deficiency Quantity	10
Quantity Uom	S.F.
Potential Action	REPLACE
Urgency of Action	PRIORITY 3
Purpose of Action	LEVEL 2
Deficiency Photo1

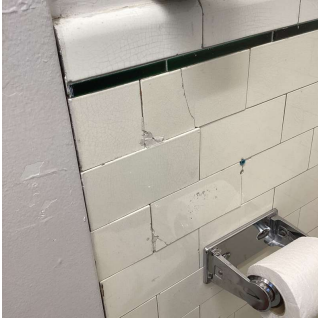
Question	Response
<b>INTERIOR</b>	
<b>TOILET ROOMS - STAFF</b>	Inspected
<b>Stalls</b>	Does not Exist
<b>Walls</b>	Inspected
Condition	2 - Between Good and Fair
Deficiency	CERAMIC TILE: BROKEN/ MISSING
Deficiency Location/Instance	Rooms 305A, 309A
Deficiency Quantity	20
Quantity Uom	S.F.
Potential Action	REPLACE
Urgency of Action	PRIORITY 3
Purpose of Action	LEVEL 2
Deficiency Photo1

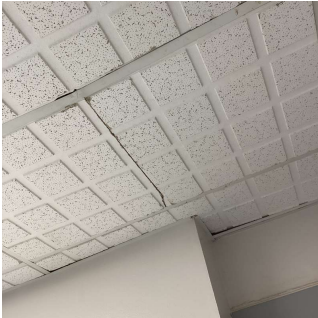
Room 305A
Violations	No violations recorded.
<b>TOILET ROOMS - STUDENTS</b>	Inspected
<b>Ceiling</b>	Inspected
Condition	2 - Between Good and Fair
Deficiency	ACOUSTIC TILES: DAMAGED/MISSING
Deficiency Location/Instance	Room 118
Deficiency Quantity	10
Quantity Uom	S.F.
Potential Action	REPLACE
Urgency of Action	PRIORITY 3
Purpose of Action	LEVEL 2
Deficiency Photo1

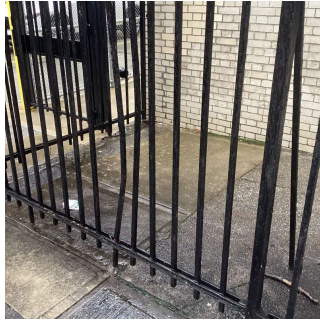
<b>Drainage System for Soil</b>	Does not Exist
<b>DRINKING FOUNTAINS</b>	Does not Exist
<b>FENCES</b>	Inspected
Condition	2 - Between Good and Fair
Deficiency	WROUGHT IRON: DAMAGED/DETERIORATED
Deficiency Location/Instance	48th Street
Deficiency Quantity	40
Quantity Uom	S.F.
Potential Action	REPLACE
Urgency of Action	PRIORITY 3
Purpose of Action	LEVEL 2

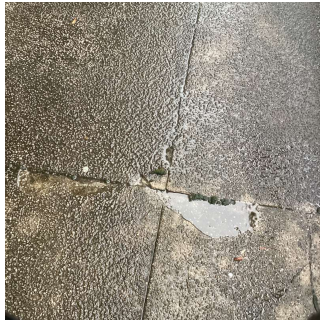
Violations	48th Street No violations recorded.
<b>IRRIGATION SYSTEM</b>	Does not Exist
<b>PAVING</b>	Inspected
<b>Student Non-Use</b>	Inspected
Gravel Exists?	No
<b>Asphalt</b>	Does not Exist
<b>Concrete</b>	Inspected
Condition	3 - Fair
Deficiency	DAMAGED/DETERIORATED/MISSING SECTIONS
Deficiency Location/Instance	48th Street
Deficiency Quantity	125
Quantity Uom	S.F.
Potential Action	REPLACE
Urgency of Action	PRIORITY 3
Purpose of Action	LEVEL 2
Deficiency Photo1

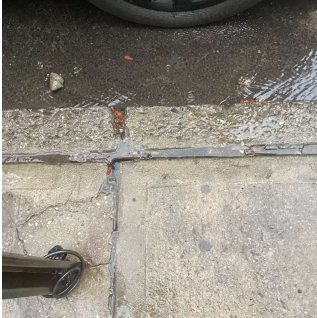
Question	Response
<b>SITE</b>	
<b>PAVING</b>	
<b>Student Use</b>	
<b>Concrete</b>	
Urgency of Action	PRIORITY 3
Purpose of Action	LEVEL 2
Deficiency Photo1	 
Violations	Schoolyard No violations recorded.
<b>Pavers</b>	Does not Exist
<b>Site Sidewalks &amp; Walkways</b>	Inspected
<b>Asphalt</b>	Does not Exist
<b>Concrete</b>	Inspected
Condition	3 - Fair
Deficiency	DAMAGED/DETERIORATED/MISSING SECTIONS
Deficiency Location/Instance	48th Street
Deficiency Quantity	175
Quantity Uom	S.F.
Potential Action	REPLACE
Urgency of Action	PRIORITY 3
Purpose of Action	LEVEL 2
Deficiency Photo1	 
Violations	48th Street No violations recorded.
<b>Pavers</b>	Does not Exist
<b>DOT Sidewalk</b>	Inspected
<b>Asphalt</b>	Does not Exist
<b>Concrete</b>	Inspected
Condition	3 - Fair
Deficiency	DAMAGED CURBS
Deficiency Location/Instance	48th Street
Deficiency Quantity	40
Quantity Uom	L.F.

Question	Response
<b>SITE</b>	
<b>PAVING</b>	
<b>DOT Sidewalk</b>	
<b>Concrete</b>	
Potential Action	REPLACE
Urgency of Action	PRIORITY 3
Purpose of Action	LEVEL 2
Deficiency Photo1

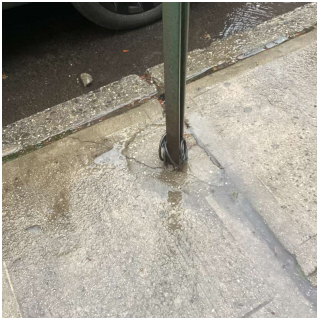
48th Street
Violations	No violations recorded.
Deficiency	DAMAGED/DETERIORATED/MISSING SECTIONS
Deficiency Location/Instance	48th Street
Deficiency Quantity	175
Quantity Uom	S.F.
Potential Action	REPLACE
Urgency of Action	PRIORITY 3
Purpose of Action	LEVEL 2
Deficiency Photo1
