NYC Department of Education
Building Condition Assessment Survey 2023 - 2024

Architectural Inspection

Asset: P.S. 188 GYM - BROOKLYN, 2815 WEST 35 STREET, New York, 11224

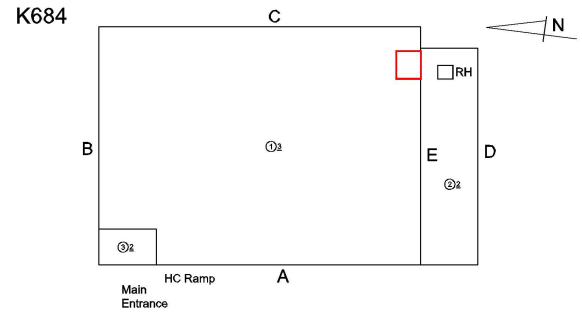
Roof Plan reference

Deficiency

IRMA: ROOFING: MAJOR ACTIVE ROOF LEAKS IN INSTRUCTIONAL SPACE

REPLACE ROOFING WITHOUT MAJOR EQUIPMENT REMOVAL

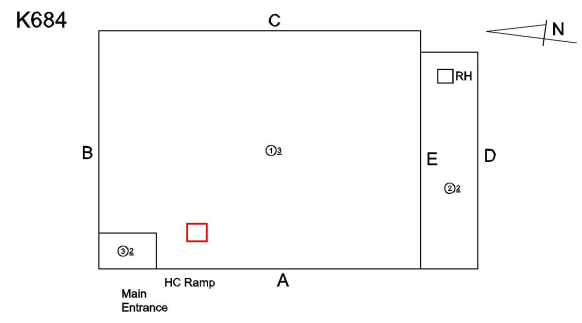
Roof Plan reference

Deficiency

DETERIORATED

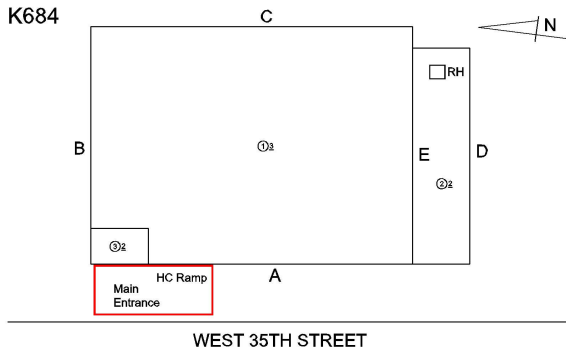
Violations	Roof 1 No violations recorded.
Specialties	Inspected
BULKHEAD/PENTHOUSE	Does not Exist
CUPOLA/ SPIRES/ TOWERS	Does not Exist
DORMER	Does not Exist
DUNNAGE STEEL	Inspected
Condition	2 - Between Good and Fair
Deficiency	No deficiencies recorded
SKYLIGHT/ROOF VENT	Does not Exist
ROOF/GRAVITY TANK	Does not Exist
STAIRS/RAMPS: EXTERIOR	Inspected
BUILDING CHEEK/FLANK WALLS	Inspected
Condition	5 - Poor
Deficiency	CAST IN PLACE CONCRETE: CRACKS/SPALLING - MINOR
Roof Plan reference	K684

Deficiency Quantity	100
Quantity Uom	S.F.
Potential Action	REPAIR
Urgency of Action	PRIORITY 3
Purpose of Action	LEVEL 2

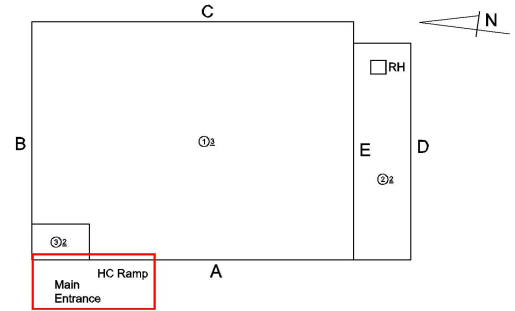
Roof Plan reference

CAST IN PLACE CONCRETE: CRACKS/SPALLING - MAJOR
K684

REPLACE
