NYC Department of Education
Building Condition Assessment Survey 2023 - 2024

Architectural Inspection

Asset: **PRE-K CENTER @ 10 BOUCK COURT - BROOKLYN, 10 BOUCK COURT, New York, 11223**

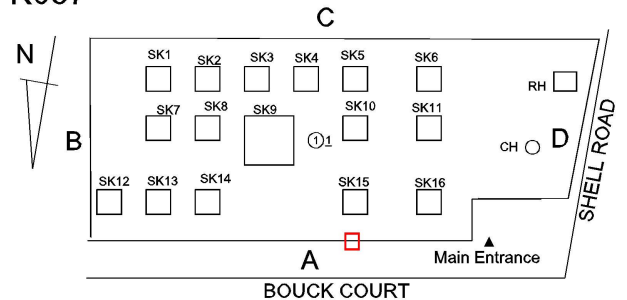
Question	Response
Architectural	
EXTERIOR	Inspected
AREAWAY	Does not Exist
AWNINGS AND CANOPIES	Inspected
Condition	2 - Between Good and Fair
Deficiency	No deficiencies recorded
CHIMNEY	Inspected
Material Type(s)	Metal
Condition	2 - Between Good and Fair
Deficiency	No deficiencies recorded
COPING	Inspected
Condition	2 - Between Good and Fair
Deficiency	CAST STONE: DETERIORATED TRANSVERSE JOINTS
Roof Plan reference	K687

10
L.F.
MAINTENANCE
PRIORITY 3
LEVEL 2

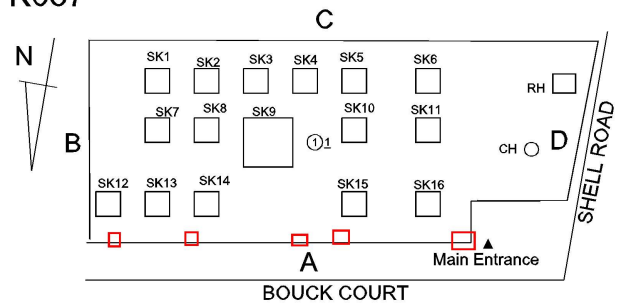
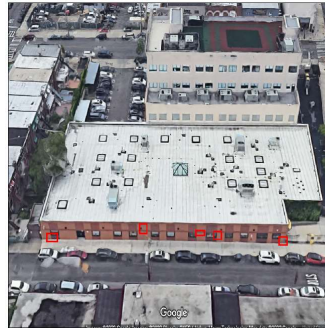
Violations	Roof 1 No violations recorded.
CORNICE	Does not Exist
DOORS	Inspected
DOORS AND FRAMES	Inspected
Condition	2 - Between Good and Fair
Deficiency	No deficiencies recorded
DOOR HARDWARE	Inspected
Condition	2 - Between Good and Fair
Deficiency	No deficiencies recorded
LINTELS	Inspected
Condition	2 - Between Good and Fair
Deficiency	No deficiencies recorded
TRANSOM/SIDE LIGHT	Does not Exist
EXTERIOR WALLS	Inspected
Material Type(s)	Masonry
Replacement Quantity	6,300
Replacement Uom	S.F.
Instance on All Facades	Inspected
Instance Condition	4 - Between Fair and Poor
Instance Quantity	6,300
Instance Quantity Uom	S.F.
Deficiency	BRICK: MAJOR / THRU CRACKS
Roof Plan reference	K687

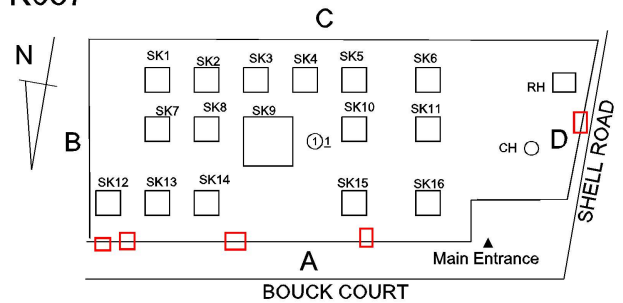
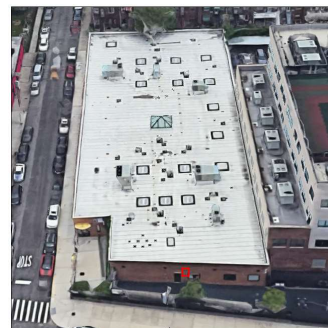
BRICK: MINOR CRACKS AND SPALLING

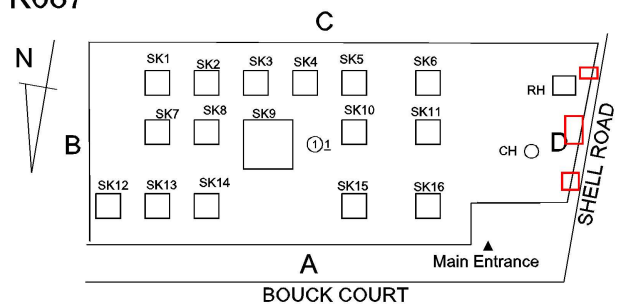
Deficiency	MODIFIED BITUMEN: FLASHING: CAP FLASHING DAMAGED
Roof Plan reference	K687

Question	Response
EXTERIOR	
ROOF	
Roofing	
ROOFING	
Quantity Uom	L.F.
Potential Action	REPLACE
Urgency of Action	PRIORITY 4
Purpose of Action	LEVEL 2
Deficiency Photo1	 
Violations	Roof 1 No violations recorded.
ROOFING DRAINS	Inspected
Condition	2 - Between Good and Fair
Deficiency	No deficiencies recorded
Specialties	Inspected
BULKHEAD/PENTHOUSE	Does not Exist
CUPOLA/ SPIRES/ TOWERS	Does not Exist
DORMER	Does not Exist
DUNNAGE STEEL	Does not Exist
SKYLIGHT/ROOF VENT	Inspected
Material Type(s)	Glass, Plastic
Condition	2 - Between Good and Fair
Deficiency	No deficiencies recorded
ROOF/GRAVITY TANK	Does not Exist
STAIRS/RAMPS: EXTERIOR	Does not Exist
WINDOWS	Inspected
Replacement Quantity	1,600
Replacement Uom	S.F.
EXTERIOR GUARDS	Inspected
Condition	2 - Between Good and Fair
Deficiency	No deficiencies recorded
LINTELS	Inspected
Condition	2 - Between Good and Fair
Deficiency	No deficiencies recorded
WINDOWS	Inspected
Material Type(s)	Aluminum
