**NYC Department of Education**  
**Building Condition Assessment Survey 2023 - 2024**

Architectural Inspection

K695

**Asset:** PRE-K CENTER @ 1258 65TH STREET - BROOKLYN, 1258 65TH STREET, New York, 11219

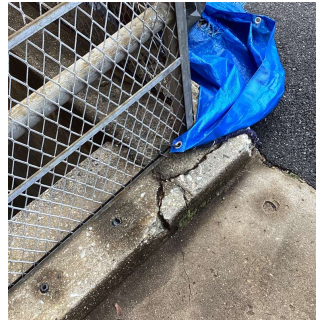
AW1  
No violations recorded.

Question	Response
<b>Architectural</b>	
<b>EXTERIOR</b>	Inspected
<b>AREAWAY</b>	Inspected
Instance on AW1, AW2	Inspected
Instance Condition	2 - Between Good and Fair
Instance Quantity	2
Instance Quantity Uom	EACH
Deficiency	AREAWAY WALLS: CRACKS AND SPALLING
Roof Plan reference	
Deficiency Quantity	20
Quantity Uom	S.F.
Potential Action	REPAIR
Urgency of Action	PRIORITY 3
Purpose of Action	LEVEL 2

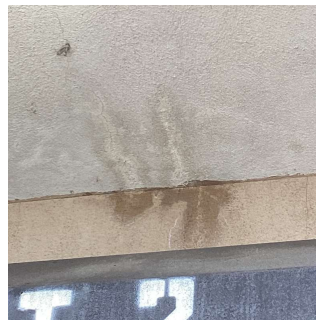
Facade A

CONCRETE: WATER PENETRATION

REPAIR

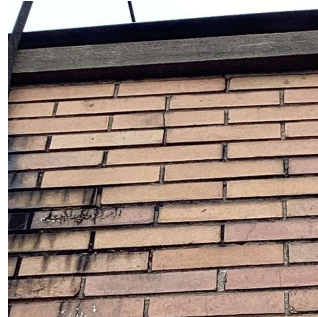
CH

BRICK: MINOR CRACKS AND SPALLING

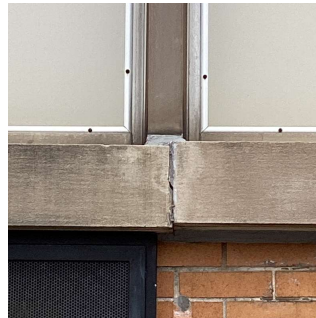
Facade A

BRICK: MASONRY SILLS - DETERIORATED JOINTS

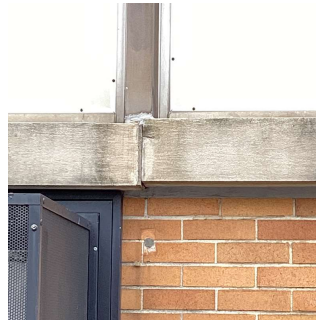
Facade A

BRICK: DETERIORATED MASONRY SILLS - MAJOR

REMOVE AND REPLACE

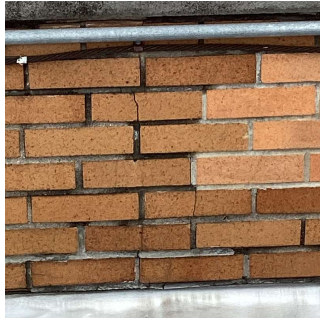
BRICK: MINOR CRACKS, SPALLING

REPAIR

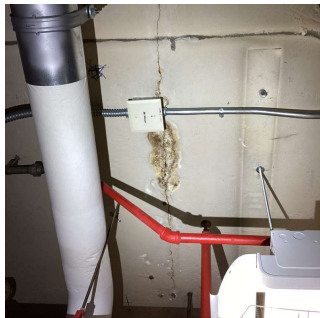
Violations	Roof 1 No violations recorded.
<b>PLAZA DECK</b>	Inspected
Instance on Concrete: Roofs 4, 5	Inspected
Instance Condition	3 - Fair
Instance Quantity	1,000
Instance Quantity Uom	S.F.
Installation Year	1965
Source of Installation	Custodial Staff
Deficiency	CONCRETE: MAJOR CRACKS
Roof Plan reference

Deficiency Quantity	10
Quantity Uom	S.F.
Potential Action	REPLACE
Urgency of Action	PRIORITY 4
Purpose of Action	LEVEL 2
Deficiency Photo1

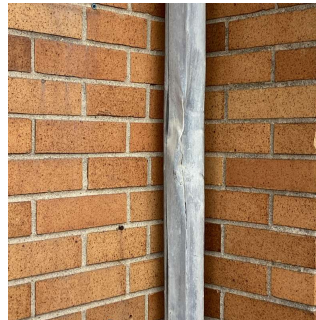
Facade A

Deficiency	DAMAGED/MISSING
------------	-----------------

REPLACE

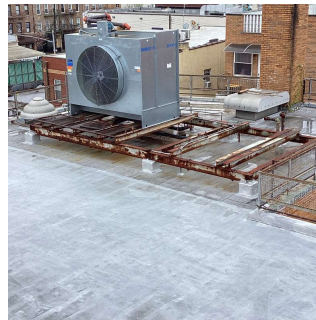
Roof 2  
No violations recorded.

Violations	BH1 No violations recorded.
<b>CUPOLA/ SPIRES/ TOWERS</b>	Does not Exist
<b>DORMER</b>	Does not Exist
<b>DUNNAGE STEEL</b>	Inspected
Condition	3 - Fair
Deficiency	HEIGHT LESS THAN 18"

50  
L.F.  
REPLACE  
PRIORITY 3  
LEVEL 2

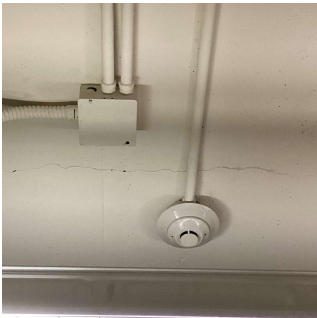
Violations	Room 10A (MER above Gymnasium similar) No violations recorded.
<b>FOUNDATION WALLS</b>	
Material Type(s)	Inspected Concrete
Condition	2 - Between Good and Fair
Deficiency	No deficiencies recorded
<b>ROOF STRUCTURE</b>	
Condition	Inspected 2 - Between Good and Fair
Deficiency	No deficiencies recorded
<b>VAULTS-BUNKERS</b>	
<b>Foundation Walls</b>	Inspected Inaccessible
<b>Slab Structure</b>	Inspected
Condition	3 - Fair
Deficiency	CONCRETE: CRACKS/SPALLED/REINFORCEMENT EXPOSED
Deficiency Location/Instance	Vault
Deficiency Quantity	35
Quantity Uom	S.F.
Potential Action	REPAIR
Urgency of Action	PRIORITY 4
Purpose of Action	LEVEL 5
Deficiency Photo1

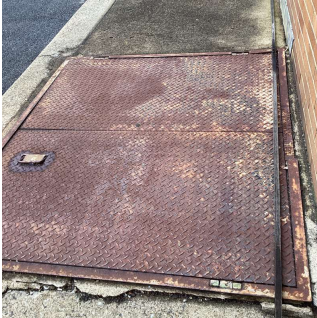
Violations	Vault No violations recorded.
<b>Vault/Ash Hoist Doors and Framing</b>	
Condition	Inspected 5 - Poor
Deficiency	DETERIORATED/DAMAGED VAULT/ASH HOIST DOORS AND FRAMING

Deficiency Location/Instance	Vault
Deficiency Quantity	2
Quantity Uom	EACH

Question	Response
<b>INTERIOR</b>	
<b>STRUCTURAL</b>	
<b>VAULTS-BUNKERS</b>	
<b>Vault/Ash Hoist Doors and Framing</b>	
Potential Action	REPLACE
Urgency of Action	PRIORITY 4
Purpose of Action	LEVEL 2
Deficiency Photo1

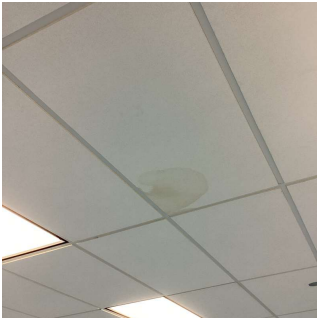
Violations	Vault No violations recorded.
<b>AUDITORIUM</b>	Does not Exist
<b>CAFETERIA</b>	Does not Exist
<b>CLASSROOMS/CORRIDORS/ADMIN SPACES</b>	Inspected
<b>Ceiling</b>	Inspected
Condition	2 - Between Good and Fair
Deficiency	ACOUSTIC TILES: DAMAGED/MISSING
Deficiency Location/Instance	Corridor near Room 010
Deficiency Quantity	10
Quantity Uom	S.F.
Potential Action	REPLACE
Urgency of Action	PRIORITY 3
Purpose of Action	LEVEL 2
Deficiency Photo1

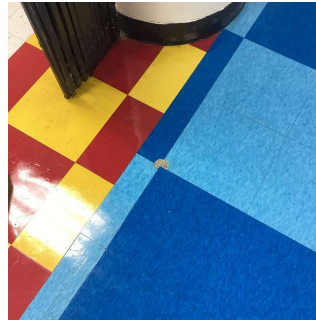
Corridor near Stair C/Basement

VINYL TILES: BROKEN/DETERIORATED/MISSING TILES

REPLACE

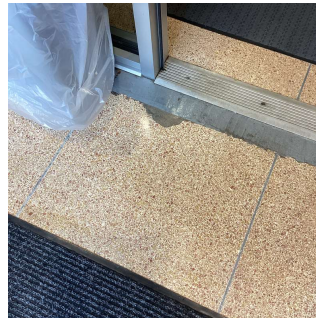
TERRAZZO: CRACKS

REPLACE

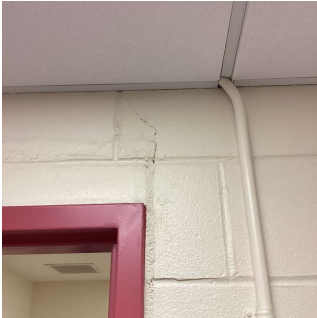
Question	Response
<b>INTERIOR</b>	
<b>CLASSROOMS/CORRIDORS/ADMIN SPACES</b>	
<b>Floor Finish</b>	Inspected
	Main Entrance - Vestibule
Violations	No violations recorded.
<b>Walls</b>	Inspected
Condition	2 - Between Good and Fair
Deficiency	MASONRY: CRACKS/SPALLING
Deficiency Location/Instance	Corridor near Rooms 303A, 305, 309
Deficiency Quantity	30
Quantity Uom	S.F.
Potential Action	REPLACE
Urgency of Action	PRIORITY 3
Purpose of Action	LEVEL 2
Deficiency Photo1

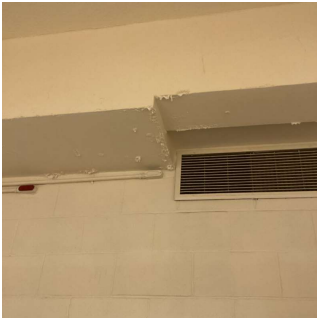
Violations	Corridor near Room 303A No violations recorded.
<b>Specialties</b>	Does not Exist
<b>GYMNASIUM</b>	Inspected
Instance on 1st Floor	Inspected
<b>Ceiling</b>	Inspected
Instance on 1st Floor	Inspected
Condition	2 - Between Good and Fair
Deficiency	PLASTER: CRACKS/SPALLING
Deficiency Location/Instance	Balcony
Deficiency Quantity	20
Quantity Uom	S.F.
Potential Action	REPLACE
Urgency of Action	PRIORITY 3
Purpose of Action	LEVEL 2
Deficiency Photo1

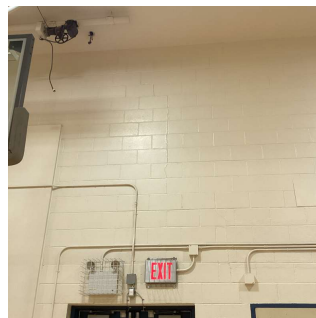
Instance on 1st Floor	Inspected
Condition	2 - Between Good and Fair
Deficiency	MASONRY: CRACKS/SPALLING
Deficiency Location/Instance	Near Stair E, by Windows
Deficiency Quantity	40
Quantity Uom	S.F.
Potential Action	REPLACE
Urgency of Action	PRIORITY 3
Purpose of Action	LEVEL 2
Deficiency Photo1

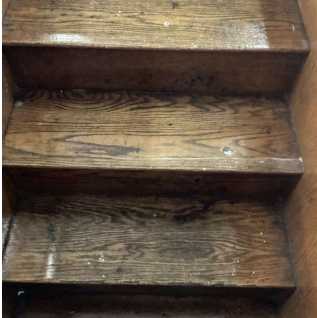
<b>Sliding-folding Partition</b>	
Instance on 1st Floor	Not Required
<b>Stage</b>	
Instance on 1st Floor	Inspected
<b>Stage</b>	
Instance on 1st Floor	Inspected
Condition	3 - Fair
Deficiency	DAMAGED STEPS
Deficiency Location/Instance	Left Side

Question	Response
<b>INTERIOR</b>	
<b>MULTI-PURPOSE ROOM</b>	
<b>Stage</b>	
<b>Stage</b>	
Deficiency Quantity	20
Quantity Uom	S.F.
Potential Action	REPLACE
Urgency of Action	PRIORITY 3
Purpose of Action	LEVEL 2
Deficiency Photo1

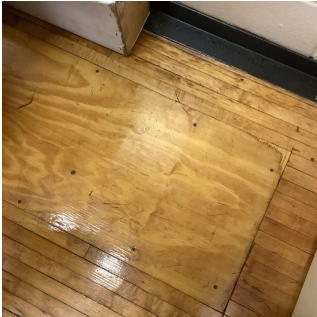
Left Side
Violations	No violations recorded.
Deficiency	DAMAGED FLOOR
Deficiency Location/Instance	Left Side
Deficiency Quantity	20
Quantity Uom	S.F.
Potential Action	REPLACE
Urgency of Action	PRIORITY 3
Purpose of Action	LEVEL 2
Deficiency Photo1

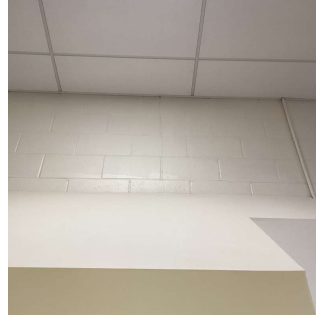
Near Sliding Folding Partition  
No violations recorded.

Left Side
Violations	No violations recorded.
<b>Stage Curtain Rigging</b>	Does not Exist
Instance on 1st Floor	Does not Exist
<b>Stage Curtains</b>	Does not Exist
Instance on 1st Floor	Does not Exist
<b>Walls</b>	
Instance on 1st Floor	Inspected
Condition	2 - Between Good and Fair
Deficiency	MASONRY: CRACKS/SPALLING
Deficiency Location/Instance	Near Sliding Folding Partition
Deficiency Quantity	10
Quantity Uom	S.F.
Potential Action	REPLACE

Urgency of Action  
Purpose of Action  
Deficiency Photo1

PRIORITY 3  
LEVEL 2

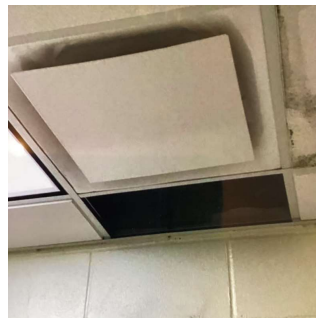
Instance on Room 004  
Condition  
Deficiency  
Deficiency Location/Instance  
Deficiency Quantity  
Quantity Uom  
Potential Action  
Urgency of Action  
Purpose of Action  
Deficiency Photo1

Inspected  
4 - Between Fair and Poor  
ACOUSTIC TILES: DAMAGED/MISSING  
Left Side  
20  
S.F.  
REPLACE  
PRIORITY 3  
LEVEL 2

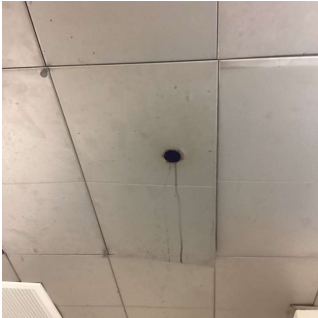
Violations	No violations recorded.
Instance on Room 017	Inspected
Condition	3 - Fair
Deficiency	METAL PAN: DAMAGED/MISSING
Deficiency Location/Instance	Near Sink
Deficiency Quantity	10
Quantity Uom	S.F.
Potential Action	REPLACE
Urgency of Action	PRIORITY 3
Purpose of Action	LEVEL 2
Deficiency Photo1

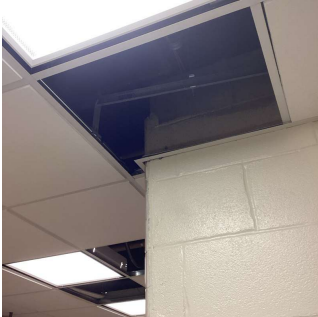
Violations	No violations recorded.
Instance on Room 002	Inspected
Condition	4 - Between Fair and Poor
Deficiency	ACOUSTIC TILES: DAMAGED/MISSING
Deficiency Location/Instance	Near Main Entrance
Deficiency Quantity	20
Quantity Uom	S.F.
Potential Action	REPLACE
Urgency of Action	PRIORITY 3
Purpose of Action	LEVEL 2
Deficiency Photo1

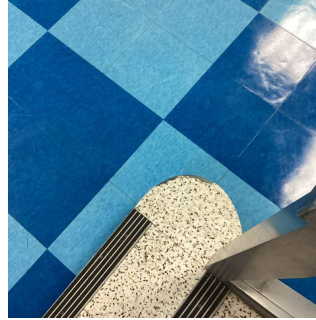
Question	Response
<b>INTERIOR</b>	
<b>SHOWER ROOM</b>	
<b>Walls</b>	
Purpose of Action	LEVEL 2
Deficiency Photo1	 
	Near Main Entrance
Violations	No violations recorded.
<b>STAIRS/RAMPS: INTERIOR</b>	
	Inspected
Do Letter Stair Signs Exist?	Yes
<b>Ceiling</b>	Inspected
Condition	2 - Between Good and Fair
Deficiency	PLASTER: CRACKS/SPALLING - ACTIVE LEAK
Deficiency Location/Instance	Stair B/3
Deficiency Quantity	20
Quantity Uom	S.F.
Potential Action	REPLACE
Urgency of Action	PRIORITY 5
Purpose of Action	LEVEL 2
Deficiency Photo1	 
	Stair B/3
Violations	No violations recorded.
<b>Door(s)</b>	Inspected
Condition	2 - Between Good and Fair
Deficiency	No deficiencies recorded
<b>Partition</b>	Does not Exist
<b>Railings</b>	Inspected
Condition	2 - Between Good and Fair
Deficiency	No deficiencies recorded
<b>Stairs and Landings</b>	Inspected
Condition	2 - Between Good and Fair
Deficiency	TERRAZZO: CRACKS
Deficiency Location/Instance	Stair C/Basement

Deficiency Quantity	10
Quantity Uom	S.F.

Potential Action	REPLACE
Urgency of Action	PRIORITY 3
Purpose of Action	LEVEL 2
Deficiency Photo1

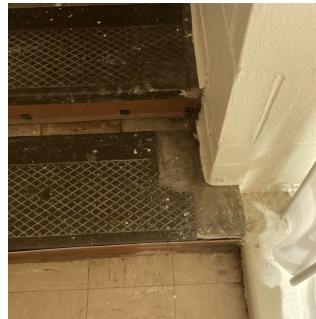
Deficiency	SHEET VINYL: BROKEN/DETERIORATED
Deficiency Location/Instance	Gymnasium - Balcony
Deficiency Quantity	10
Quantity Uom	S.F.
Potential Action	REPLACE
Urgency of Action	PRIORITY 3
Purpose of Action	LEVEL 2
Deficiency Photo1

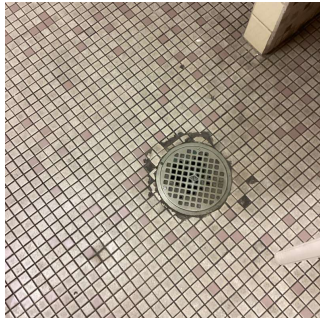
Violations	Room 203 No violations recorded.
<b>Floor Finish</b>	Inspected
Condition	3 - Fair
Deficiency	CERAMIC TILE: BROKEN/MISSING TILES
Deficiency Location/Instance	Room 007
Deficiency Quantity	10
Quantity Uom	S.F.
Potential Action	REPLACE
Urgency of Action	PRIORITY 3
Purpose of Action	LEVEL 2
Deficiency Photo1

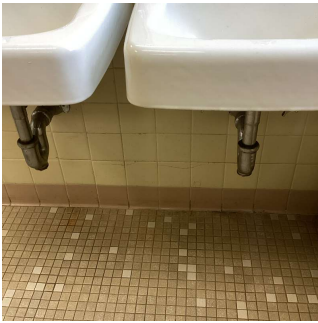
Violations	Room 007 No violations recorded.
<b>Stalls</b>	Inspected
Condition	2 - Between Good and Fair
Deficiency	No deficiencies recorded
<b>Walls</b>	Inspected
Condition	2 - Between Good and Fair
Deficiency	CERAMIC TILE: BROKEN/ MISSING
Deficiency Location/Instance	Rooms 019, 203, In Room 110
Deficiency Quantity	30
Quantity Uom	S.F.
Potential Action	REPLACE
Urgency of Action	PRIORITY 3
Purpose of Action	LEVEL 2

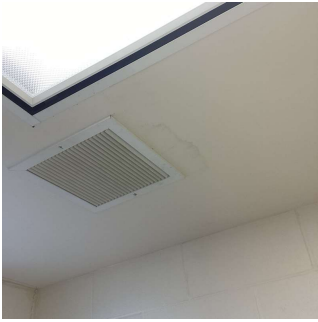
Violations	Room 203 No violations recorded.
<b>TOILET ROOMS - STUDENTS</b>	
<b>Ceiling</b>	Inspected
Condition	2 - Between Good and Fair
Deficiency	PLASTER: CRACKS/SPALLING
Deficiency Location/Instance	Room 305
Deficiency Quantity	10
Quantity Uom	S.F.
Potential Action	REPLACE
Urgency of Action	PRIORITY 3
Purpose of Action	LEVEL 2
Deficiency Photo1

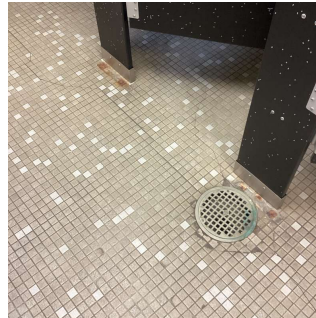
Room 105

CERAMIC TILE: DETERIORATED SUBSTRATE

REPLACE

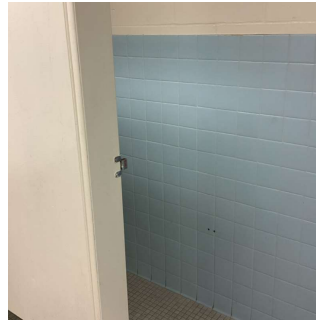
In Room R017

BROKEN/MISSING

REPLACE

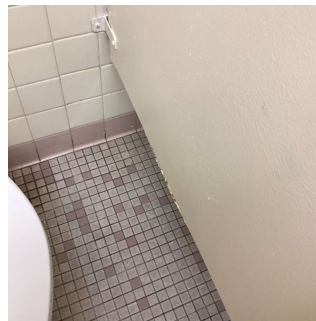
Room 309

RUST - MAJOR

REPLACE

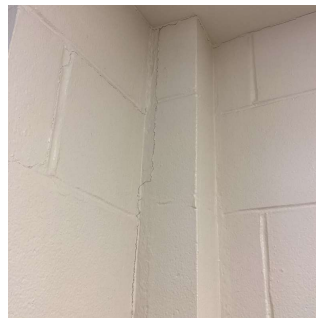
MASONRY: CRACKS/SPALLING

REPLACE

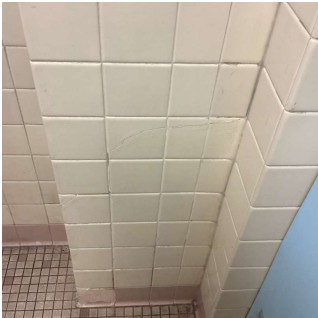
Question	Response
<b>INTERIOR</b>	
<b>TOILET ROOMS - STUDENTS</b>	
<b>Walls</b>	
Violations	Room 309 No violations recorded.
Deficiency	CERAMIC TILE: BROKEN/ MISSING
Deficiency Location/Instance	Rooms 105, 113, 309
Deficiency Quantity	30
Quantity Uom	S.F.
Potential Action	REPLACE
Urgency of Action	PRIORITY 3
Purpose of Action	LEVEL 2
Deficiency Photo1

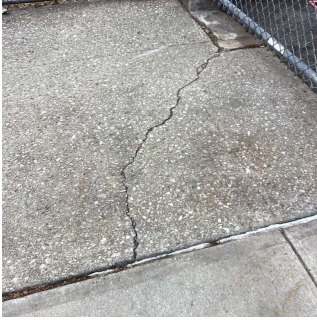
Violations	65th Street No violations recorded.
<b>Pavers</b>	Does not Exist
<b>DOT Sidewalk</b>	Inspected

Question	Response
<b>SITE</b>	
<b>FENCES</b>	
Deficiency Photo1	 
Violations	65th Street No violations recorded.
<b>IRRIGATION SYSTEM</b>	Does not Exist
<b>PAVING</b>	Inspected
<b>Student Non-Use</b>	Inspected
Gravel Exists?	No
<b>Asphalt</b>	Inspected
Condition	2 - Between Good and Fair
Deficiency	No deficiencies recorded
<b>Concrete</b>	Inspected
Condition	2 - Between Good and Fair
Deficiency	No deficiencies recorded
<b>Pavers</b>	Does not Exist
<b>Student Use</b>	Does not Exist
<b>Site Sidewalks &amp; Walkways</b>	Inspected
<b>Asphalt</b>	Does not Exist
<b>Concrete</b>	Inspected
Condition	3 - Fair
Deficiency	DAMAGED/DETERIORATED/MISSING SECTIONS
Deficiency Location/Instance	65th Street
Deficiency Quantity	75
Quantity Uom	S.F.
Potential Action	REPLACE
Urgency of Action	PRIORITY 3
Purpose of Action	LEVEL 2
Deficiency Photo1

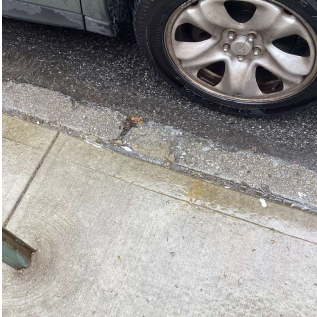
Question	Response
<b>SITE</b>	
<b>PAVING</b>	
<b>DOT Sidewalk</b>	
<b>Asphalt</b>	Does not Exist
<b>Concrete</b>	Inspected
Condition	3 - Fair
Deficiency	DAMAGED CURBS
Deficiency Location/Instance	65th Street
Deficiency Quantity	60
Quantity Uom	L.F.
Potential Action	REPLACE
Urgency of Action	PRIORITY 3
Purpose of Action	LEVEL 2
Deficiency Photo1

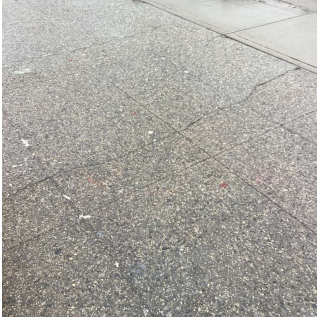
65th Street
Violations	No violations recorded.
Deficiency	DAMAGED/DETERIORATED/MISSING SECTIONS
Deficiency Location/Instance	65th Street
Deficiency Quantity	225
Quantity Uom	S.F.
Potential Action	REPLACE
Urgency of Action	PRIORITY 3
Purpose of Action	LEVEL 2
Deficiency Photo1
