NYC Department of Education
Building Condition Assessment Survey 2023 - 2024

Architectural Inspection

K705

Asset: MIDWOOD HS ADDITION - BROOKLYN, 2886 BEDFORD AVENUE, New York, 11210

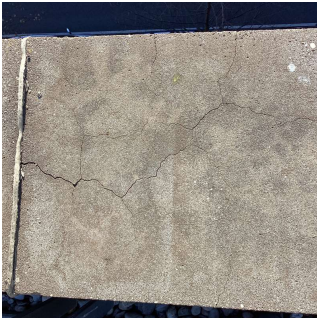
Violations	Roof 1 No violations recorded.
Deficiency	CAST STONE: DISINTEGRATING / FREEZE THAW
Roof Plan reference	K705

Deficiency Quantity	100
Quantity Uom	L.F.
Potential Action	REPLACE-IN-KIND
Urgency of Action	PRIORITY 4
Purpose of Action	LEVEL 2
Deficiency Photo1

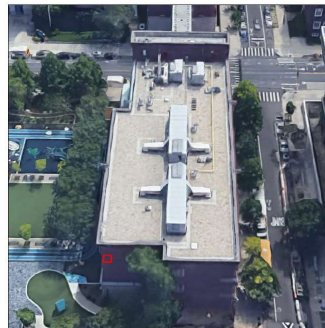
Elevation

Deficiency	BRICK: MAJOR / THRU CRACKS
------------	-----------------------------------

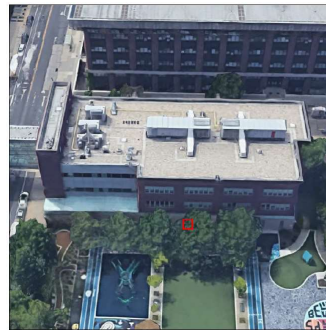
Elevation

BRICK: DETERIORATED MASONRY SILLS - MAJOR

REMOVE AND REPLACE

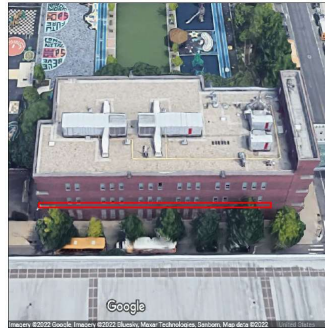
Elevation

BRICK: DETERIORATED JOINTS

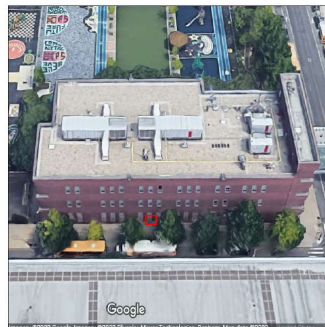
Elevation

BRICK: MINOR CRACKS AND SPALLING

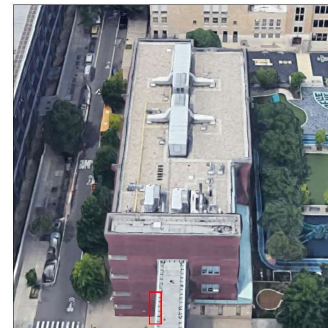
Elevation

METAL/GLASS CURT WALL: WATER INFILTRATION IN INSTRUCTIONAL SPACE

200
S.F.
REPAIR
PRIORITY 5
LEVEL 2

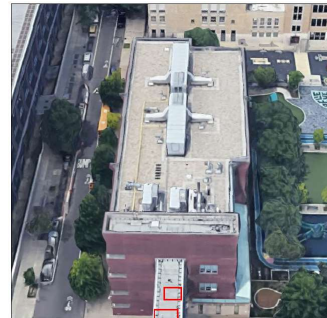
Elevation

Question	Response
EXTERIOR	
EXTERIOR WALLS	Inspected
Violations	3rd Floor Bridge (2nd Floor Bridge similar) No violations recorded.
EXTERIOR SOFFITS	Inspected
Condition	3 - Fair
Deficiency	METAL: DETERIORATION/DAMAGED/MISSING PIECES
Roof Plan reference	K705

Deficiency Quantity	40
Quantity Uom	S.F.
Potential Action	REPLACE
Urgency of Action	PRIORITY 4
Purpose of Action	LEVEL 2
Deficiency Photo1

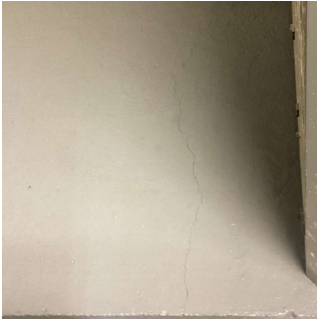
Question	Response
INTERIOR	
STRUCTURAL	
COLUMNS/BEAMS/BEARING WALLS	Inspected
Violations	No violations recorded.
FLOOR STRUCTURE	Inspected
Condition	3 - Fair
Deficiency	CONCRETE SLAB ON GRADE: THRU CRACKS
Deficiency Location/Instance	Basement
Deficiency Quantity	120
Quantity Uom	S.F.
Potential Action	REPAIR
Urgency of Action	PRIORITY 3
Purpose of Action	LEVEL 5
Deficiency Photo1

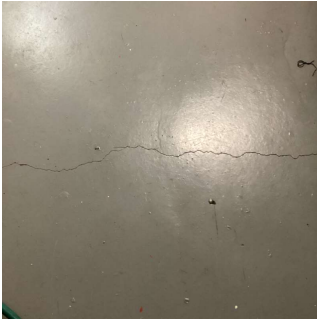
Electrical Panel Room (Room C08, Basement Corridor, Pump Room similar)
Violations	No violations recorded.
Deficiency	CONCRETE: CRACKS/SPALLED/REINFORCEMENT EXPOSED
Deficiency Location/Instance	BH/PH, 1st Floor
Deficiency Quantity	90
Quantity Uom	S.F.
Potential Action	REPAIR
Urgency of Action	PRIORITY 3
Purpose of Action	LEVEL 5
Deficiency Photo1

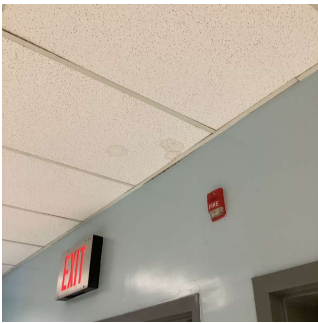
Question	Response
INTERIOR	
STRUCTURAL	Inspected
VAULTS-BUNKERS	Does not Exist
AUDITORIUM	Does not Exist
CAFETERIA	Does not Exist
CLASSROOMS/CORRIDORS/ADMIN SPACES	Inspected
Ceiling	Inspected
Condition	2 - Between Good and Fair
Deficiency	ACOUSTIC TILES: DAMAGED/MISSING
Deficiency Location/Instance	Corridor near rooms 300,317, 314,320,Room 313 and others
Deficiency Quantity	100
Quantity Uom	S.F.
Potential Action	REPLACE
Urgency of Action	PRIORITY 3
Purpose of Action	LEVEL 2
Deficiency Photo1

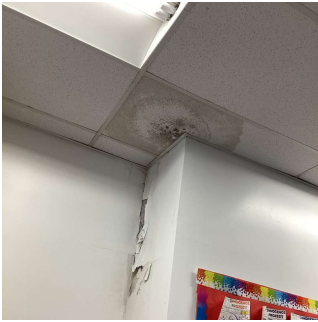
Corridor near room 300
Violations	No violations recorded.
Deficiency	ACOUSTIC TILES: DAMAGED/MISSING - ACTIVE LEAK
Deficiency Location/Instance	Rooms 320, 313 Corridor near room 313
Deficiency Quantity	30
Quantity Uom	S.F.
Potential Action	REPLACE
Urgency of Action	PRIORITY 5
Purpose of Action	LEVEL 2
Deficiency Photo1

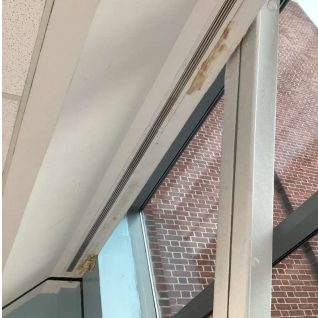
Room 320
Violations	No violations recorded.
Deficiency	GYPSUM BOARD: DAMAGED/DETERIORATED - ACTIVE LEAK

Deficiency Location/Instance	2nd Floor Bridge, 3rd Floor Bridge
Deficiency Quantity	40
Quantity Uom	S.F.
Potential Action	REPLACE

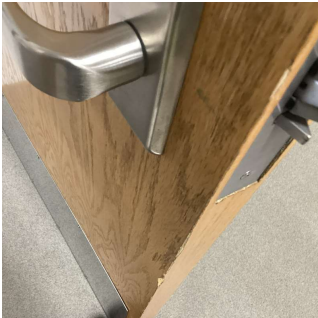
2nd Floor Bridge
Violations	No violations recorded.
Door(s)	Inspected
Condition	5 - Poor
Deficiency	WOOD: DETERIORATED DOOR
Deficiency Location/Instance	Rooms 217, 219, 314, 317,319 and others
Deficiency Quantity	12
Quantity Uom	EACH
Potential Action	MAINTENANCE
Urgency of Action	PRIORITY 3
Purpose of Action	LEVEL 2
Deficiency Photo1

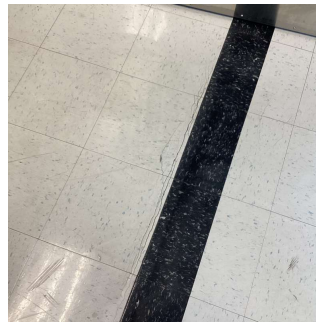
Corridor near room 200

Room 314
Violations	No violations recorded.
Floor Finish	Inspected
Condition	2 - Between Good and Fair
Deficiency	VINYL TILES: DETERIORATED SUBSTRATE
Deficiency Location/Instance	Corridor near room 200, 2nd and 3rd Annex Bridge
Deficiency Quantity	40
Quantity Uom	S.F.
Potential Action	REPLACE
Urgency of Action	PRIORITY 3
Purpose of Action	LEVEL 2

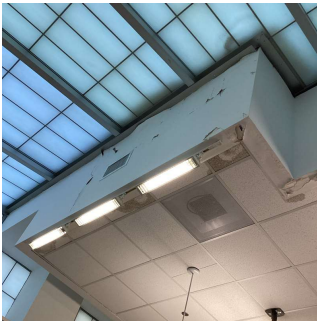
Question	Response
INTERIOR	
CLASSROOMS/CORRIDORS/ADMIN SPACES	Inspected
Walls	Inspected
Violations	Corridor near room 202 No violations recorded.
Specialties	Does not Exist
GYMNASIUM	Does not Exist
INTERIOR DOOR HARDWARE	Inspected
Condition	3 - Fair
Deficiency	No deficiencies recorded
INTERIOR GUARDS	Inspected
Condition	2 - Between Good and Fair
Deficiency	No deficiencies recorded
KITCHEN	Does not Exist
LIBRARY	Inspected
Instance on Room 100-1A	Inspected
Built-in Furnishing	
Instance on Room 100-1A	Does not Exist
Ceiling	
Instance on Room 100-1A	Inspected
Condition	4 - Between Fair and Poor
Deficiency	ACOUSTIC TILES: DAMAGED/MISSING
Deficiency Location/Instance	Center
Deficiency Quantity	20
Quantity Uom	S.F.
Potential Action	REPLACE
Urgency of Action	PRIORITY 3
Purpose of Action	LEVEL 2
Deficiency Photo1	 
Violations	Center No violations recorded.
Deficiency	GYPSUM BOARD: DAMAGED/DETERIORATED - ACTIVE LEAK
Deficiency Location/Instance	Room 100A

Deficiency Quantity	50
Quantity Uom	S.F.
Potential Action	REPLACE
Urgency of Action	PRIORITY 5
Purpose of Action	LEVEL 2

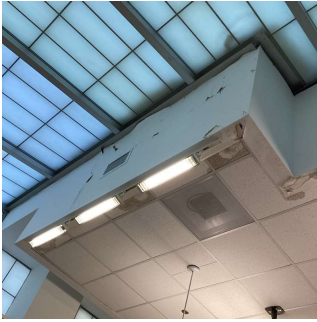
Violations	Room 100-1A No violations recorded.
Deficiency	ACOUSTIC TILES: DAMAGED/MISSING - ACTIVE LEAK
Deficiency Location/Instance	Room 100A
Deficiency Quantity	20
Quantity Uom	S.F.
Potential Action	REPLACE
Urgency of Action	PRIORITY 5
Purpose of Action	LEVEL 2
Deficiency Photo1

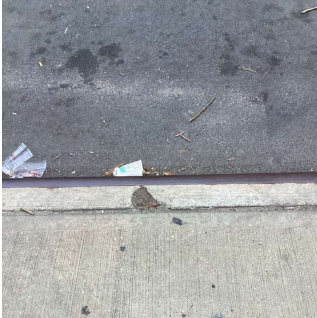
Question	Response
SITE	
PAVING	
DOT Sidewalk	
Concrete	
Deficiency	DAMAGED CURBS
Deficiency Location/Instance	Campus Road, Bedford Avenue
Deficiency Quantity	40
Quantity Uom	L.F.
Potential Action	REPLACE
Urgency of Action	PRIORITY 3
Purpose of Action	LEVEL 2
Deficiency Photo1

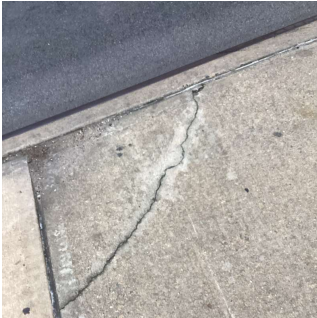
Violations	Campus Road No violations recorded.
Deficiency	DAMAGED/DETERIORATED/MISSING SECTIONS
Deficiency Location/Instance	Campus Road, Bedford Avenue
Deficiency Quantity	200
Quantity Uom	S.F.
Potential Action	REPLACE
Urgency of Action	PRIORITY 3
Purpose of Action	LEVEL 2
Deficiency Photo1
