NYC Department of Education
Building Condition Assessment Survey 2023 - 2024

Architectural Inspection

Asset: P.S. 721 OTC - BROOKLYN, 64 AVENUE X, New York, 11223

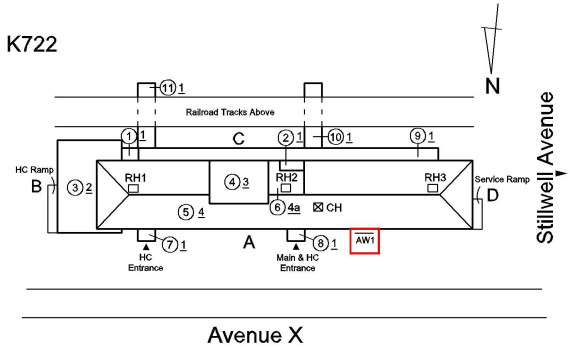
Question	Response
Architectural	
EXTERIOR	Inspected
AREAWAY	Inspected
Instance on AW1	Inspected
Instance Condition	3 - Fair
Instance Quantity	1
Instance Quantity Uom	EACH
Deficiency	AREAWAY LADDER: DETERIORATED

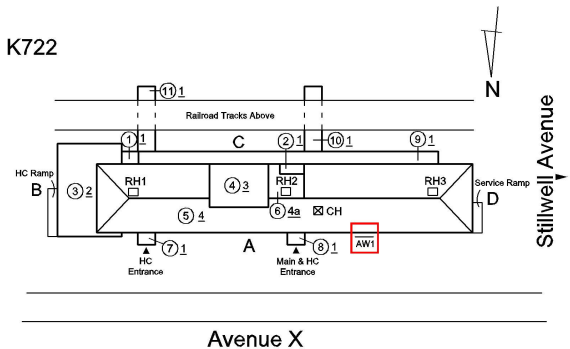
AREAWAY WALLS: CRACKS AND SPALLING

REPAIR

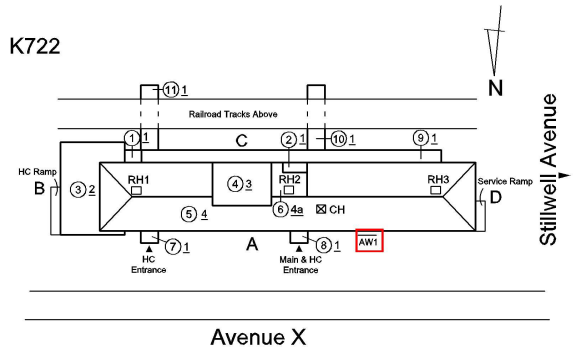
AREAWAY SLAB: CRACKS AND SPALLING

REPAIR

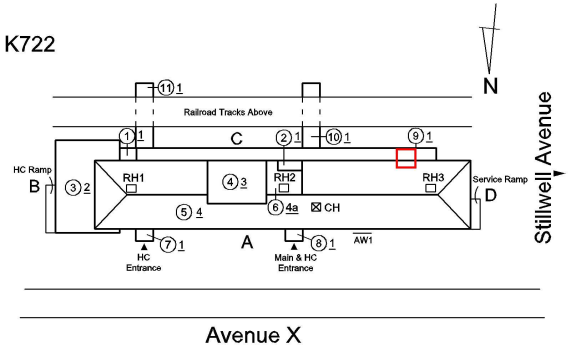
METAL: DETERIORATED DOOR AND FRAME - MAJOR DETERIORATION

REPLACE

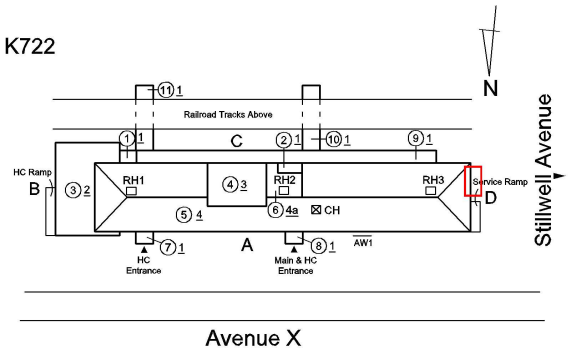
ROLL-UP DOOR: DETERIORATED DOOR - MINOR DETERIORATION

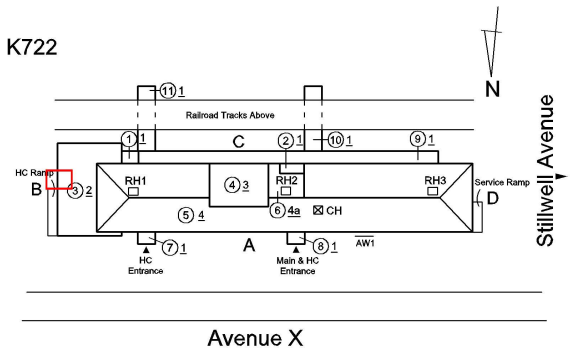
METAL: AIR/WATER INFILTRATION, DETERIORATED JOINTS WITH DAMAGED CAULKING

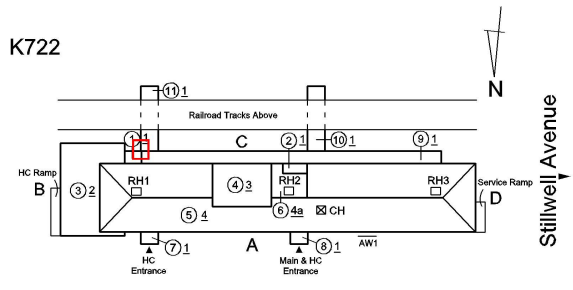
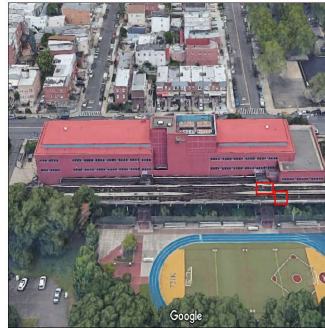
BRICK: CRACKS/DISPLACED/SPALLED BRICK AT BUILDING CORNERS

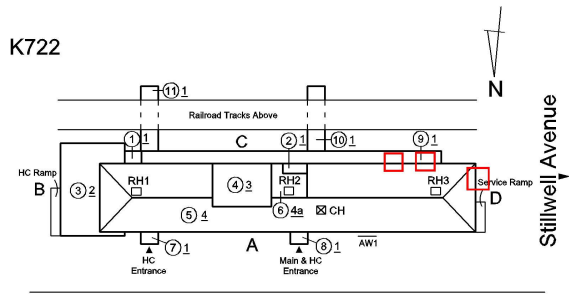
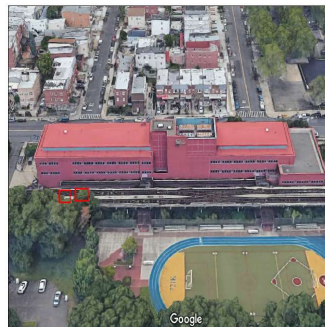
BRICK: MAJOR / THRU CRACKS

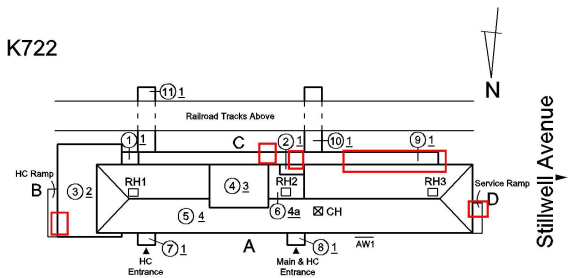
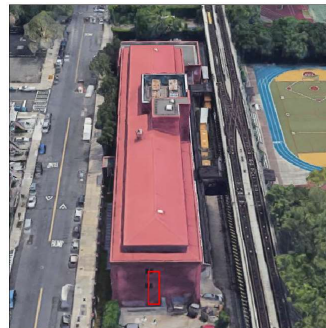
BRICK: DETERIORATED CONTROL/EXPANSION JOINTS

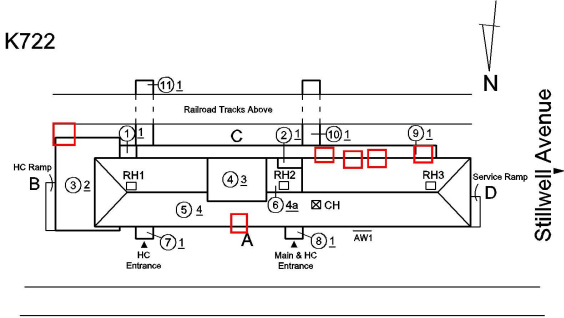
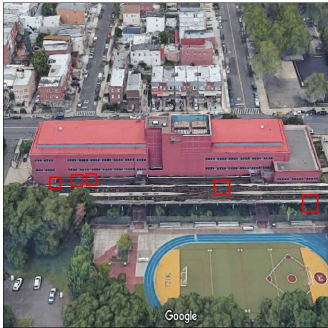
Question	Response
EXTERIOR	
EXTERIOR WALLS	
Violations	No violations recorded.
Deficiency	BRICK: MINOR CRACKS AND SPALLING
Roof Plan reference	<p>K722</p>

Deficiency Quantity	60
Quantity Uom	S.F.
Potential Action	RESTITCH
Urgency of Action	PRIORITY 3
Purpose of Action	LEVEL 2
Deficiency Photo1

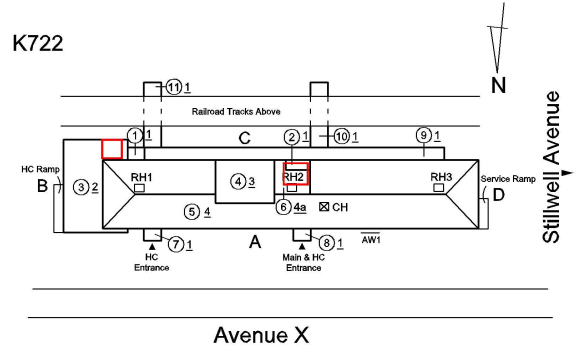
Does this roof instance have a Sustainable Roof System?	No
Do solar panels exist on these roofs?	No
Is/Are the roof(s) suitable for Solar Panel installation?	No
Installation Year	1997
Source of Installation	Custodial Staff
Deficiency	IRMA: ROOFING: DAMAGED INSULATION

20
S.F.
REPLACE
PRIORITY 4
LEVEL 2

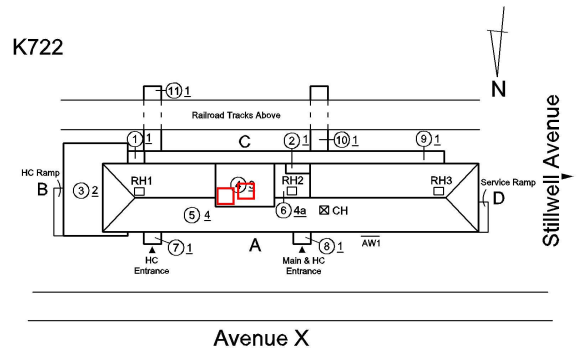
IRMA: ROOFING: DETERIORATED PAVERS WITH INTEGRAL INSULATION

20
S.F.
REPLACE
PRIORITY 4
LEVEL 2

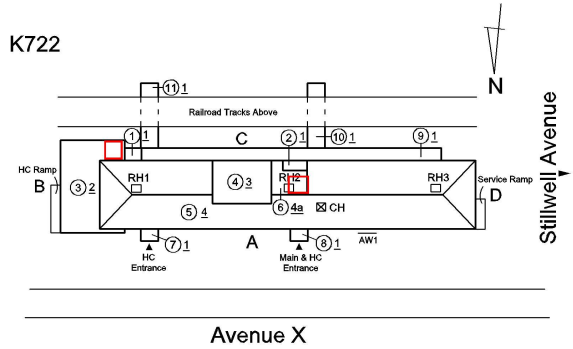
DETERIORATED

REPLACE

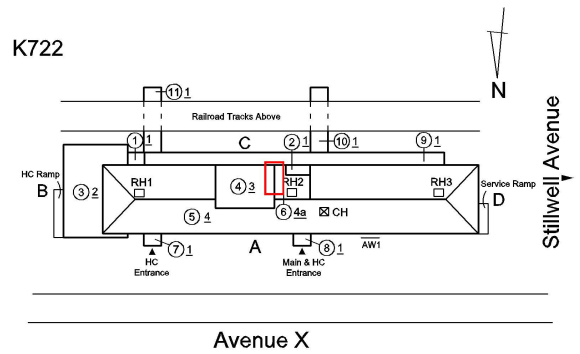
Deficiency	BULKHEAD/PENTHOUSE WALLS/EXTERIOR: DETERIORATED JOINTS
------------	--

20
 S.F.
 REPOINT
 PRIORITY 3
 LEVEL 2

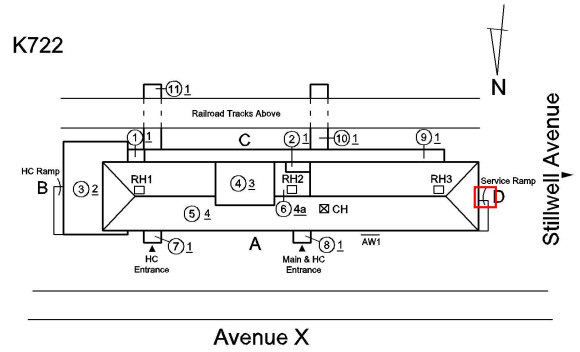
MISSING RAILING

10
 L.F.
 REPLACE
 PRIORITY 5
 LEVEL 6

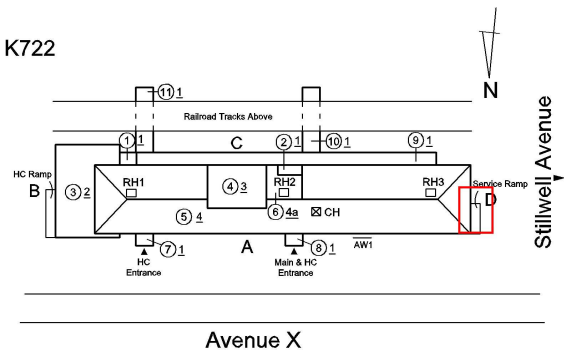
DAMAGED

REPLACE

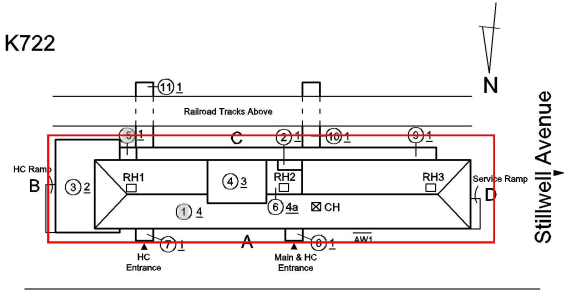
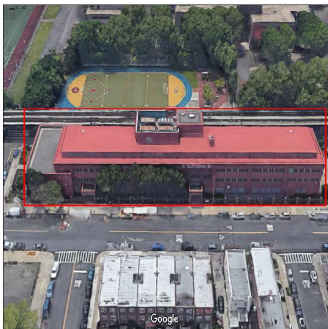
Question	Response
EXTERIOR	
WINDOWS	
LINTELS	Inspected
Condition	2 - Between Good and Fair
Deficiency	No deficiencies recorded
WINDOWS	Inspected
Material Type(s)	Aluminum
Instance on Aluminum - Double Hung: All Facades	Inspected
Instance Condition	3 - Fair
Instance Quantity	10,000
Instance Quantity Uom	S.F.
Are these windows insulated	Yes
Installation Year	1997
Source of Installation	Custodial Staff
Deficiency	ALUMINUM - DOUBLE HUNG: INOPERABLE BALANCE
Roof Plan reference	<p>K722</p>

Deficiency Quantity	40
Quantity Uom	EACH
Potential Action	REPLACE BALANCES
Urgency of Action	PRIORITY 3
Purpose of Action	LEVEL 2
Deficiency Photo	No photo recorded
Violations	No violations recorded.
INTERIOR	Inspected
POOLS	Does not Exist
STRUCTURAL	Inspected
COLUMNS/BEAMS/BEARING WALLS	Inspected
Condition	3 - Fair
Deficiency	STEEL COLUMNS/BEAMS: DETERIORATED/MISSING SPRAY-ON FIREPROOFING
Deficiency Location/Instance	Basement - Rooms 1C9, 1C21, Stair D/Basement

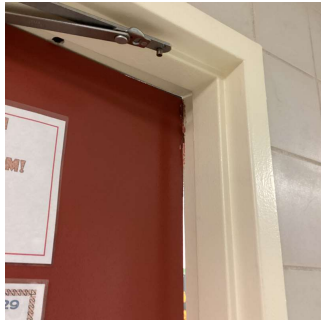
Question	Response
INTERIOR	
CLASSROOMS/CORRIDORS/ADMIN SPACES	
Door(s)	Inspected
Condition	3 - Fair
Deficiency	METAL: DETERIORATED DOOR AND FRAME
Deficiency Location/Instance	Room 329, Exit 3
Deficiency Quantity	2
Quantity Uom	EACH
Potential Action	MAINTENANCE
Urgency of Action	PRIORITY 3
Purpose of Action	LEVEL 2
Deficiency Photo1

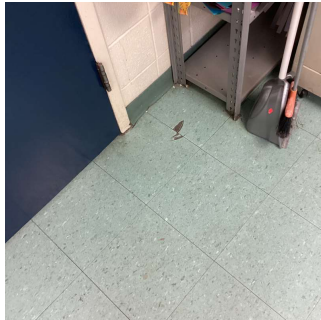
Violations	Room 329 No violations recorded.
Floor Finish	Inspected
Condition	2 - Between Good and Fair
Deficiency	VINYL TILES: BROKEN/DETERIORATED/MISSING TILES
Deficiency Location/Instance	Room 301
Deficiency Quantity	10
Quantity Uom	S.F.
Potential Action	REPLACE
Urgency of Action	PRIORITY 3
Purpose of Action	LEVEL 2
Deficiency Photo1

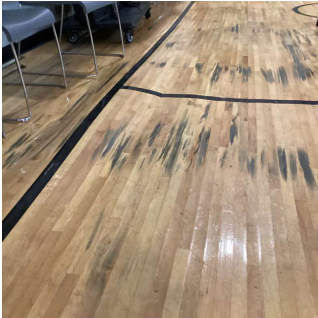
Question	Response
INTERIOR	
GYMNASIUM	
Fixed Equipment	
Deficiency	No deficiencies recorded
Floor Finish	
Instance on 1st Floor	Inspected
Condition	5 - Poor
Deficiency	WOOD: DAMAGED/DETERIORATED
Deficiency Location/Instance	Entire Floor
Deficiency Quantity	5,000
Quantity Uom	S.F.
Potential Action	REPLACE
Urgency of Action	PRIORITY 3
Purpose of Action	LEVEL 2
Deficiency Photo1

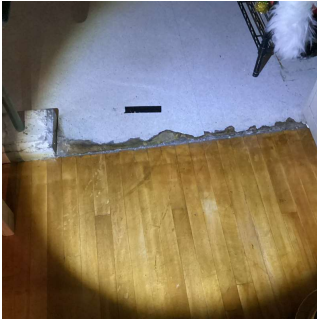
Violations	Right Side Ramp No violations recorded.
Stage Curtain Rigging	Inspected
Instance on 1st Floor	Inspected
Condition	2 - Between Good and Fair

Question	Response
INTERIOR	
MULTI-PURPOSE ROOM	
Door(s)	
Instance on 1st Floor	Inspected
Condition	2 - Between Good and Fair
Deficiency	No deficiencies recorded
Fixed Equipment	
Instance on 1st Floor	Does not Exist
Floor Finish	
Instance on 1st Floor	Inspected
Condition	2 - Between Good and Fair
Deficiency	No deficiencies recorded
Sliding-folding Partition	
Instance on 1st Floor	Inspected
Condition	2 - Between Good and Fair
Deficiency	No deficiencies recorded
Stage	
Instance on 1st Floor	Inspected
Stage	Inspected
Instance on 1st Floor	Inspected
Condition	2 - Between Good and Fair
Deficiency	DAMAGED FLOOR
Deficiency Location/Instance	Right Side Ramp
Deficiency Quantity	15
Quantity Uom	S.F.
Potential Action	REPLACE
Urgency of Action	PRIORITY 3
Purpose of Action	LEVEL 2
Deficiency Photo1

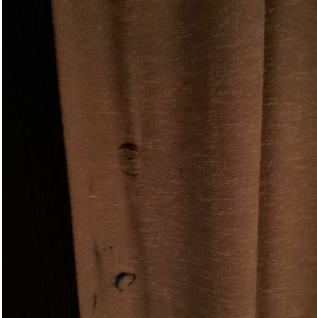
Deficiency	No deficiencies recorded
Stage Curtains	Inspected
Instance on 1st Floor	Inspected
Condition	3 - Fair
Deficiency	WORN/DETERIORATED
Deficiency Location/Instance	Rear
Deficiency Quantity	100
Quantity Uom	S.F.

Question	Response
INTERIOR	
MULTI-PURPOSE ROOM	
Stage	
Stage Curtains	
Potential Action	REPLACE
Urgency of Action	PRIORITY 3
Purpose of Action	LEVEL 2
Deficiency Photo1

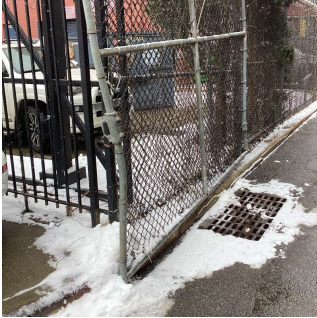
Question	Response
SITE	
Drainage System for Soil	Inspected
Catch Basins/Manhole - Surrounded by Soil	Inspected
Condition	2 - Between Good and Fair
Deficiency	No deficiencies recorded
Culverts - Soil Covering	Does not Exist
DRINKING FOUNTAINS	Does not Exist
FENCES	Inspected
Condition	3 - Fair
Deficiency	CHAIN LINK: DAMAGED POST/RAIL
Deficiency Location/Instance	Near Containerization
Deficiency Quantity	10
Quantity Uom	L.F.
Potential Action	REPLACE
Urgency of Action	PRIORITY 3
Purpose of Action	LEVEL 2
Deficiency Photo1

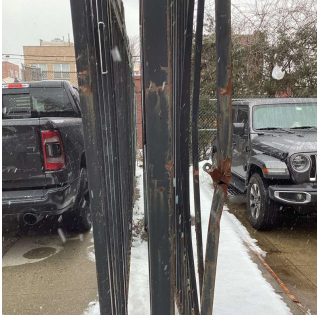
Violations	Near Containerization No violations recorded.
IRRIGATION SYSTEM	Does not Exist
PAVING	Inspected

Violations	Near Containerization No violations recorded.
Deficiency	WROUGHT IRON: DAMAGED/DETERIORATED
Deficiency Location/Instance	Near Containerization
Deficiency Quantity	80
Quantity Uom	S.F.
Potential Action	REPLACE
Urgency of Action	PRIORITY 3
Purpose of Action	LEVEL 2
Deficiency Photo1

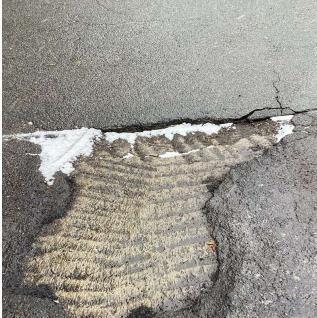
Violations	Service Road No violations recorded.
Deficiency	CRACKS - MAJOR
Deficiency Location/Instance	Rear Service Road, Both Service Entrances from Avenue X
Deficiency Quantity	3,500
Quantity Uom	S.F.
Potential Action	REPLACE
Urgency of Action	PRIORITY 3
Purpose of Action	LEVEL 2
Deficiency Photo1

Question	Response
SITE	
PAVING	
Student Non-Use	
Asphalt	
Condition	5 - Poor
Deficiency	POTHOLES
Deficiency Location/Instance	Rear Service Road, Both Service Entrances from Avenue X
Deficiency Quantity	1,500
Quantity Uom	S.F.
Potential Action	REPAIR
Urgency of Action	PRIORITY 3
Purpose of Action	LEVEL 2
Deficiency Photo1

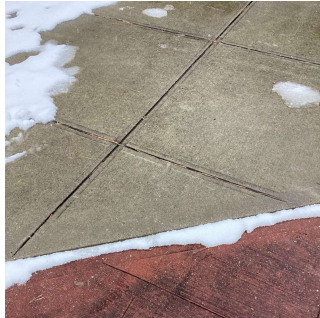
Violations	Schoolyard No violations recorded.
Deficiency	CRACKS - MAJOR
Deficiency Location/Instance	Schoolyard
Deficiency Quantity	50
Quantity Uom	S.F.
Potential Action	REPLACE
Urgency of Action	PRIORITY 3
Purpose of Action	LEVEL 2

Violations	Near Schoolyard Entrance No violations recorded.
Pavers	Does not Exist
Student Use	Inspected
Gravel Exists?	No
Asphalt	Does not Exist
Concrete	Inspected
Condition	3 - Fair
Deficiency	HEAVING
Deficiency Location/Instance	Schoolyard
Deficiency Quantity	50
Quantity Uom	S.F.
Potential Action	REPLACE
Urgency of Action	PRIORITY 3
Purpose of Action	LEVEL 2
Deficiency Photo1
