NYC Department of Education
Building Condition Assessment Survey 2023 - 2024

Architectural Inspection

Asset: LIBERATION DIPLOMA PLUS H.S. - K, 2865 WEST 19TH STREET, New York, 11224

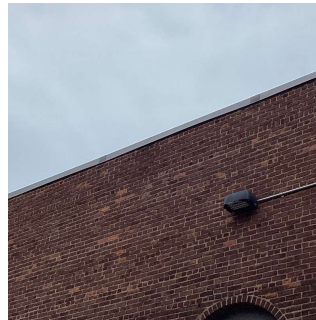
Roof 2 - Facade D
 No violations recorded.

BRICK: DETERIORATED JOINTS

PARAPETS

K728
 100
 S.F.
 REPOINT
 PRIORITY 4
 LEVEL 2
