NYC Department of Education
Building Condition Assessment Survey 2023 - 2024

Architectural Inspection

Asset: P.S. 207 ANNEX - BROOKLYN, 3874 FLATLANDS AVENUE, New York, 11234

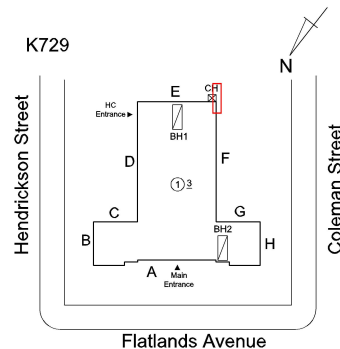
Question	Response
Architectural	
EXTERIOR	Inspected
AREAWAY	Does not Exist
AWNINGS AND CANOPIES	Does not Exist
CHIMNEY	Inspected
Material Type(s)	Masonry
Condition	2 - Between Good and Fair
Deficiency	BRICK: DETERIORATED JOINTS
Roof Plan reference

Deficiency Quantity	20
Quantity Uom	S.F.
Potential Action	REPOINT

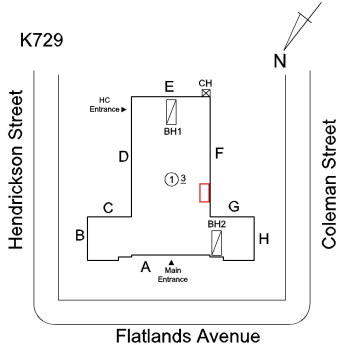
Violations	CH No violations recorded.
COPING	
Condition	Inspected 3 - Fair
Deficiency	CAST STONE: DISINTEGRATING / FREEZE THAW
Roof Plan reference

Deficiency Quantity	10
Quantity Uom	L.F.
Potential Action	REPLACE-IN-KIND
Urgency of Action	PRIORITY 4
Purpose of Action	LEVEL 2
Deficiency Photo1

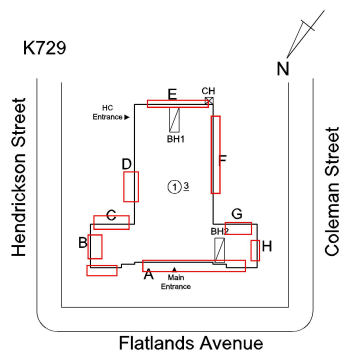
Violations	Roof 1 No violations recorded.
Deficiency	CAST STONE: DETERIORATED TRANSVERSE JOINTS

Deficiency Quantity	40
Quantity Uom	L.F.
Potential Action	MAINTENANCE
Urgency of Action	PRIORITY 3
Purpose of Action	LEVEL 2
Deficiency Photo1

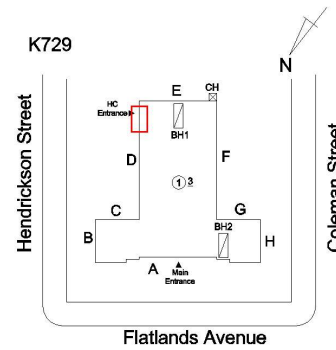
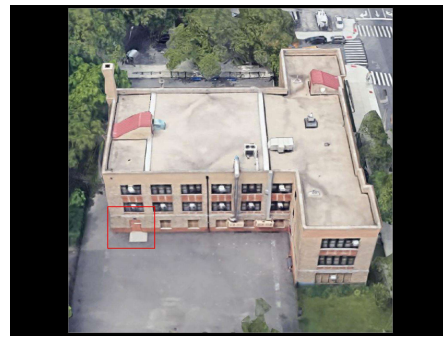
BRICK: WATER INFILTRATION IN INSTRUCTIONAL SPACE

REPAIR

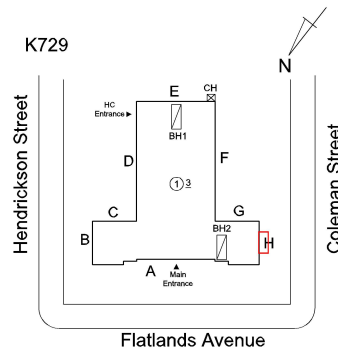
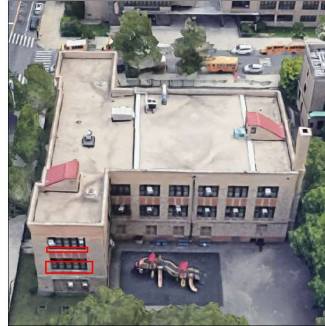
BRICK: MASONRY SILLS - DETERIORATED JOINTS

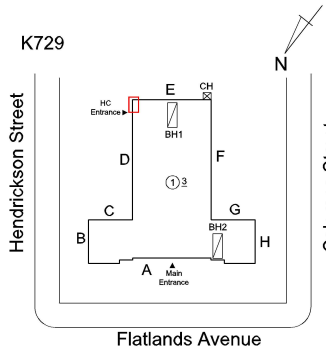
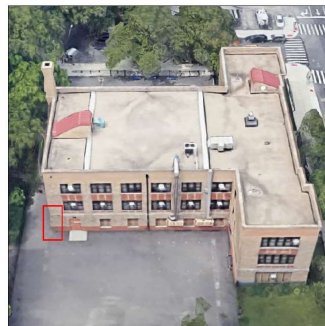
BRICK: CRACKS/DISPLACED/SPALLED BRICK AT BUILDING CORNERS

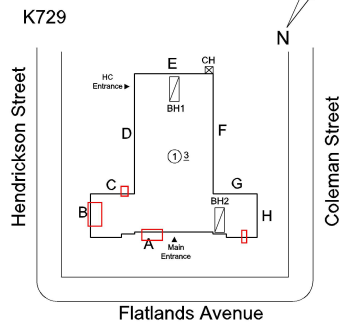
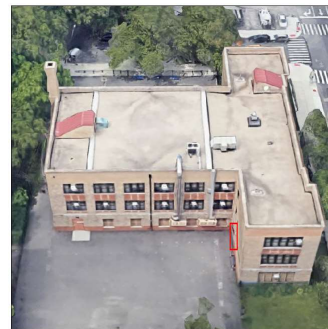
BRICK: MINOR CRACKS AND SPALLING

30
 S.F.
 RESTITCH
 PRIORITY 3
 LEVEL 2

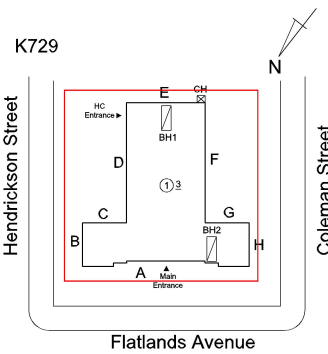
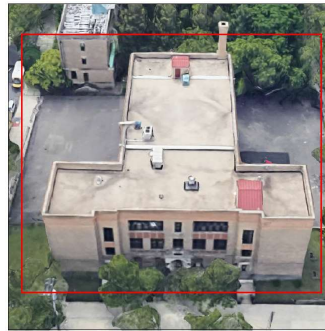
BRICK: DETERIORATED JOINTS

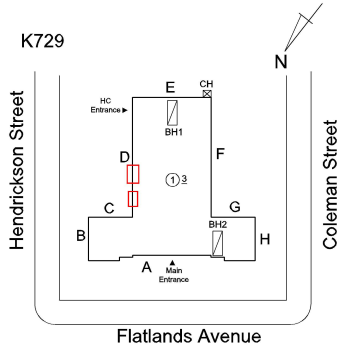
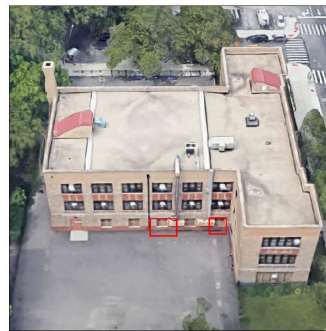
BRICK: DETERIORATED MASONRY SILLS - MINOR

REPAIR

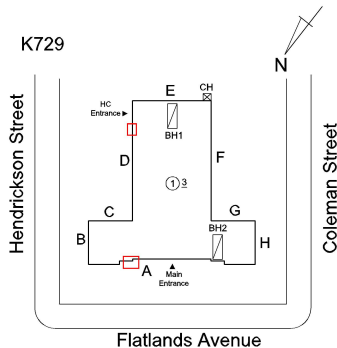
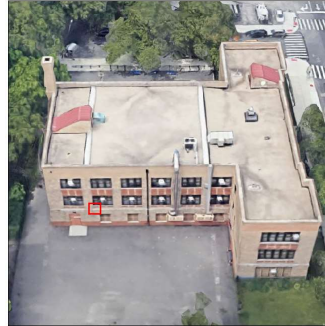
STONE: DETERIORATED JOINTS

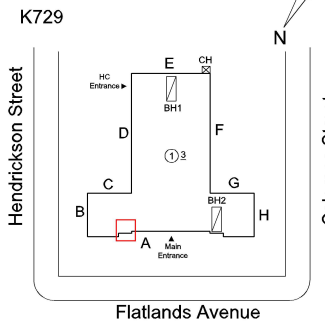
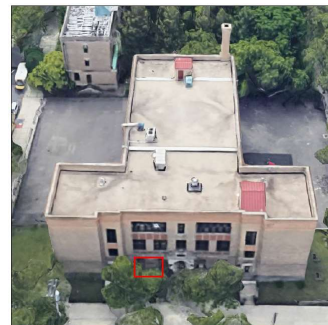
BRICK: MAJOR / THRU CRACKS

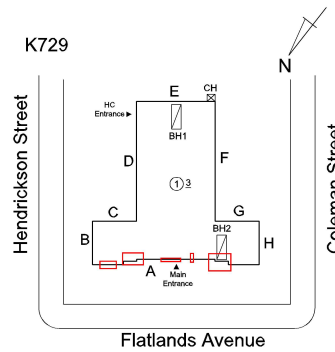
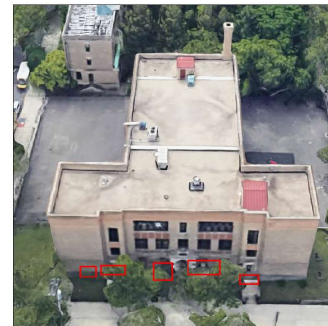
STONE: CHIPPED/SPALLED/BROKEN PIECES - MAJOR

REPLACE

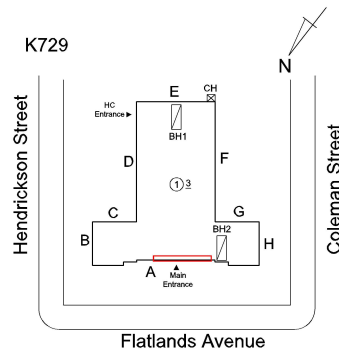
Instance on All Facades	Inspected
Instance Condition	5 - Poor
Instance Quantity	4,600
Instance Quantity Uom	C.F.
Deficiency	BRICK: EFFLORESCENCE
Roof Plan reference

Deficiency Quantity	60
Quantity Uom	S.F.
Potential Action	MAINTENANCE
Urgency of Action	PRIORITY 1
Purpose of Action	LEVEL 1
Deficiency Photo1	No photo recorded
Violations	No violations recorded.

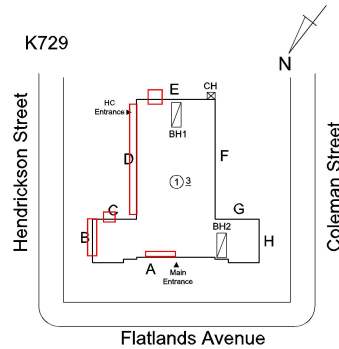
Deficiency	BRICK: DETERIORATED JOINTS
Roof Plan reference

Deficiency Quantity	220
Quantity Uom	S.F.
Potential Action	REPOINT
Urgency of Action	PRIORITY 4
Purpose of Action	LEVEL 2

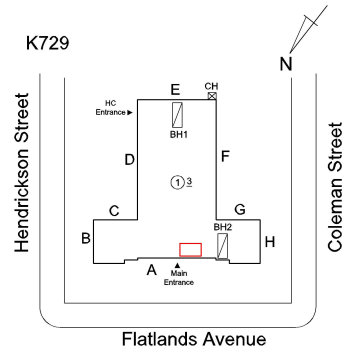
Installation Year	2009
Source of Installation	Custodial Staff
Deficiency	BUILT-UP: ROOFING: MAJOR ACTIVE ROOF LEAKS IN INSTRUCTIONAL SPACE

100
S.F.
REPLACE ROOFING WITHOUT MAJOR EQUIPMENT
REMOVAL
PRIORITY 5
LEVEL 2

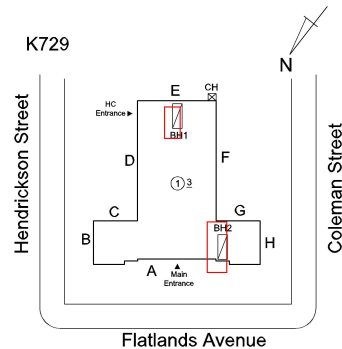
BULKHEAD/PENTHOUSE WALLS/EXTERIOR:
CRACKS/SPALLING - MINOR

Question	Response
EXTERIOR	
ROOF	
Specialties	
BULKHEAD/PENTHOUSE	
Potential Action	REPAIR
Urgency of Action	PRIORITY 3
Purpose of Action	LEVEL 2
Deficiency Photo1

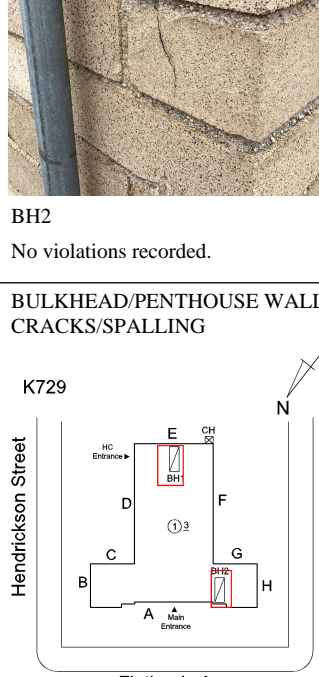
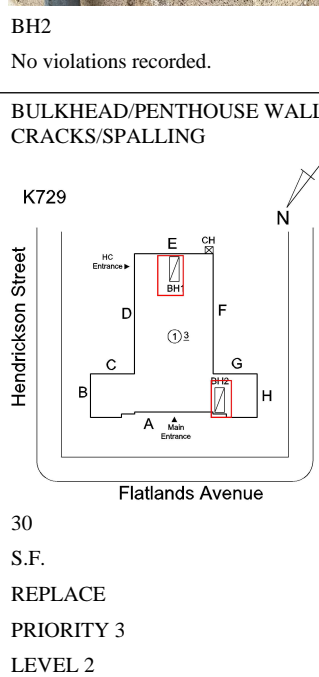
Violations	BH2
Deficiency	No violations recorded.
Roof Plan reference	BULKHEAD/PENTHOUSE WALLS/INTERIOR: BRICK CRACKS/SPALLING
Deficiency Quantity

Quantity Uom	30
Potential Action	S.F.
Urgency of Action	REPLACE
Purpose of Action	PRIORITY 3
Deficiency Photo1	LEVEL 2
Violations

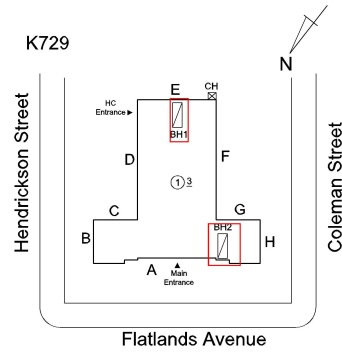
Violations	BH2
Deficiency	No violations recorded.
Deficiency	BULKHEAD/PENTHOUSE CEILING: PLASTER DAMAGED/DETERIORATED

90
S.F.
REPLACE
PRIORITY 3
LEVEL 2

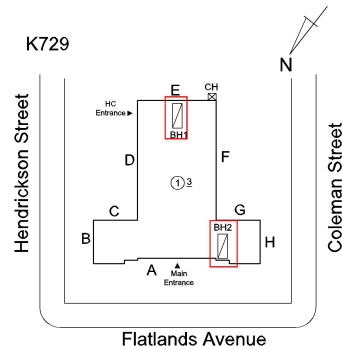
**BULKHEAD/PENTHOUSE WALLS/INTERIOR: BRICK
DETERIORATED JOINTS**

60
S.F.
REPOINT
PRIORITY 3
LEVEL 2

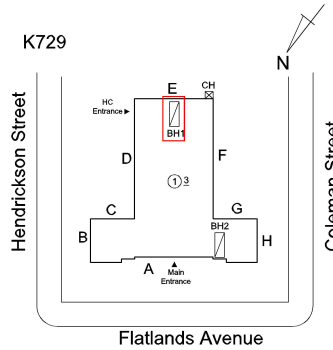
BULKHEAD/PENTHOUSE WALLS/EXTERIOR: DETERIORATED JOINTS

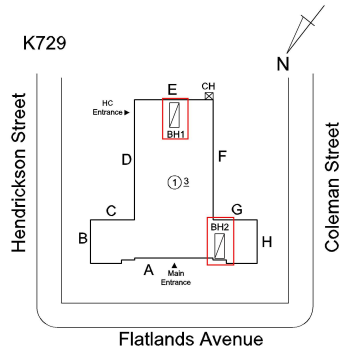
BULKHEAD/PENTHOUSE ROOF: MAJOR LEAKAGE

200
S.F.
REPLACE
PRIORITY 5
LEVEL 2

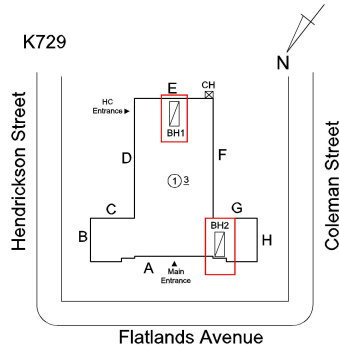
BULKHEAD/PENTHOUSE WALLS/EXTERIOR: WATER INFILTRATION

200
S.F.
REPAIR
PRIORITY 5
LEVEL 2

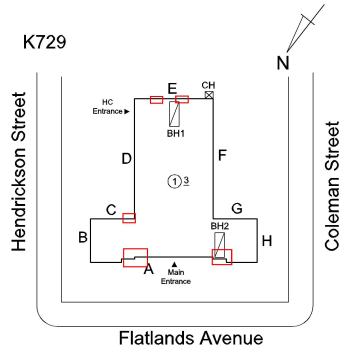
STONE: CRACKS/SPALLING - MAJOR

REPLACE

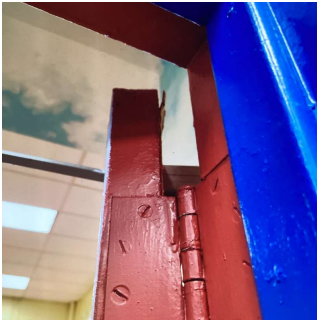
Main Entrance
Violations	No violations recorded.
Fixed Equipment	
Instance on 1st Floor	Does not Exist
Floor Finish	
Instance on 1st Floor	Inspected
Condition	2 - Between Good and Fair

Question	Response
INTERIOR	
STRUCTURAL	
FOUNDATION WALLS	Inspected
Deficiency Photo1	 
	Basement - Boiler Room
Violations	No violations recorded.
ROOF STRUCTURE	Inspected
Condition	2 - Between Good and Fair
Deficiency	No deficiencies recorded
VAULTS-BUNKERS	Does not Exist
AUDITORIUM	Does not Exist
CAFETERIA	Inspected
Instance on 1st Floor	Inspected
Ceiling	
Instance on 1st Floor	Does not Exist
Door(s)	
Instance on 1st Floor	Inspected
Condition	3 - Fair
Deficiency	METAL: DETERIORATED DOOR
Deficiency Location/Instance	Main Entrance
Deficiency Quantity	1
Quantity Uom	EACH
Potential Action	MAINTENANCE
Urgency of Action	PRIORITY 3
Purpose of Action	LEVEL 2
Deficiency Photo1

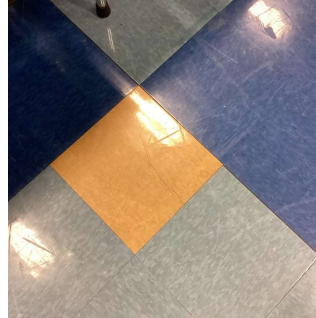
Near Servery

Deficiency	VINYL TILES: BROKEN/DETERIORATED/MISSING TILES
Deficiency Location/Instance	Near Servery, by Ramp
Deficiency Quantity	20
Quantity Uom	S.F.
Potential Action	REPLACE
Urgency of Action	PRIORITY 3
Purpose of Action	LEVEL 2
Deficiency Photo1

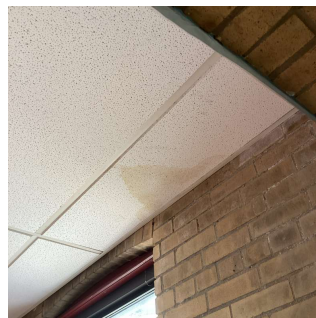
Condition	2 - Between Good and Fair
Deficiency	ACOUSTIC TILES: DAMAGED/MISSING
Deficiency Location/Instance	Corridor near Rooms 318, 309, 129, 121, by Stair B/1 and others
Deficiency Quantity	100
Quantity Uom	S.F.
Potential Action	REPLACE
Urgency of Action	PRIORITY 3
Purpose of Action	LEVEL 2
Deficiency Photo1

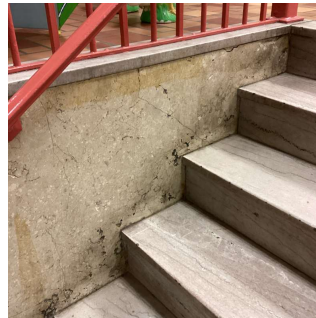
Deficiency	STONE: CRACKS/SPALLING
Deficiency Location/Instance	Main Entrance
Deficiency Quantity	10
Quantity Uom	S.F.
Potential Action	REPLACE
Urgency of Action	PRIORITY 3
Purpose of Action	LEVEL 2
Deficiency Photo1

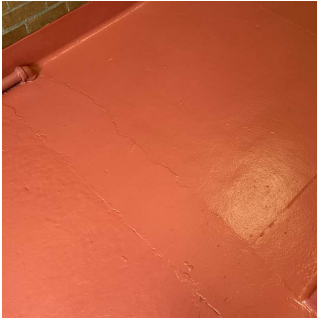
Question	Response
INTERIOR	
STAIRS/RAMPS: INTERIOR	
Railings	Inspected
Condition	2 - Between Good and Fair
Deficiency	No deficiencies recorded
Stairs and Landings	Inspected
Condition	2 - Between Good and Fair
Deficiency	CONCRETE: CRACKS/SPALLING - MAJOR
Deficiency Location/Instance	Stairs A/1, A/Exist - Vestibule
Deficiency Quantity	20
Quantity Uom	S.F.
Potential Action	REPLACE
Urgency of Action	PRIORITY 3
Purpose of Action	LEVEL 2
Deficiency Photo1

Stair A/Exit - Vestibule
Violations	No violations recorded.
Deficiency	STONE: BROKEN/MISSING
Deficiency Location/Instance	Corridor Near Cafeteria, Main Entrance
Deficiency Quantity	40
Quantity Uom	S.F.
Potential Action	REPLACE
Urgency of Action	PRIORITY 3
Purpose of Action	LEVEL 2
Deficiency Photo1
