**NYC Department of Education**  
**Building Condition Assessment Survey 2023 - 2024**

Architectural Inspection

**K743**

**Asset: ADULT LRNG CTR (OLD GRLS HS) - K, 475 NOSTRAND AVENUE, New York, 11216**

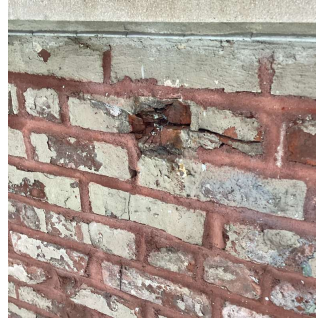
Question	Response
<b>Architectural</b>	
<b>EXTERIOR</b>	Inspected
<b>AREAWAY</b>	Inspected
Instance on AW1 - AW2	Inspected
Instance Condition	3 - Fair
Instance Quantity	2
Instance Quantity Uom	EACH
Deficiency	AREAWAY WALLS: CRACKS AND SPALLING
Roof Plan reference	K743
Deficiency Quantity	10
Quantity Uom	S.F.
Potential Action	REPLACE
Urgency of Action	PRIORITY 4
Purpose of Action	LEVEL 2

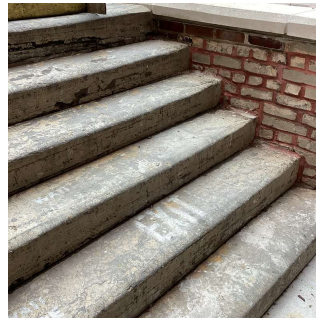
AW1

**AREAWAY STAIRS: DETERIORATED TREADS/RISERS/NOSINGS**

20

REPAIR

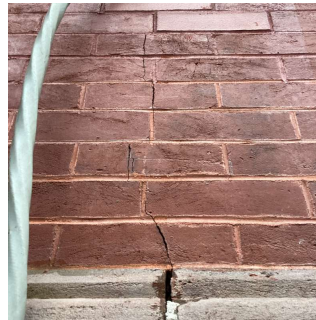
Facade F

BRICK: MAJOR / THRU CRACKS

20

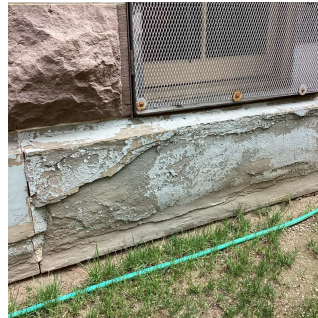
Facade A

STONE: CHIPPED/SPALLED/BROKEN PIECES - MAJOR

60

REPLACE

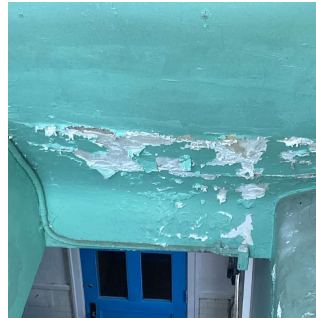
BH

Roof 8
Instance Quantity	300
Instance Quantity Uom	S.F.
Does the roof have major mechanical equipment sitting on Dunnage Steel less than 18" above the Roofing?	No
Does this roof instance have a Sustainable Roof System?	Yes
Sustainable Roof Type	White Roof
Sustainable Roof Location (Roof Number)	Roofs 7-11
Do solar panels exist on these roofs?	No
Is/Are the roof(s) suitable for Solar Panel installation?	No
Installation Year	2022
Source of Installation	Custodial Staff
Deficiency	No deficiencies recorded
<b>ROOFING DRAINS</b>	
	Inspected
Condition	2 - Between Good and Fair
Deficiency	No deficiencies recorded
<b>Specialties</b>	
	Inspected
<b>BULKHEAD/PENTHOUSE</b>	
	Inspected
Condition	3 - Fair
Deficiency	BULKHEAD/PENTHOUSE CEILING: PLASTER DAMAGED/DETERIORATED
Roof Plan reference

Deficiency Quantity	20
Quantity Uom	S.F.

Potential Action	REPLACE
Urgency of Action	PRIORITY 4
Purpose of Action	LEVEL 2

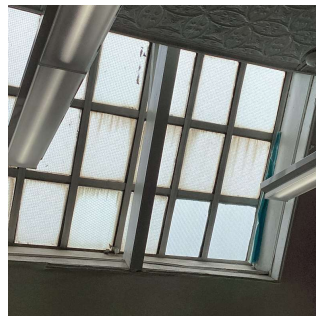
**WATER INFILTRATION**

100

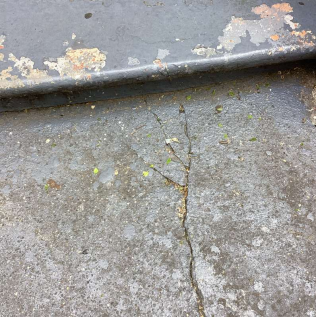
Question	Response
<b>EXTERIOR</b>	
<b>ROOF</b>	Inspected
<b>Specialties</b>	
<b>SKYLIGHT/ROOF VENT</b>	Inspected Roof 5 - SK2 - Room 424
Violations	No violations recorded.
<b>ROOF/GRAVITY TANK</b>	Does not Exist
<b>STAIRS/RAMPS: EXTERIOR</b>	Inspected
<b>BUILDING CHEEK/FLANK WALLS</b>	Inspected
Condition	2 - Between Good and Fair
Deficiency	No deficiencies recorded
<b>RAILINGS</b>	Inspected
Condition	2 - Between Good and Fair
Deficiency	No deficiencies recorded
<b>STAIRS/RAMPS</b>	Inspected
Condition	4 - Between Fair and Poor
Deficiency	<b>STONE: CRACKS/SPALLING - MAJOR</b>
Roof Plan reference

Deficiency Quantity	10
Quantity Uom	S.F.
Potential Action	REPLACE
Urgency of Action	PRIORITY 4
Purpose of Action	LEVEL 2
Deficiency Photo1

Violations	Facade A No violations recorded.
Deficiency	<b>CONCRETE: CRACKS/SPALLING - MAJOR</b>

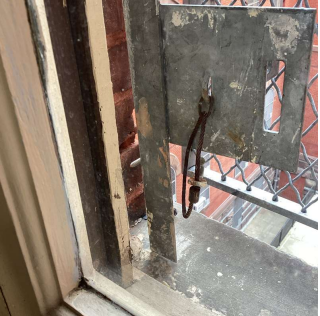
Deficiency Quantity	30
Quantity Uom	S.F.
Potential Action	REPLACE
Urgency of Action	PRIORITY 4
Purpose of Action	LEVEL 2
Deficiency Photo1

Violations	Facade G - Corridor near Room 304 No violations recorded.
<b>LINTELS</b>	Inspected
Condition	2 - Between Good and Fair
Deficiency	No deficiencies recorded
<b>WINDOWS</b>	Inspected
Material Type(s)	Aluminum, Solid Wood
Instance on Wood: All Facades	Inspected
Instance Condition	3 - Fair
Instance Quantity	7,400
Instance Quantity Uom	S.F.
Are these windows insulated	No
Installation Year	1993
Source of Installation	Custodial Staff
Deficiency	WOOD: BROKEN PANE

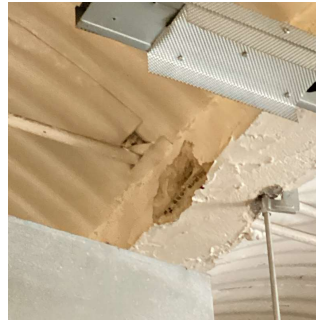
Room B5

STEEL COLUMNS/BEAMS: DETERIORATED MASONRY FIREPROOFING

REPLACE

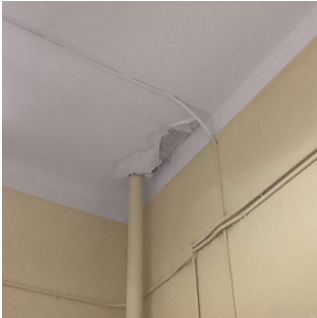
Deficiency	PLASTER: CRACKS/SPALLING
Deficiency Location/Instance	Room 329

Question	Response
<b>INTERIOR</b>	
<b>CLASSROOMS/CORRIDORS/ADMIN SPACES</b>	
<b>Ceiling</b>	
Deficiency Quantity	10
Quantity Uom	S.F.
Potential Action	REPLACE
Urgency of Action	PRIORITY 3
Purpose of Action	LEVEL 2
Deficiency Photo1

Room 329
Violations	No violations recorded.
Deficiency	METAL PAN: DAMAGED/MISSING
Deficiency Location/Instance	Main Entrance Vestibule
Deficiency Quantity	10
Quantity Uom	S.F.
Potential Action	REPLACE
Urgency of Action	PRIORITY 3
Purpose of Action	LEVEL 2
Deficiency Photo1

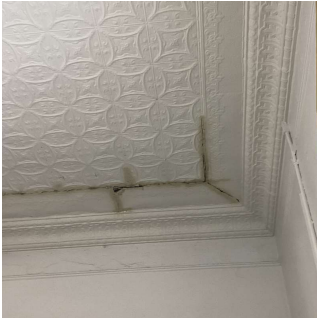
Main Entrance Vestibule
Violations	No violations recorded.
<b>Door(s)</b>	Inspected
Condition	5 - Poor
Deficiency	WOOD: DETERIORATED DOOR
Deficiency Location/Instance	Basement Exit 2 Vestibule, Rooms B8, 204, 309, 403, and others
Deficiency Quantity	13
Quantity Uom	EACH
Potential Action	MAINTENANCE
Urgency of Action	PRIORITY 3
Purpose of Action	LEVEL 2

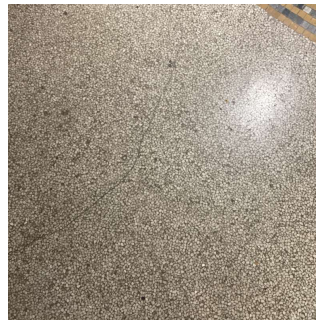
Main Entrance Vestibule

TERRAZZO: CRACKS

REPLACE

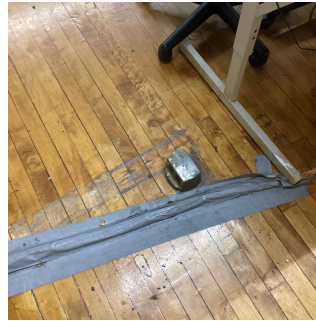
Room 209

Violations	Room 307 No violations recorded.
Deficiency	WOOD: TRIPPING HAZARD - ELECTRICAL OUTLET
Deficiency Location/Instance	Rooms 209, 228
Deficiency Quantity	30
Quantity Uom	S.F.
Potential Action	REMOVE
Urgency of Action	PRIORITY 5

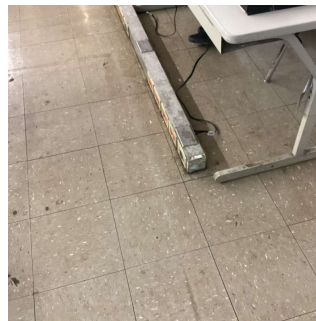
Room 210

VINYL TILES: TRIPPING HAZARD - ELECTRICAL OUTLET

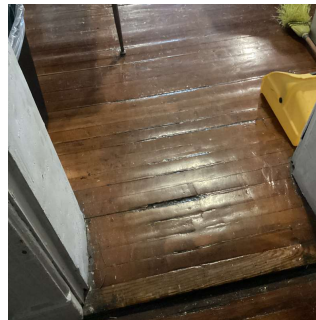
Room 428

WOOD: DAMAGED/DETERIORATED

REPLACE

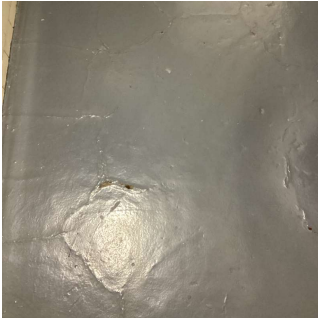
Question	Response
<b>INTERIOR</b>	
<b>STAIRS/RAMPS: INTERIOR</b>	
<b>Stairs and Landings</b>	
Deficiency	ROLLED ASPHALT: CRACKS
Deficiency Location/Instance	Stair AB/1,2,3,4
Deficiency Quantity	1,000
Quantity Uom	S.F.
Potential Action	REPLACE
Urgency of Action	PRIORITY 3
Purpose of Action	LEVEL 2
Deficiency Photo1

Stair AB/1
Violations	No violations recorded.
Deficiency	VINYL TILES: DETERIORATED SUBSTRATE
Deficiency Location/Instance	Stairs AB/1, DE/1
Deficiency Quantity	60
Quantity Uom	S.F.
Potential Action	REPLACE
Urgency of Action	PRIORITY 3
Purpose of Action	LEVEL 2
Deficiency Photo1

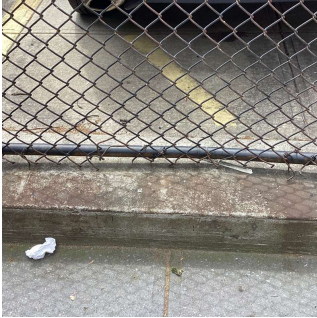
Violations	Parking Lot At Exit 2 No violations recorded.
<b>Culverts - Concrete Covering</b>	Does not Exist
<b>Drainage System for Soil</b>	Does not Exist
<b>DRINKING FOUNTAINS</b>	Does not Exist
<b>FENCES</b>	Inspected
Condition	4 - Between Fair and Poor
Deficiency	CHAIN LINK: DAMAGED/DETERIORATED
Deficiency Location/Instance	Halsey Street
Deficiency Quantity	40
Quantity Uom	S.F.
Potential Action	REPLACE
Urgency of Action	PRIORITY 3
Purpose of Action	LEVEL 2
Deficiency Photo1

Violations	Halsey Street No violations recorded.
Deficiency	WROUGHT IRON: DAMAGED/DETERIORATED
Deficiency Location/Instance	Halsey Street
Deficiency Quantity	240
Quantity Uom	S.F.
Potential Action	REPLACE
Urgency of Action	PRIORITY 3
Purpose of Action	LEVEL 2

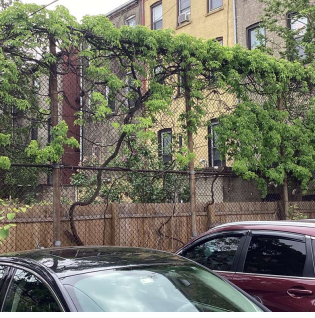
Question	Response
<b>SITE</b>	
<b>FENCES</b>	
Deficiency Photo1	 
Violations	Halsey Street No violations recorded.
Deficiency	CHAIN LINK: RUST - MAJOR
Deficiency Location/Instance	Parking Lot
Deficiency Quantity	900
Quantity Uom	S.F.
Potential Action	REPLACE
Urgency of Action	PRIORITY 3
Purpose of Action	LEVEL 2
Deficiency Photo1

Violations	Parking Lot No violations recorded.
Deficiency	WROUGHT IRON: RUST - MAJOR
Deficiency Location/Instance	Nostrand Avenue, Halsey Street
Deficiency Quantity	120
Quantity Uom	S.F.
Potential Action	REPLACE
Urgency of Action	PRIORITY 3
Purpose of Action	LEVEL 2
Deficiency Photo1	 
Violations	Nostrand Avenue No violations recorded.
Deficiency	CONCRETE CURB: DAMAGED/DETERIORATED

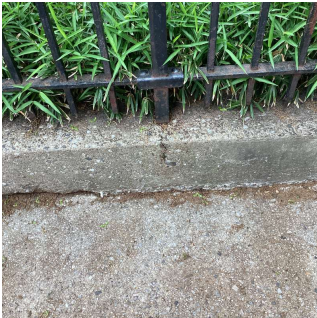
Question	Response
<b>SITE</b>	
<b>FENCES</b>	
Deficiency Location/Instance	Macon Street, Nostrand Avenue, Halsey Street
Deficiency Quantity	65
Quantity Uom	S.F.
Potential Action	REPLACE
Urgency of Action	PRIORITY 3
Purpose of Action	LEVEL 2
Deficiency Photo1

Macon Street
Violations	No violations recorded.
<b>IRRIGATION SYSTEM</b>	
	Does not Exist
<b>PAVING</b>	
	Inspected
<b>Student Non-Use</b>	
Gravel Exists?	No
<b>Asphalt</b>	
	Does not Exist
<b>Concrete</b>	
Condition	4 - Between Fair and Poor
Deficiency	HEAVING
Deficiency Location/Instance	Macon Street, Parking Lot
Deficiency Quantity	175
Quantity Uom	S.F.
Potential Action	REPLACE
Urgency of Action	PRIORITY 3
Purpose of Action	LEVEL 2
Deficiency Photo1
