**NYC Department of Education**  
**Building Condition Assessment Survey 2023 - 2024**

Architectural Inspection

**K749**

**Asset:**        **PRE-K CENTER @ 173 25TH STREET - BROOKLYN, 173 25TH STREET, New York, 11232**

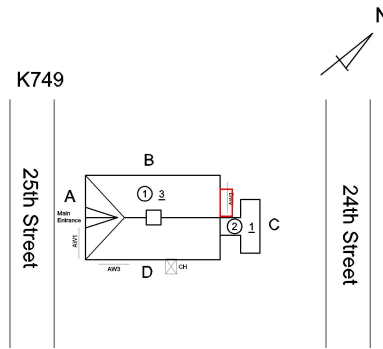
Question	Response
<b>Architectural</b>	
<b>EXTERIOR</b>	Inspected
<b>AREAWAY</b>	Inspected
Instance on AW1-AW-3	Inspected
Instance Condition	3 - Fair
Instance Quantity	3
Instance Quantity Uom	EACH
Deficiency	AREAWAY WALLS: DETERIORATED COPING STONE
Roof Plan reference

Deficiency Quantity	15
Quantity Uom	S.F.
Potential Action	REPAIR
Urgency of Action	PRIORITY 3
Purpose of Action	LEVEL 2

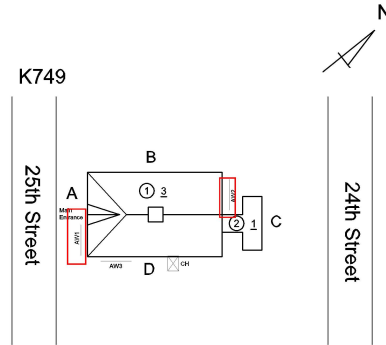
AREAWAY STAIRS: DETERIORATED TREADS/RISERS/NOSINGS

REPAIR

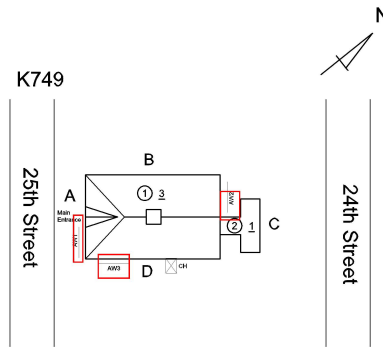
AREAWAY SLAB: CRACKS AND SPALLING

REPAIR

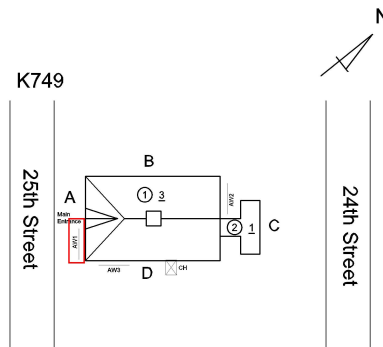
AREAWAY WALLS: CRACKS AND SPALLING

REPAIR

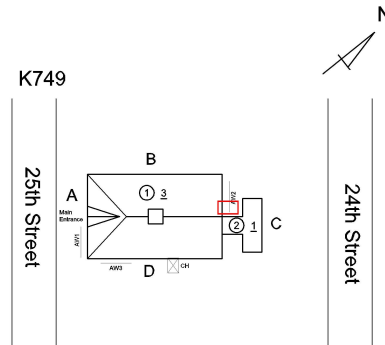
METAL: DETERIORATED DOOR AND FRAME - MAJOR DETERIORATION

REPLACE

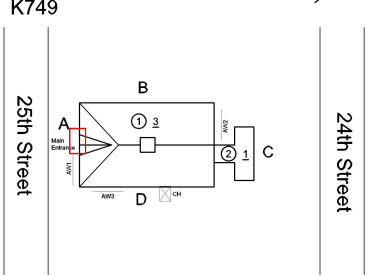
Question	Response
<b>EXTERIOR</b>	
<b>DOORS</b>	
<b>DOORS AND FRAMES</b>	Inspected
	AW2-Exit 7, Exit 2
Violations	No violations recorded.
<b>DOOR HARDWARE</b>	Inspected
Condition	2 - Between Good and Fair
Deficiency	No deficiencies recorded
<b>LINTELS</b>	Inspected
Condition	2 - Between Good and Fair
Deficiency	No deficiencies recorded
<b>TRANSOM/SIDE LIGHT</b>	Inspected
Condition	3 - Fair
Deficiency	WOOD: EXCESSIVELY WEATHERED
Roof Plan reference	<div style="text-align: right;">

</div>
Deficiency Quantity	30
Quantity Uom	S.F.
Potential Action	REPAIR
Urgency of Action	PRIORITY 3
Purpose of Action	LEVEL 2
Deficiency Photo1

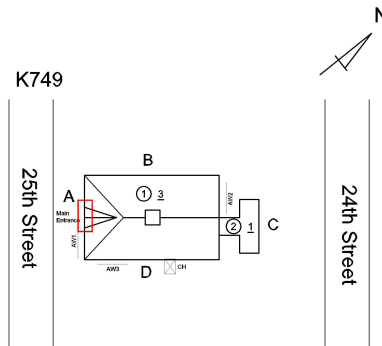
Main Entrance
Violations	No violations recorded.
Deficiency	WOOD: BROKEN GLASS

10  
 S.F.  
 MAINTENANCE  
 PRIORITY 3  
 LEVEL 2

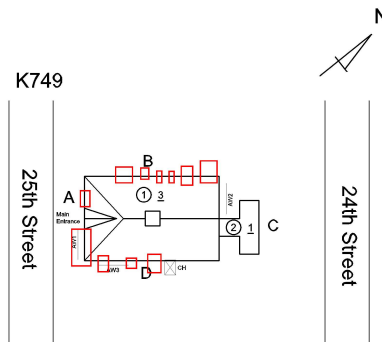
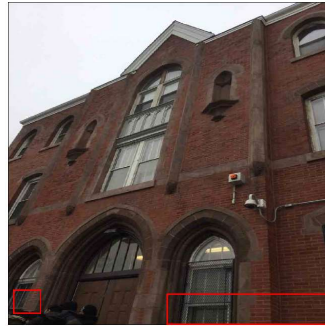
STONE: CHIPPED/SPALLED/BROKEN PIECES - MINOR

70  
S.F.  
REPAIR  
PRIORITY 3  
LEVEL 2

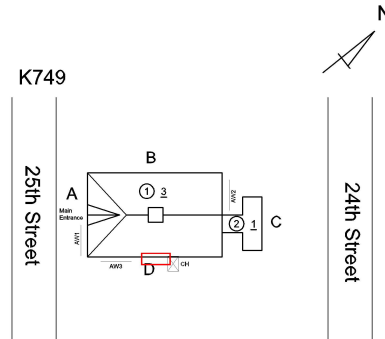
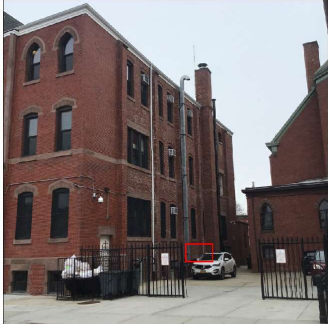
BROKEN/ DENTED BLADES

Deficiency Quantity	20
Quantity Uom	S.F.
Potential Action	REPLACE
Urgency of Action	PRIORITY 4
Purpose of Action	LEVEL 2
Deficiency Photo1

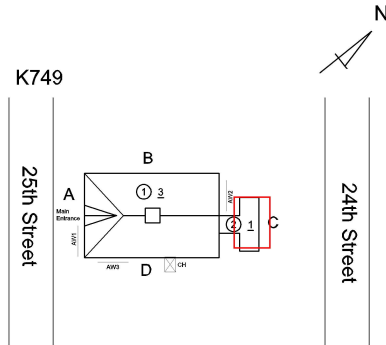
Violations	Roof 2 No violations recorded.
Deficiency	MODIFIED BITUMEN: FLASHING: DETERIORATED JOINTS
Roof Plan reference

Deficiency Quantity	60
Quantity Uom	L.F.
Potential Action	MAINTENANCE
Urgency of Action	PRIORITY 3
Purpose of Action	LEVEL 2
Deficiency Photo1

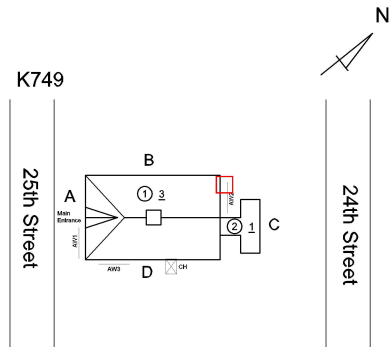
Question	Response
<b>EXTERIOR</b>	
<b>ROOF</b>	Inspected
Specialties	Does not Exist
<b>STAIRS/RAMPS: EXTERIOR</b>	Inspected
<b>BUILDING CHEEK/FLANK WALLS</b>	Inspected
Condition	2 - Between Good and Fair
Deficiency	No deficiencies recorded
<b>RAILINGS</b>	Inspected
Condition	2 - Between Good and Fair
Deficiency	No deficiencies recorded
<b>STAIRS/RAMPS</b>	Inspected
Condition	5 - Poor
Deficiency	CONCRETE: CRACKS/SPALLING - MINOR
Roof Plan reference

20  
S.F.  
REPAIR  
PRIORITY 3  
LEVEL 2

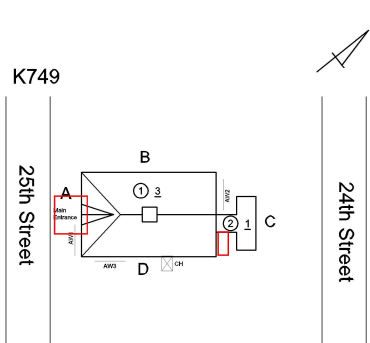
Violations	Exit 4 No violations recorded.
Deficiency	CONCRETE: CRACKS/SPALLING - MAJOR
Roof Plan reference

Deficiency Quantity	150
Quantity Uom	S.F.
Potential Action	REPLACE
Urgency of Action	PRIORITY 4
Purpose of Action	LEVEL 2
Deficiency Photo1

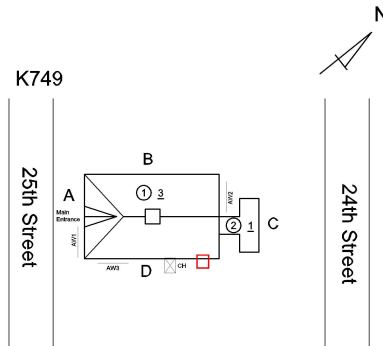
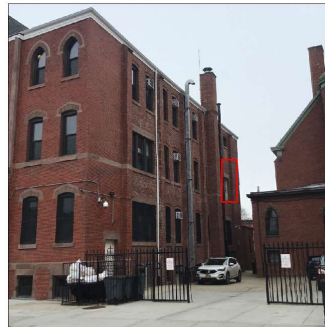
Material Type(s)	Inspected
	Aluminum, Solid Wood
Instance on Aluminum - Double Hung: All Facades	Inspected
Instance Condition	1 - Good
Instance Quantity	1,770
Instance Quantity Uom	S.F.
Are these windows insulated	Yes
Installation Year	2018
Source of Installation	Custodial Staff
Deficiency	No deficiencies recorded
Instance on Wood: Facade D	Inspected
Instance Condition	5 - Poor
Instance Quantity	30
Instance Quantity Uom	S.F.
Are these windows insulated	No
Installation Year	1911
Source of Installation	Inspector Estimate
Deficiency	WOOD: DETERIORATED
Roof Plan reference

Deficiency Quantity	30
Quantity Uom	S.F.
Potential Action	REPLACE WINDOW
Urgency of Action	PRIORITY 4
Purpose of Action	LEVEL 2

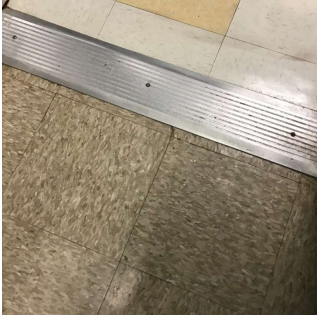
Question	Response
<b>INTERIOR</b>	
<b>STAIRS/RAMPS: INTERIOR</b>	
<b>Railings</b>	Inspected
	Stair D/1
Violations	No violations recorded.
<b>Stairs and Landings</b>	Inspected
Condition	4 - Between Fair and Poor
Deficiency	VINYL TILES: BROKEN/DETERIORATED/MISSING TILES
Deficiency Location/Instance	Stair A/Basement
Deficiency Quantity	10
Quantity Uom	S.F.
Potential Action	REPLACE
Urgency of Action	PRIORITY 3
Purpose of Action	LEVEL 2
Deficiency Photo1
