**NYC Department of Education**  
**Building Condition Assessment Survey 2023 - 2024**

Architectural Inspection

K751

Asset: **PRE-K CENTER @ 131 UNION STREET - BROOKLYN, 131 UNION STREET, New York, 11231**

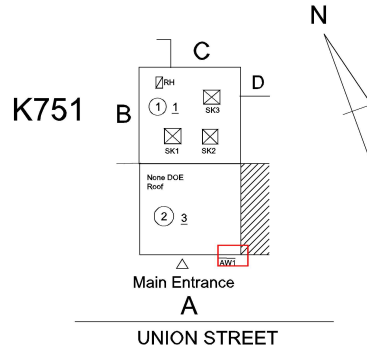
Roof Plan reference

AREAWAY WALLS: CRACKS AND SPALLING

80

REPAIR

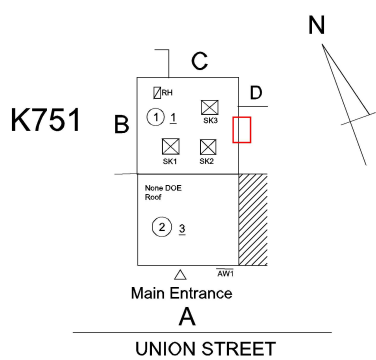
Question	Response
<b>EXTERIOR</b>	
<b>EXTERIOR WALLS</b>	Inspected
Deficiency	No deficiencies recorded
<b>EXTERIOR SOFFITS</b>	Does not Exist
<b>LOADING DOCK</b>	Does not Exist
<b>LOUVER</b>	Does not Exist
<b>PARAPETS</b>	Inspected
Material Type(s)	Masonry
Replacement Quantity	650
Replacement Uom	C.F.
Instance on Roof 1	Inspected
Instance Condition	3 - Fair
Instance Quantity	650
Instance Quantity Uom	C.F.
Deficiency	BRICK: DETERIORATED JOINTS
Roof Plan reference

Deficiency Quantity	20
Quantity Uom	S.F.
Potential Action	REPOINT
Urgency of Action	PRIORITY 3
Purpose of Action	LEVEL 2
Deficiency Photo1

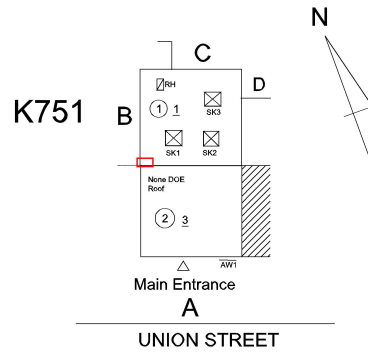
Roof Plan reference

Violations	Roof No violations recorded.
Deficiency	BRICK: DETERIORATED CONTROL/EXPANSION JOINT

Deficiency Quantity  
Quantity Uom  
Potential Action  
Urgency of Action  
Purpose of Action  
Deficiency Photo1

10  
L.F.  
MAINTENANCE  
PRIORITY 3  
LEVEL 2

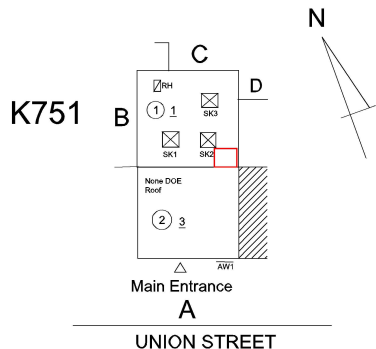
Question	Response
<b>EXTERIOR</b>	
<b>ROOF</b>	
<b>Roofing</b>	
<b>ROOFING</b>	
Instance Quantity	2,000
Instance Quantity Uom	S.F.
Does the roof have major mechanical equipment sitting on Dunnage Steel less than 18" above the Roofing?	No
Does this roof instance have a Sustainable Roof System?	Yes
Sustainable Roof Type	White Roof
Sustainable Roof Location (Roof Number)	Roof 1
Do solar panels exist on these roofs?	No
Is/Are the roof(s) suitable for Solar Panel installation?	No
Installation Year	2016
Source of Installation	Custodial Staff
Deficiency	MODIFIED BITUMEN: ROOFING: DELAMINATION
Roof Plan reference

Deficiency Quantity	250
Quantity Uom	S.F.
Potential Action	REPLACE ROOFING WITHOUT MAJOR EQUIPMENT REMOVAL
Urgency of Action	PRIORITY 4
Purpose of Action	LEVEL 2
Deficiency Photo1
