NYC Department of Education
Building Condition Assessment Survey 2023 - 2024

Architectural Inspection

Asset: **P.S. 118 MAURICE SENDAK COMMUNITY SCHOOL - BROOKLYN, 211 8TH STREET,
New York, 11215**

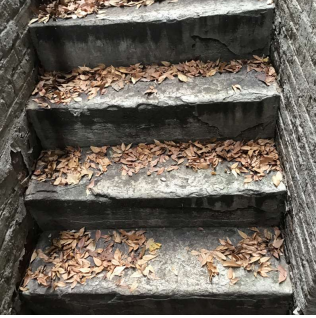
AREAWAY STAIRS: DETERIORATED
TREADS/RISERS/NOSINGS

Deficiency Quantity	50
Quantity Uom	S.F.
Potential Action	REPLACE
Urgency of Action	PRIORITY 4
Purpose of Action	LEVEL 2
Deficiency Photo1

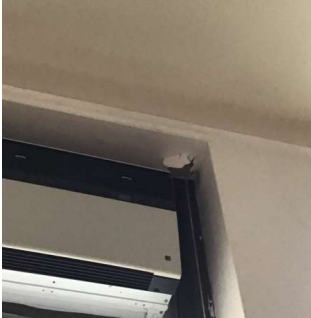
Question	Response
EXTERIOR	
EXTERIOR WALLS	
Material Type(s)	Concrete, Masonry
Replacement Quantity	34,000
Replacement Uom	S.F.
Instance on All Facades	Inspected
Instance Condition	3 - Fair
Instance Quantity	34,000
Instance Quantity Uom	S.F.
Deficiency	BRICK: WATER INFILTRATION IN INSTRUCTIONAL SPACE
Roof Plan reference	<p>K763</p>

Deficiency Quantity	200
Quantity Uom	S.F.
Potential Action	REPAIR
Urgency of Action	PRIORITY 5
Purpose of Action	LEVEL 2
Deficiency Photo1

Violations	Facade D - Room 209 shown, Facade G - Room 218 similar No violations recorded.
Deficiency	STONE: CHIPPED/SPALLED/BROKEN PIECES - MINOR

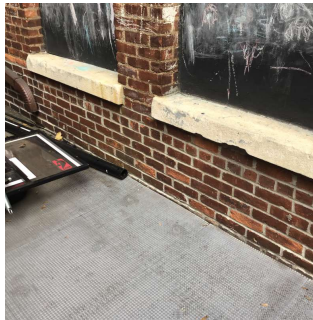
Facade J, K

BRICK: DETERIORATED MASONRY SILLS - MAJOR

REMOVE AND REPLACE

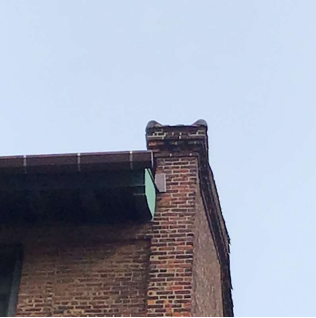
Question	Response
EXTERIOR	
EXTERIOR WALLS	Inspected
Violations	No violations recorded.
EXTERIOR SOFFITS	Does not Exist
LOADING DOCK	Does not Exist
LOUVER	Inspected
Condition	2 - Between Good and Fair
Deficiency	No deficiencies recorded
PARAPETS	Inspected
Material Type(s)	Masonry
Replacement Quantity	350
Replacement Uom	C.F.
Instance on Facades B, F, H, M	Inspected
Instance Condition	3 - Fair
Instance Quantity	350
Instance Quantity Uom	C.F.
Deficiency	BRICK: DETERIORATED JOINTS
Roof Plan reference	K763

Deficiency Quantity	25
Quantity Uom	S.F.
Potential Action	REPOINT
Urgency of Action	PRIORITY 3
Purpose of Action	LEVEL 2
Deficiency Photo1

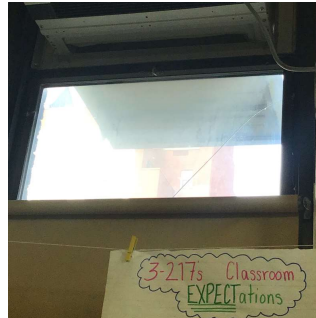
Facade F - Room 217, Facade K - 4th Floor Corridor
No violations recorded.

Violations	All Facades No violations recorded.
LINTELS	Inspected
Condition	2 - Between Good and Fair
Deficiency	No deficiencies recorded
WINDOWS	Inspected
Material Type(s)	Aluminum
Instance on Aluminum - Double Hung: All Facades	Inspected
Instance Condition	3 - Fair
Instance Quantity	4,000
Instance Quantity Uom	S.F.
Are these windows insulated	Yes
Installation Year	2013
Source of Installation	Custodial Staff
Deficiency	ALUMINUM - DOUBLE HUNG: BROKEN PANE
Roof Plan reference	K763

Deficiency Quantity	60
Quantity Uom	S.F.
Potential Action	MAINTENANCE
Urgency of Action	PRIORITY 3

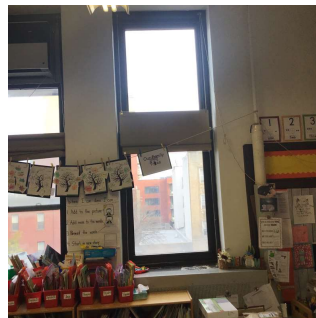
Facade G

ALUMINUM - DOUBLE HUNG: INOPERABLE BALANCE

REPLACE BALANCES

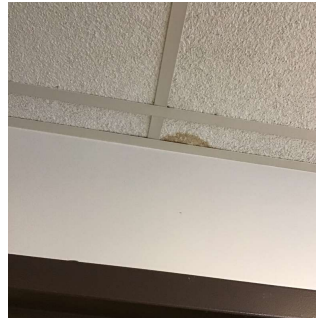
Room 401

ACOUSTIC TILES: DAMAGED/MISSING

REPLACE

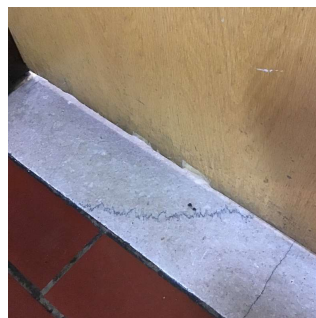
WOOD: DETERIORATED DOOR

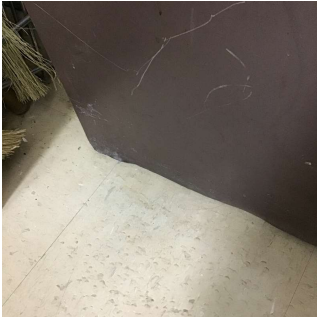
Room 401
Violations	No violations recorded.
Specialties	Does not Exist
GYMNASIUM	Does not Exist
INTERIOR DOOR HARDWARE	Inspected
Condition	3 - Fair
Deficiency	No deficiencies recorded
INTERIOR GUARDS	Inspected
Condition	2 - Between Good and Fair
Deficiency	No deficiencies recorded
KITCHEN	Inspected
Instance on Basement	Inspected
Ceiling	
Instance on Basement	Does not Exist
Door(s)	
Instance on Basement	Inspected
Condition	3 - Fair
Deficiency	METAL: DETERIORATED DOOR
Deficiency Location/Instance	Storage Room
Deficiency Quantity	1
Quantity Uom	EACH
Potential Action	MAINTENANCE
Urgency of Action	PRIORITY 3
Purpose of Action	LEVEL 2
Deficiency Photo1

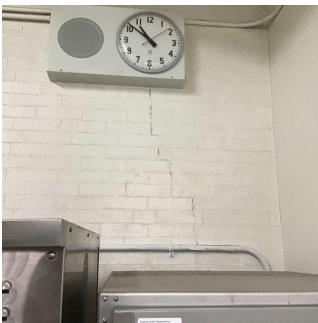
Violations	Near Clock No violations recorded.
LIBRARY	
Instance on Room 118	Inspected
Built-in Furnishing	
Instance on Room 118	Does not Exist
Ceiling	
Instance on Room 118	Inspected
Condition	2 - Between Good and Fair
Deficiency	No deficiencies recorded

Violations	Serving Area No violations recorded.
Walls	
Instance on Basement	Inspected
Condition	2 - Between Good and Fair
Deficiency	BRICK: CRACKS/SPALLING
Deficiency Location/Instance	Near Clock
Deficiency Quantity	10
Quantity Uom	S.F.
Potential Action	REPLACE
Urgency of Action	PRIORITY 3
Purpose of Action	LEVEL 2
Deficiency Photo1

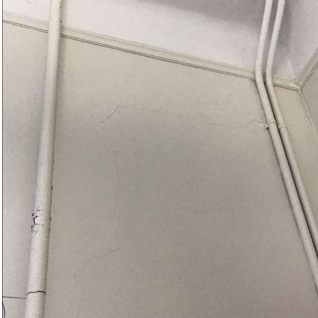
Question	Response
INTERIOR	
LIBRARY	
Door(s)	
Instance on Room 118	Inspected
Condition	2 - Between Good and Fair
Deficiency	No deficiencies recorded
Floor Finish	
Instance on Room 118	Inspected
Condition	2 - Between Good and Fair
Deficiency	No deficiencies recorded
Walls	
Instance on Room 118	Inspected
Condition	2 - Between Good and Fair
Deficiency	PLASTER: CRACKS/SPALLING
Deficiency Location/Instance	Left Side
Deficiency Quantity	10
Quantity Uom	S.F.
Potential Action	REPLACE
Urgency of Action	PRIORITY 3
Purpose of Action	LEVEL 2
Deficiency Photo1

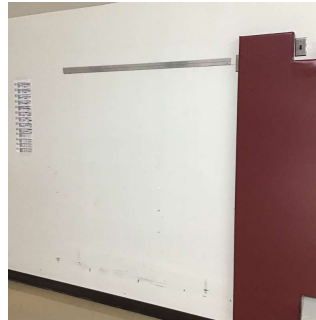
West Side

WALL PADDING: DETERIORATED

REPLACE

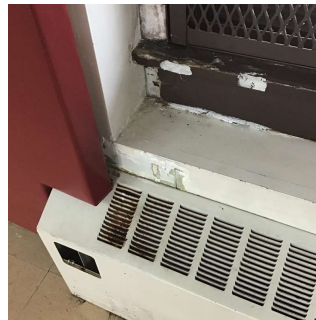
West Side

GYPSUM BOARD: DETERIORATED - ACTIVE LEAK

REPLACE

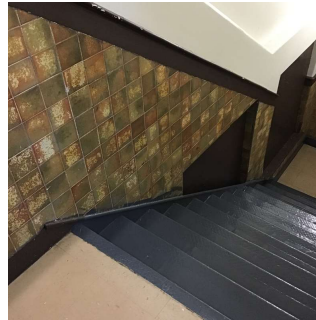
Stair A/4

METAL: MISSING

REPLACE

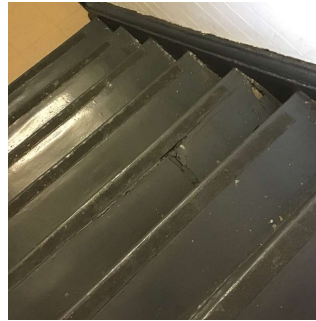
Stair A/Basement

CONCRETE: CRACKS/SPALLING - MAJOR

REPLACE

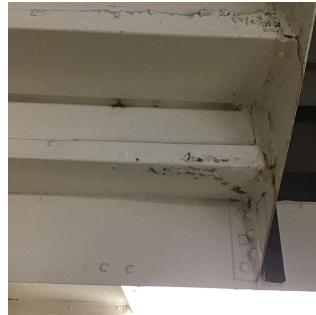
Stair AW/3

METAL: RUST - MAJOR

REPLACE

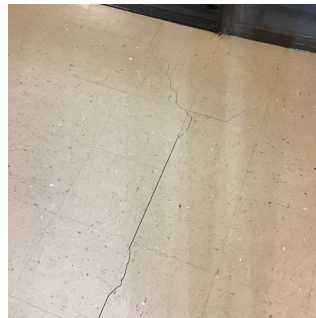
Stair A/3

VINYL TILES: DETERIORATED SUBSTRATE

REPLACE

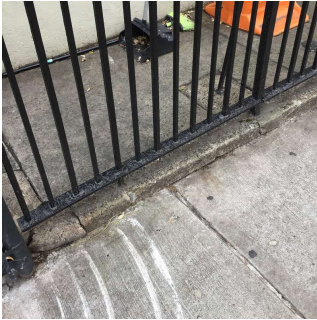
Question	Response
SITE	Inspected
CONTAINERIZATION	Does not Exist
Drainage System for Asphalt	Inspected
Catch Basins/Manhole - Surrounded by asphalt	Inspected
Condition	2 - Between Good and Fair
Deficiency	No deficiencies recorded
Culverts - Asphalt Covering	Does not Exist
Drainage System for Concrete	Inspected
Catch Basins/Manhole - Surrounded by concrete	Inspected
Condition	2 - Between Good and Fair
Deficiency	No deficiencies recorded
Culverts - Concrete Covering	Does not Exist
Drainage System for Soil	Does not Exist
DRINKING FOUNTAINS	Does not Exist
FENCES	Inspected
Condition	4 - Between Fair and Poor
Deficiency	WROUGHT IRON: DAMAGED/DETERIORATED
Deficiency Location/Instance	4th Avenue, 8th Street
Deficiency Quantity	200
Quantity Uom	S.F.
Potential Action	REPLACE
Urgency of Action	PRIORITY 3
Purpose of Action	LEVEL 2
Deficiency Photo1	 
	4th Avenue
Violations	No violations recorded.
Deficiency	CONCRETE CURB: DAMAGED/DETERIORATED

Deficiency Location/Instance	4th Avenue, 8th Street
Deficiency Quantity	55
Quantity Uom	S.F.
Potential Action	REPLACE
Urgency of Action	PRIORITY 3
Purpose of Action	LEVEL 2

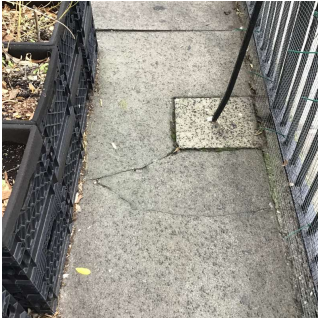
Question	Response
SITE	
PAVING	
Student Non-Use	
Concrete	
Deficiency Location/Instance	4th Avenue, 8th Street
Deficiency Quantity	450
Quantity Uom	S.F.
Potential Action	REPLACE
Urgency of Action	PRIORITY 3
Purpose of Action	LEVEL 2
Deficiency Photo1

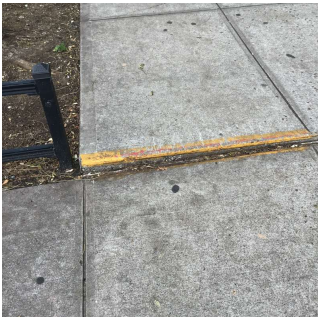
Question	Response
SITE	
PAVING	
Site Sidewalks & Walkways	Inspected
Concrete	Inspected
Condition	2 - Between Good and Fair
Deficiency	No deficiencies recorded
Pavers	Does not Exist
DOT Sidewalk	Inspected
Asphalt	Does not Exist
Concrete	Inspected
Condition	4 - Between Fair and Poor
Deficiency	HEAVING
Deficiency Location/Instance	4th Avenue
Deficiency Quantity	100
Quantity Uom	S.F.
Potential Action	REPLACE
Urgency of Action	PRIORITY 5
Purpose of Action	LEVEL 6
Deficiency Photo1

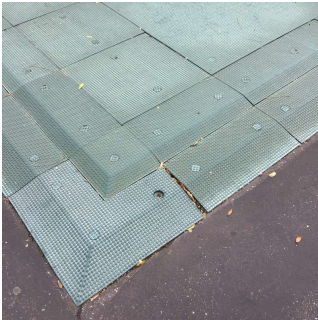
Question	Response
SITE	
PLAYGROUNDS	
Pavement	
Instance on Schoolyard	Does not Exist
Instance on Rear of Building	Does not Exist
Play Equipment	
Instance on Rear of Building	Inspected
Condition	2 - Between Good and Fair
Deficiency	No deficiencies recorded
Instance on Schoolyard	Inspected
Condition	2 - Between Good and Fair
Deficiency	No deficiencies recorded
Safety Surfacing	
Instance on Schoolyard	Inspected
Condition	2 - Between Good and Fair
Deficiency	DETERIORATED/MISSING
Deficiency Location/Instance	West Side
Deficiency Quantity	10
Quantity Uom	S.F.
Potential Action	MAINTENANCE
Urgency of Action	PRIORITY 3
Purpose of Action	LEVEL 2
Deficiency Photo1

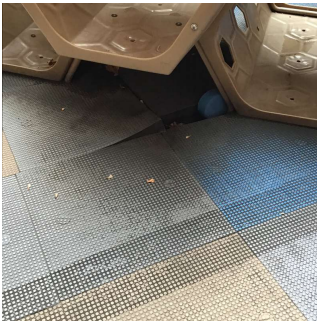
West Side
Violations	No violations recorded.
Instance on Rear of Building	Inspected
Condition	2 - Between Good and Fair
Deficiency	DETERIORATED/MISSING
Deficiency Location/Instance	Under Play Equipment
Deficiency Quantity	10
Quantity Uom	S.F.
Potential Action	REPLACE

Urgency of Action	PRIORITY 3
Purpose of Action	LEVEL 2

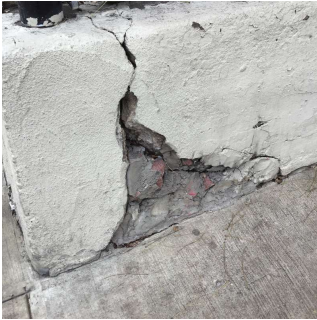
Violations	Under Play Equipment No violations recorded.
Unpaved Area	
Instance on Rear of Building	Does not Exist
Instance on Schoolyard	Does not Exist
PLAYING SURFACE	Does not Exist
RETAINING WALLS	Inspected
Are there any Retaining Walls 6' OR higher facing public street/sidewalk?	No
Condition	3 - Fair
Deficiency	CAST IN PLACE CONCRETE: CRACKS/SPALLING - MAJOR
Deficiency Location/Instance	7th Street, 4th Avenue
Deficiency Quantity	120
Quantity Uom	S.F.
Potential Action	REPLACE
Urgency of Action	PRIORITY 4
Purpose of Action	LEVEL 4
Deficiency Photo1
