NYC Department of Education
Building Condition Assessment Survey 2023 - 2024

Architectural Inspection

K765

Asset: **PRE-K CENTER @ 1139 CONEY ISLAND AVENUE - BROOKLYN, 1139 CONEY ISLAND AVENUE, New York, 11230**

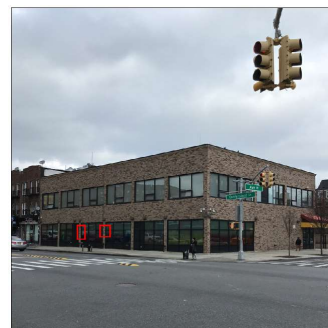
Question	Response
EXTERIOR	
EXTERIOR WALLS	
Material Type(s)	Masonry
Replacement Quantity	6,000
Replacement Uom	S.F.
Instance on All Facades	Inspected
Instance Condition	3 - Fair
Instance Quantity	6,000
Instance Quantity Uom	S.F.
Deficiency	BRICK: MINOR CRACKS AND SPALLING
Roof Plan reference	  <p>K765</p> <p>A Playground Main Entrance BH1 ① 2 B C Avenue H Coney Island Avenue</p>
Elevation

Deficiency Quantity	10
Quantity Uom	S.F.
Potential Action	RESTITCH
Urgency of Action	PRIORITY 3
Purpose of Action	LEVEL 2
Deficiency Photo1

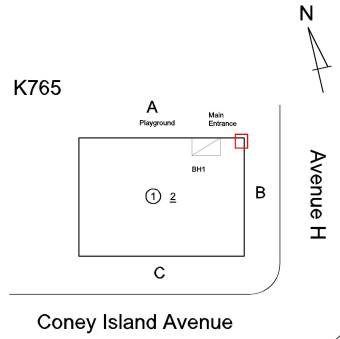
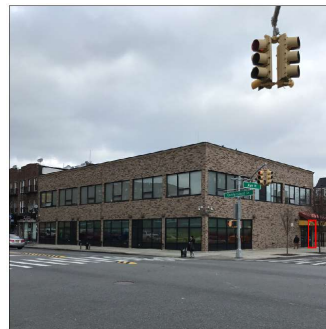
Violations	Facade C No violations recorded.
Deficiency	BRICK: CRACKS/DISPLACED/SPALLED BRICK AT BUILDING CORNERS

Deficiency Quantity

10

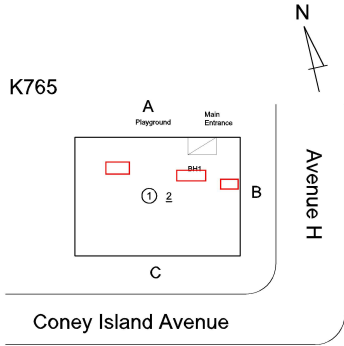
Installation Year	2015
Source of Installation	Custodial Staff
Deficiency	MODIFIED BITUMEN: ROOFING: DELAMINATION
Roof Plan reference

Deficiency Quantity	100
Quantity Uom	S.F.
Potential Action	REPLACE ROOFING WITHOUT MAJOR EQUIPMENT REMOVAL
Urgency of Action	PRIORITY 4
