NYC Department of Education
Building Condition Assessment Survey 2023 - 2024

Architectural Inspection

K767

Asset: **PRE-K CENTER @ 1668 46TH STREET - BROOKLYN, 1668 46TH STREET, New York, 11204**

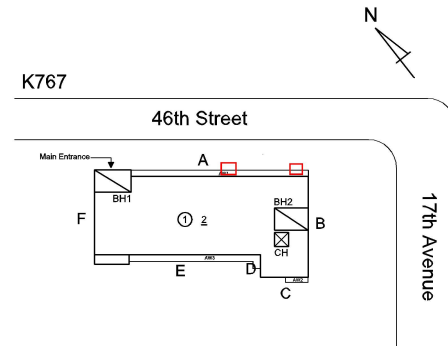
AREAWAY SLAB: CRACKS AND SPALLING

40

REPAIR

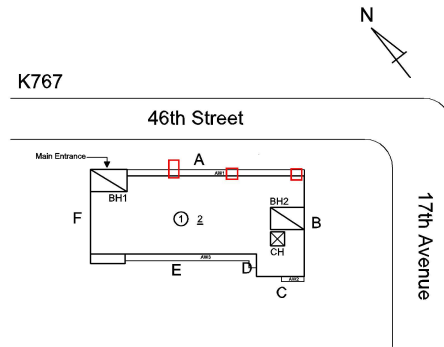
AREAWAY DRAINS: DETERIORATED

3
EACH
REPLACE
PRIORITY 4
LEVEL 2

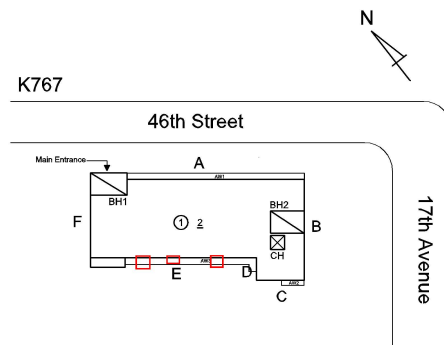
AREAWAY WALLS: CRACKS AND SPALLING

30
S.F.
REPAIR
PRIORITY 3
LEVEL 2

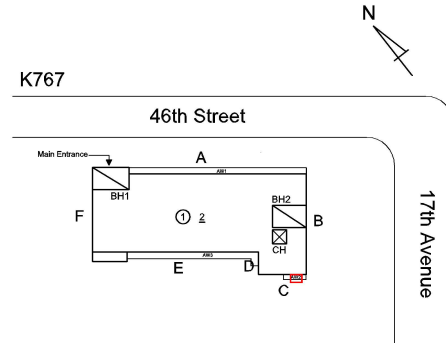
AREAWAY GRATINGS: MAJOR RUSTING / OR BROKEN

25
S.F.
REPLACE
PRIORITY 4
LEVEL 2

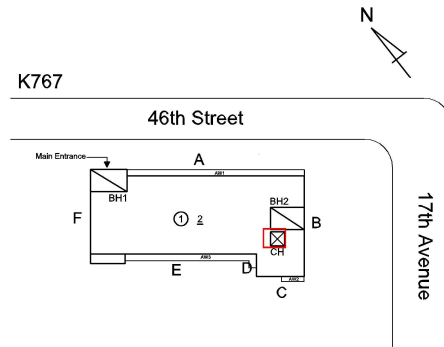
CHIMNEY

BRICK: MINOR CRACKS AND SPALLING

25
S.F.
RESTITCH
PRIORITY 3
LEVEL 2

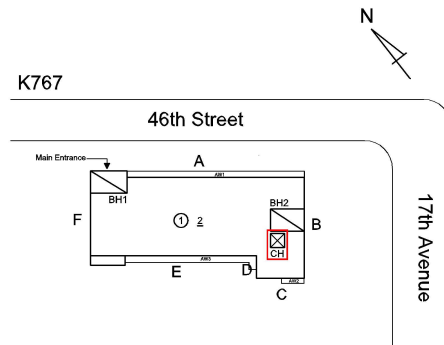
BRICK: DETERIORATED JOINTS

20
S.F.
REPOINT
PRIORITY 4
LEVEL 2

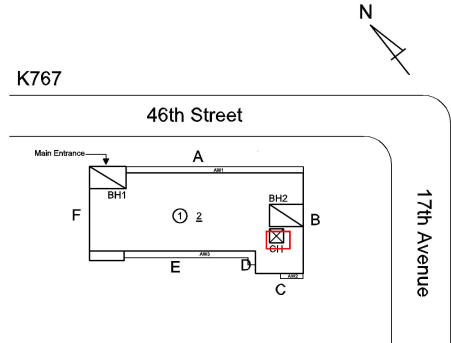
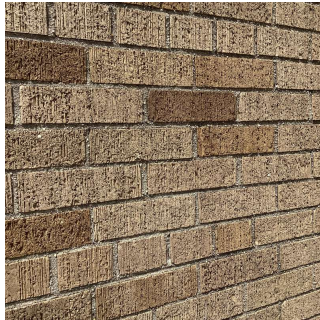
Violations	CH No violations recorded.
Deficiency	BRICK: DETERIORATED JOINTS
Roof Plan reference

Deficiency Quantity	120
Quantity Uom	S.F.
Potential Action	REPOINT
Urgency of Action	PRIORITY 3
Purpose of Action	LEVEL 2
Deficiency Photo1

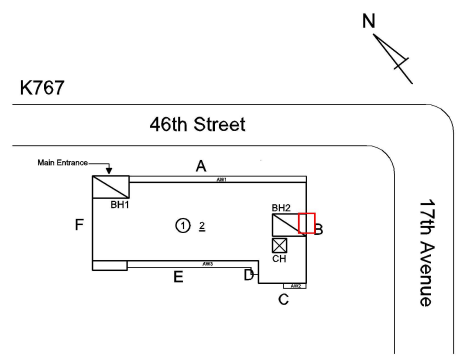
Violations	CH No violations recorded.
COPING	Inspected
Condition	2 - Between Good and Fair
Deficiency	No deficiencies recorded
CORNICE	Does not Exist
DOORS	Inspected
DOORS AND FRAMES	Inspected
Condition	5 - Poor
Deficiency	METAL: DETERIORATED DOOR AND FRAME - MAJOR DETERIORATION

Deficiency Quantity	2
Quantity Uom	EACH
Potential Action	REPLACE
Urgency of Action	PRIORITY 4
Purpose of Action	LEVEL 2
Deficiency Photo1

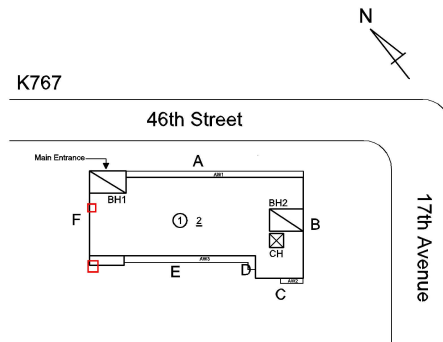
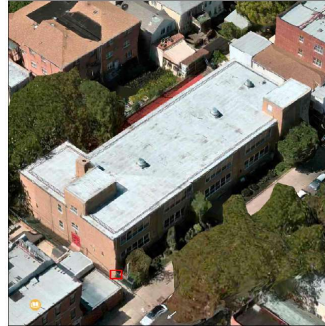
BRICK: MAJOR / THRU CRACKS

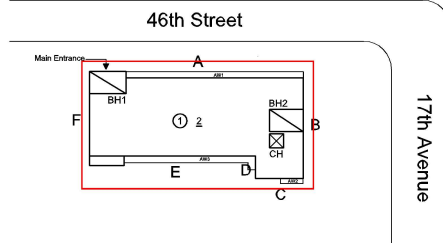
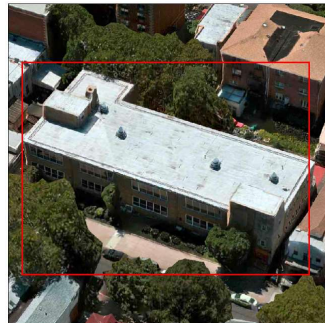
BRICK: DETERIORATED JOINTS

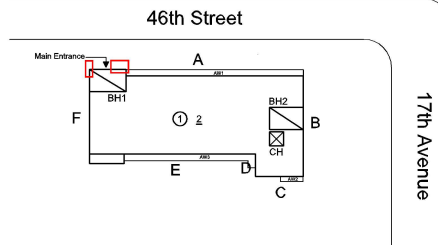
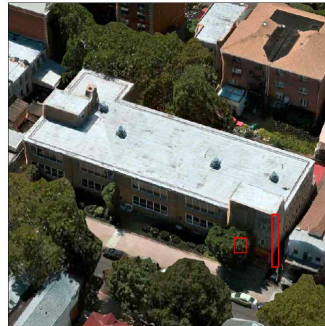
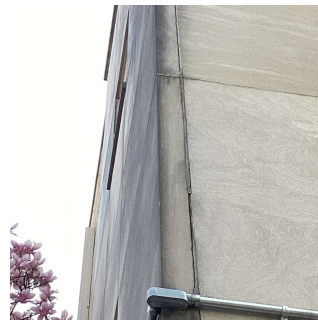
Facade F

STONE: DETERIORATED JOINTS

30
L.F.
REPOINT
PRIORITY 4
LEVEL 2

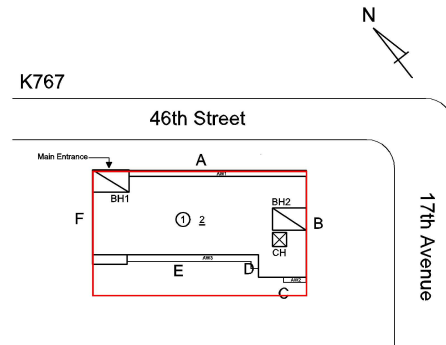
Deficiency	MODIFIED BITUMEN: ROOFING: DELAMINATION
------------	---

Deficiency Quantity	1,000
---------------------	-------

Potential Action	REPLACE ROOFING WITHOUT MAJOR EQUIPMENT REMOVAL
------------------	---

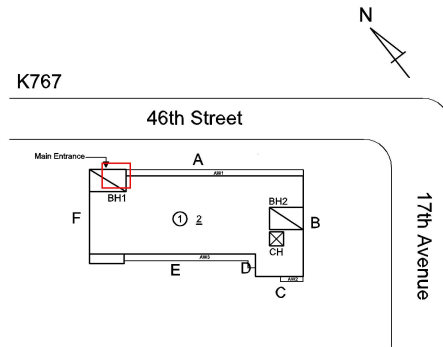
Deficiency	BULKHEAD/PENTHOUSE WALLS/EXTERIOR: CRACKS/SPALLING - MINOR
------------	---

25
S.F.
REPAIR
PRIORITY 3
LEVEL 2

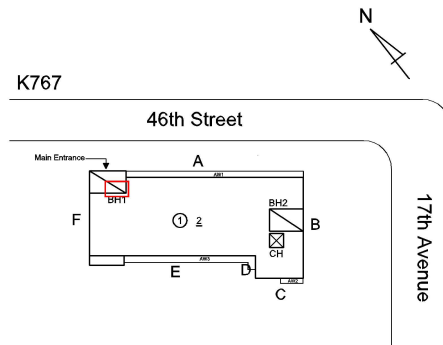
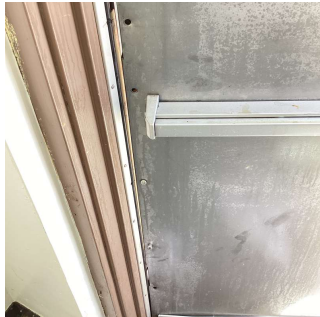
Deficiency	BULKHEAD/PENTHOUSE DOORS: DETERIORATED DOOR
------------	---

1
EACH
REPLACE DOOR
PRIORITY 4
LEVEL 2

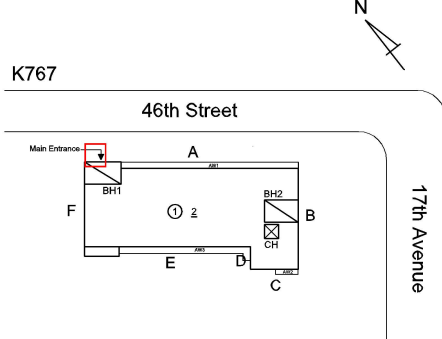
Question	Response
EXTERIOR	
STAIRS/RAMPS: EXTERIOR	
RAILINGS	Does not Exist
STAIRS/RAMPS	Inspected
Condition	4 - Between Fair and Poor
Deficiency	STONE: CRACKS/SPALLING - MINOR
Roof Plan reference

<p>K767 46th Street 17th Avenue</p>
Deficiency Quantity	10
Quantity Uom	S.F.
Potential Action	REPAIR
Urgency of Action	PRIORITY 3
Purpose of Action	LEVEL 2
Deficiency Photo1

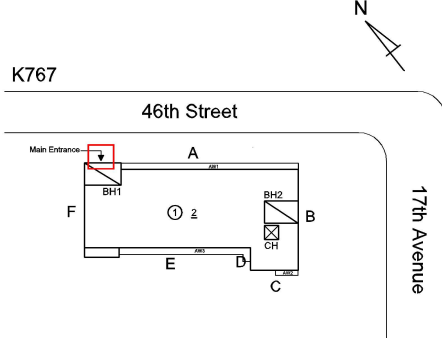
<p>Facade A</p>
Violations	No violations recorded.
Deficiency	STONE: DETERIORATED JOINTS
Roof Plan reference

<p>K767 46th Street 17th Avenue</p>
Deficiency Quantity	10
Quantity Uom	L.F.
Potential Action	REPOINT
Urgency of Action	PRIORITY 3
Purpose of Action	LEVEL 2

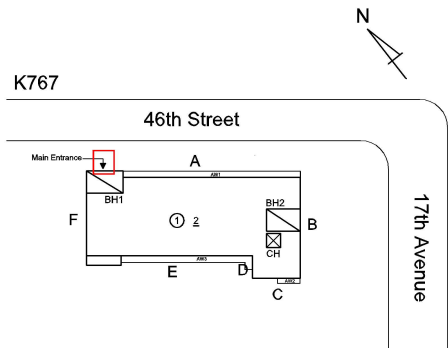
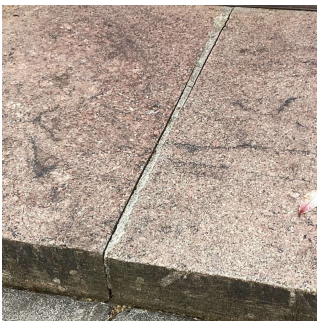
Violations	Facade A No violations recorded.
Deficiency	STONE: DETERIORATED SUBSTRATE
Roof Plan reference

Deficiency Quantity	20
Quantity Uom	S.F.
Potential Action	REPLACE SUBSTRATE AND RESET
Urgency of Action	PRIORITY 4
Purpose of Action	LEVEL 2
Deficiency Photo1

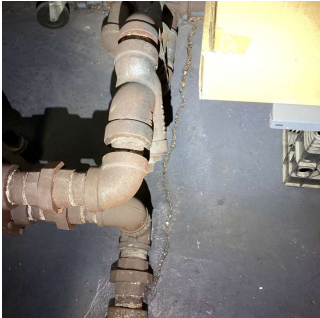
Question	Response
INTERIOR	
STRUCTURAL	Inspected
COLUMNS/BEAMS/BEARING WALLS	Inspected
Condition	2 - Between Good and Fair
Deficiency	No deficiencies recorded
FLOOR STRUCTURE	Inspected
Condition	3 - Fair
Deficiency	CONCRETE SLAB ON GRADE: THRU CRACKS
Deficiency Location/Instance	Basement
Deficiency Quantity	20
Quantity Uom	S.F.
Potential Action	REPLACE
Urgency of Action	PRIORITY 4
Purpose of Action	LEVEL 5
Deficiency Photo1

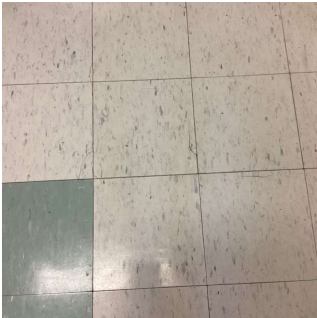
Question	Response
INTERIOR	
CLASSROOMS/CORRIDORS/ADMIN SPACES	
Floor Finish	
Violations	No violations recorded.
Deficiency	VINYL TILES: BROKEN/DETERIORATED/MISSING TILES
Deficiency Location/Instance	Corridor near Rooms 7, 12A, 16, Corridor near Stair B/Basement
Deficiency Quantity	40
Quantity Uom	S.F.
Potential Action	REPLACE
Urgency of Action	PRIORITY 3
Purpose of Action	LEVEL 2
Deficiency Photo1

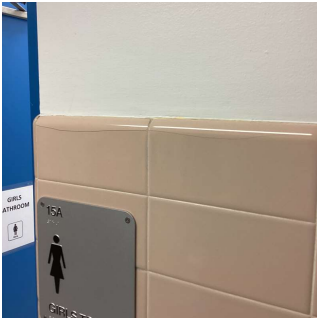
Violations	Corridor near Room 16
Violations	No violations recorded.
Walls	Inspected
Condition	2 - Between Good and Fair
Deficiency	CERAMIC TILE: BROKEN/ MISSING
Deficiency Location/Instance	Corridor near Room 15A, Corridor near Stair A/2
Deficiency Quantity	20
Quantity Uom	S.F.
Potential Action	REPLACE
Urgency of Action	PRIORITY 3
Purpose of Action	LEVEL 2
Deficiency Photo1

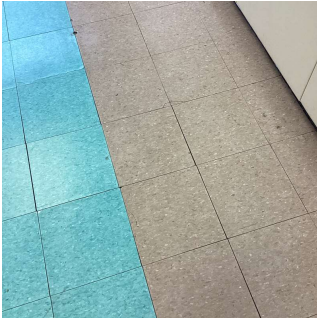
Question	Response
INTERIOR	
MULTI-PURPOSE ROOM	
Fixed Equipment	
Instance on Basement	Does not Exist
Floor Finish	
Instance on Basement	Inspected
Condition	2 - Between Good and Fair
Deficiency	VINYL TILES: BROKEN/DETERIORATED/MISSING TILES
Deficiency Location/Instance	Rear, Near Stage
Deficiency Quantity	40
Quantity Uom	S.F.
Potential Action	REPLACE
Urgency of Action	PRIORITY 3
Purpose of Action	LEVEL 2
Deficiency Photo1

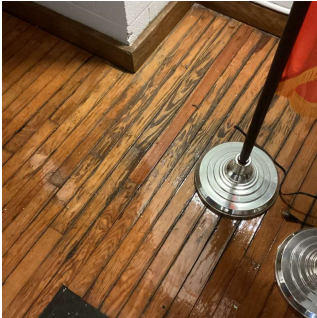
Violations	Rear No violations recorded.
Sliding-folding Partition	
Instance on Basement	Does not Exist
Stage	
Instance on Basement	Inspected
Stage	
Instance on Basement	Inspected
Condition	3 - Fair
Deficiency	DAMAGED FLOOR
Deficiency Location/Instance	Left Side, Right Side
Deficiency Quantity	20
Quantity Uom	S.F.
Potential Action	REPLACE
Urgency of Action	PRIORITY 3
Purpose of Action	LEVEL 2
Deficiency Photo1

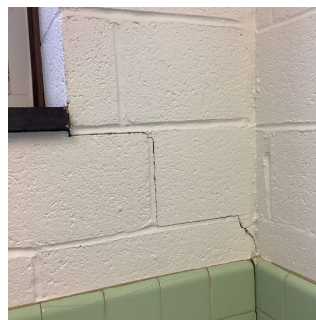
MASONRY: CRACKS/SPALLING

REPLACE

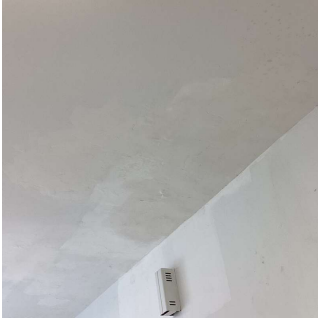
Question	Response
INTERIOR	
TOILET ROOMS - STAFF	Inspected
Walls	Inspected
Violations	Basement Men No violations recorded.
TOILET ROOMS - STUDENTS	Inspected
Ceiling	Inspected
Condition	2 - Between Good and Fair
Deficiency	PLASTER: CRACKS/SPALLING
Deficiency Location/Instance	Room 7A
Deficiency Quantity	10
Quantity Uom	S.F.
Potential Action	REPLACE
Urgency of Action	PRIORITY 3
Purpose of Action	LEVEL 2
Deficiency Photo1

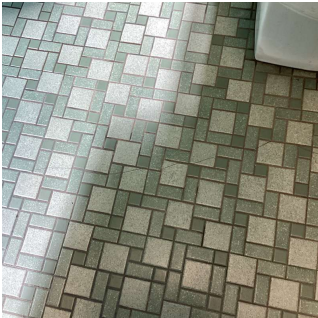
Violations	Room 9B No violations recorded.

Violations	Room 7A No violations recorded.
Door(s)	Inspected
Condition	2 - Between Good and Fair
Deficiency	No deficiencies recorded
Floor Finish	Inspected
Condition	4 - Between Fair and Poor
Deficiency	CERAMIC TILE: BROKEN/MISSING TILES
Deficiency Location/Instance	Rooms 1D, 9B
Deficiency Quantity	10
Quantity Uom	S.F.
Potential Action	REPLACE
Urgency of Action	PRIORITY 3
Purpose of Action	LEVEL 2
Deficiency Photo1

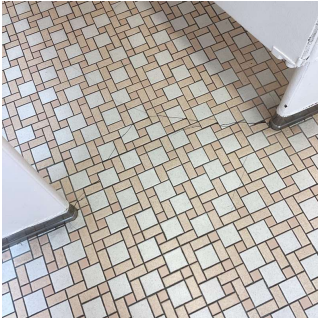
Question	Response
INTERIOR	
TOILET ROOMS - STUDENTS	Inspected
Floor Finish	
Deficiency	CERAMIC TILE: DETERIORATED SUBSTRATE
Deficiency Location/Instance	Rooms 7A, 15A
Deficiency Quantity	60
Quantity Uom	S.F.
Potential Action	REPLACE
Urgency of Action	PRIORITY 3
Purpose of Action	LEVEL 2
Deficiency Photo1

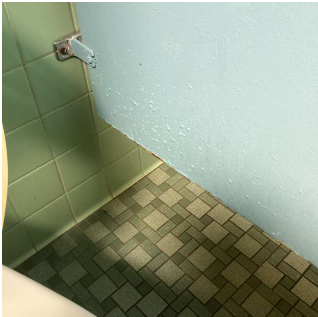
Room 15A
Violations	No violations recorded.
Stalls	
	Inspected
Condition	5 - Poor
Deficiency	RUST - MAJOR
Deficiency Location/Instance	Rooms 1D, 9B
Deficiency Quantity	3
Quantity Uom	EACH
Potential Action	REPLACE
Urgency of Action	PRIORITY 3
Purpose of Action	LEVEL 2
Deficiency Photo1

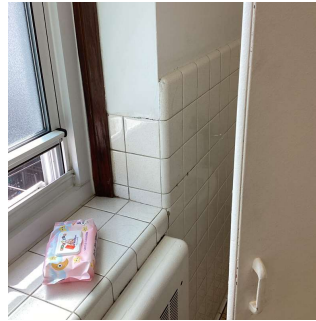
Room 15A

Room 9B
Violations	No violations recorded.
Deficiency	BROKEN/MISSING
Deficiency Location/Instance	Rooms 7A, 15A
Deficiency Quantity	2
Quantity Uom	EACH
Potential Action	REPLACE
Urgency of Action	PRIORITY 3
Purpose of Action	LEVEL 2

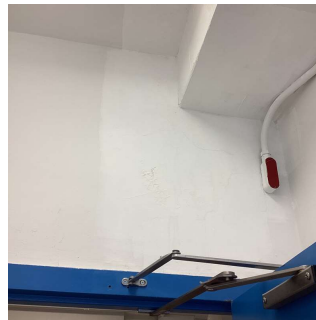
Room 15A

PLASTER: CRACKS/SPALLING

REPLACE

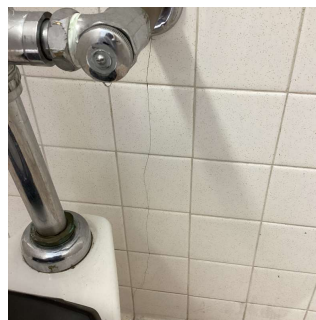
CERAMIC TILE: BROKEN/ MISSING

REPLACE

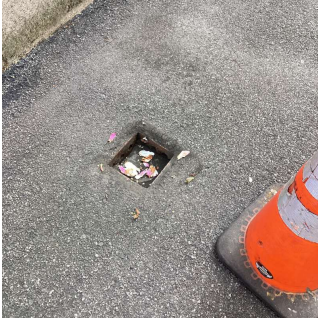
Question	Response
INTERIOR	Inspected
TOILET ROOMS - STUDENTS	Inspected
Walls	
Violations	Room 15A No violations recorded.
LIFE SAFETY	Inspected
F.D. HOLDING AREA	Does not Exist
STEEL STAIRS	Does not Exist
SITE	Inspected
CONTAINERIZATION	Does not Exist
Drainage System for Asphalt	Inspected
Catch Basins/Manhole - Surrounded by asphalt	Inspected
Condition	3 - Fair
Deficiency	DAMAGED COVER
Deficiency Location/Instance	Alleyway Adjacent to Main Entrance
Deficiency Quantity	1
Quantity Uom	EACH
Potential Action	REPLACE
Urgency of Action	PRIORITY 5
Purpose of Action	LEVEL 6
Deficiency Photo1

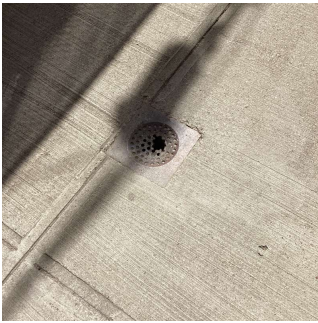
Violations	Alleyway Adjacent to Main Entrance No violations recorded.
Culverts - Asphalt Covering	Does not Exist
Drainage System for Concrete	Inspected
Catch Basins/Manhole - Surrounded by concrete	Inspected
Condition	3 - Fair
Deficiency	DAMAGED COVER
Deficiency Location/Instance	Near Exit 2
Deficiency Quantity	1
Quantity Uom	EACH
Potential Action	REPLACE

Urgency of Action	PRIORITY 3
Purpose of Action	LEVEL 2

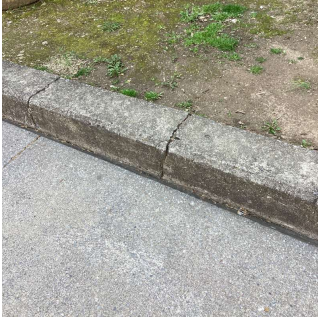
Near Exit 2
Violations	No violations recorded.
Culverts - Concrete Covering	
	Does not Exist
Drainage System for Soil	
	Does not Exist
DRINKING FOUNTAINS	
	Does not Exist
FENCES	
Condition	3 - Fair
Deficiency	CONCRETE CURB: DAMAGED/DETERIORATED
Deficiency Location/Instance	46th Street
Deficiency Quantity	20
Quantity Uom	S.F.
Potential Action	REPLACE
Urgency of Action	PRIORITY 3
Purpose of Action	LEVEL 2
Deficiency Photo1

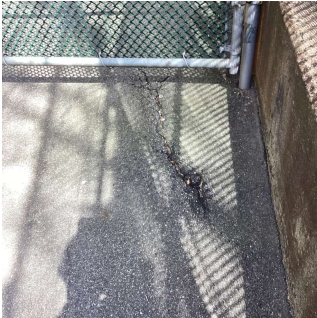
Question	Response
SITE	
PAVING	
Site Sidewalks & Walkways	
Asphalt	
Deficiency	HEAVING
Deficiency Location/Instance	Near Schoolyard
Deficiency Quantity	20
Quantity Uom	S.F.
Potential Action	REPLACE
Urgency of Action	PRIORITY 3
Purpose of Action	LEVEL 2
Deficiency Photo1

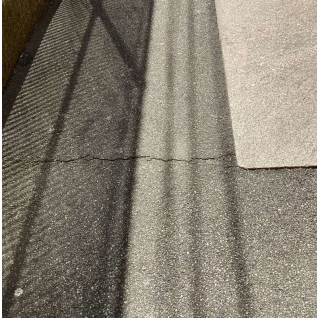
Violations	Near Schoolyard No violations recorded.
Deficiency	CRACKS - MAJOR
Deficiency Location/Instance	Near Exit 2
Deficiency Quantity	10
Quantity Uom	S.F.
Potential Action	REPLACE
Urgency of Action	PRIORITY 3
Purpose of Action	LEVEL 2
Deficiency Photo1
