**NYC Department of Education
Building Condition Assessment Survey 2023 - 2024**

Architectural Inspection

K778

Asset: EL PUENTE HS - BROOKLYN, 250 HOOPER STREET, New York, 11211

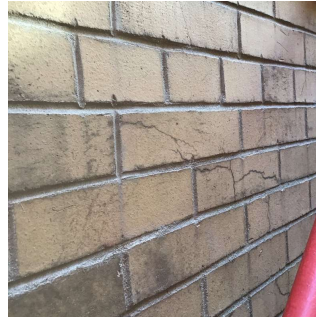
AW3

AREAWAY WALLS: CRACKS AND SPALLING

REPAIR

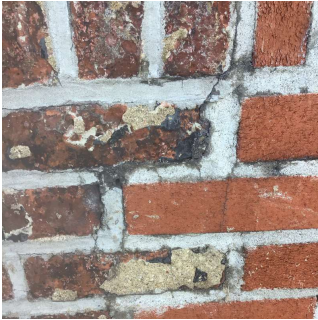
BRICK: MAJOR / THRU CRACKS

K778
 20
 S.F.
 REMOVE AND REBUILD
 PRIORITY 4
 LEVEL 2

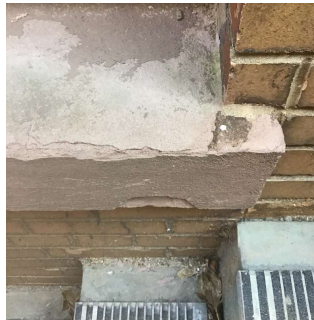
Facade D

BRICK: DETERIORATED MASONRY SILLS - MAJOR

REMOVE AND REPLACE

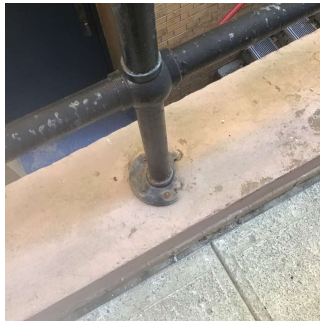
BROKEN BRACKET

REPLACE

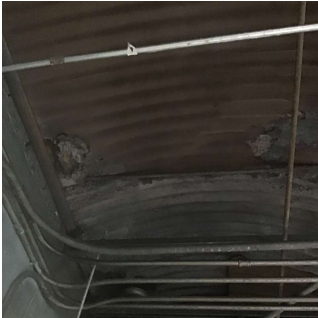
Question	Response
INTERIOR	
STRUCTURAL	
COLUMNS/BEAMS/BEARING WALLS	Inspected
Condition	2 - Between Good and Fair
Deficiency	No deficiencies recorded
FLOOR STRUCTURE	Inspected
Condition	3 - Fair
Deficiency	CINDER CONCRETE ARCH: METAL PAN DETERIORATED, SPALLED
Deficiency Location/Instance	Basement - Boiler Room
Deficiency Quantity	30
Quantity Uom	S.F.
Potential Action	REPAIR
Urgency of Action	PRIORITY 4
Purpose of Action	LEVEL 5
Deficiency Photo1

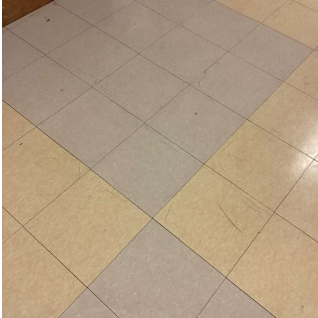
Question	Response
INTERIOR	
CAFETERIA	
Ceiling	
Potential Action	REPLACE
Urgency of Action	PRIORITY 3
Purpose of Action	LEVEL 2
Deficiency Photo1	 
	Room 009
Violations	No violations recorded.
Deficiency	ACOUSTIC TILES: DAMAGED/MISSING
Deficiency Location/Instance	Near Rooms 002A, 004, By Stair A/Basement, Exit Vestibule near Cafeteria
Deficiency Quantity	120
Quantity Uom	S.F.
Potential Action	REPLACE
Urgency of Action	PRIORITY 3
Purpose of Action	LEVEL 2
Deficiency Photo1	 
	Near Room 004
Violations	No violations recorded.
Door(s)	
Instance on Basement	Inspected
Condition	2 - Between Good and Fair
Deficiency	No deficiencies recorded
Fixed Equipment	
Instance on Basement	Does not Exist
Floor Finish	
Instance on Basement	Inspected
Condition	2 - Between Good and Fair
Deficiency	VINYL TILES: BROKEN/DETERIORATED/MISSING TILES
Deficiency Location/Instance	Near Room 004, 005, by Exit - Vestibule, Right Side
Deficiency Quantity	60

Quantity Uom	S.F.
Potential Action	REPLACE

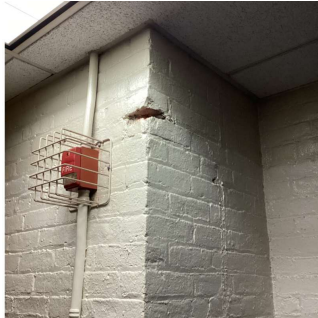
Violations	Near Room 004 No violations recorded.
Sliding-folding Partition	
Instance on Basement	Does not Exist
Stage	
Instance on Basement	Does not Exist
Walls	
Instance on Basement	Inspected
Condition	3 - Fair
Deficiency	BRICK: CRACKS/SPALLING
Deficiency Location/Instance	Exit - Vestibule
Deficiency Quantity	10
Quantity Uom	S.F.
Potential Action	REPLACE
Urgency of Action	PRIORITY 3
Purpose of Action	LEVEL 2
Deficiency Photo1

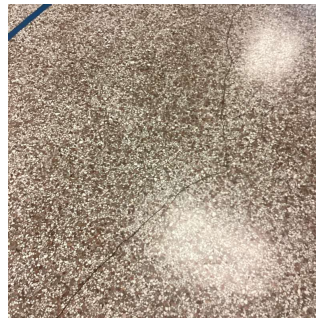
Corridor near Stair A/1

TERRAZZO: CRACKS

REPLACE

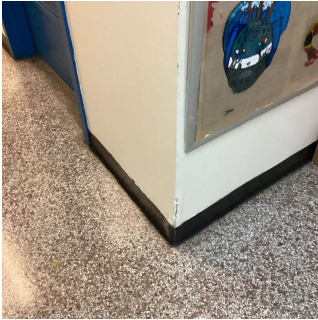
Question	Response
INTERIOR	
CLASSROOMS/CORRIDORS/ADMIN SPACES	
Floor Finish	Inspected
Violations	No violations recorded.
Walls	Inspected
Condition	2 - Between Good and Fair
Deficiency	GYPSUM BOARD: DETERIORATED
Deficiency Location/Instance	Corridor near Room 311
Deficiency Quantity	10
Quantity Uom	S.F.
Potential Action	REPLACE
Urgency of Action	PRIORITY 3
Purpose of Action	LEVEL 2
Deficiency Photo1

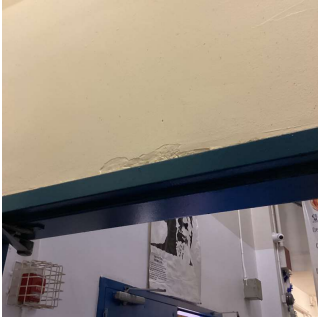
Violations	Corridor near Room 311 No violations recorded.
Deficiency	PLASTER: CRACKS/SPALLING
Deficiency Location/Instance	Main Entrance - Vestibule, Corridor near Rooms 309, 308
Deficiency Quantity	30
Quantity Uom	S.F.
Potential Action	REPLACE
Urgency of Action	PRIORITY 3
Purpose of Action	LEVEL 2
Deficiency Photo1

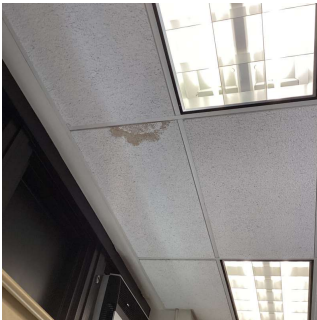
Question	Response
INTERIOR	
INTERIOR DOOR HARDWARE	Inspected
Condition	3 - Fair
Deficiency	No deficiencies recorded
INTERIOR GUARDS	Inspected
Condition	2 - Between Good and Fair
Deficiency	No deficiencies recorded
KITCHEN	Inspected
Instance on Basement	Inspected
Ceiling	
Instance on Basement	Not Required
Door(s)	
Instance on Basement	Does not Exist
Floor Finish	
Instance on Basement	Not Required
Walls	
Instance on Basement	Not Required
LIBRARY	Inspected
Instance on Room 303	Inspected
Built-in Furnishing	
Instance on Room 303	Does not Exist
Ceiling	
Instance on Room 303	Inspected
Condition	2 - Between Good and Fair
Deficiency	ACOUSTIC TILES: DAMAGED/MISSING
Deficiency Location/Instance	Near Windows
Deficiency Quantity	10
Quantity Uom	S.F.
Potential Action	REPLACE
Urgency of Action	PRIORITY 3
Purpose of Action	LEVEL 2
Deficiency Photo1

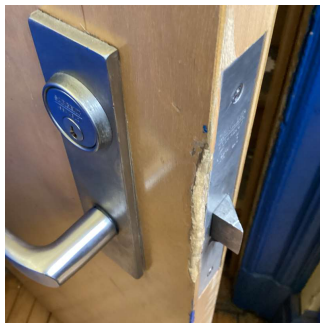
Question	Response
INTERIOR	
MULTI-PURPOSE ROOM	
Door(s)	
Deficiency Photo1

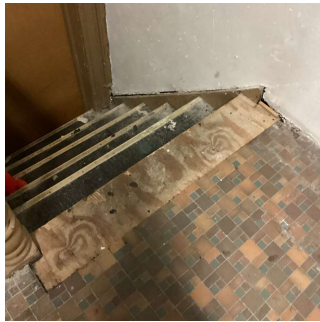
Violations	Room 101 No violations recorded.
Fixed Equipment	
Instance on 1st Floor	Does not Exist
Floor Finish	
Instance on 1st Floor	Inspected
Condition	2 - Between Good and Fair
Deficiency	CERAMIC TILE: BROKEN/MISSING TILES
Deficiency Location/Instance	Room 101
Deficiency Quantity	10
Quantity Uom	S.F.
Potential Action	REPLACE
Urgency of Action	PRIORITY 3
Purpose of Action	LEVEL 2
Deficiency Photo1

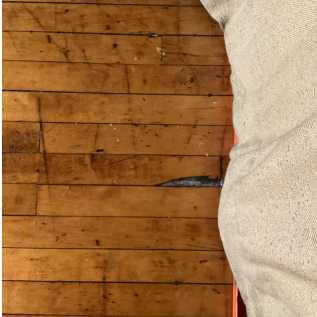
Question	Response
INTERIOR	
MULTI-PURPOSE ROOM	
Stage	
Stage	
Deficiency Photo1

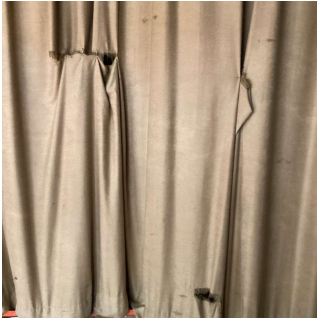
Violations	Back Center No violations recorded.
Stage Curtain Rigging	Inspected
Instance on 1st Floor	Inspected
Condition	2 - Between Good and Fair
Deficiency	No deficiencies recorded
Stage Curtains	Inspected
Instance on 1st Floor	Inspected
Condition	4 - Between Fair and Poor
Deficiency	WORN/DETERIORATED
Deficiency Location/Instance	Right and Left Side, Back Curtain
Deficiency Quantity	900
Quantity Uom	S.F.
Potential Action	REPLACE
Urgency of Action	PRIORITY 3
Purpose of Action	LEVEL 2
Deficiency Photo1

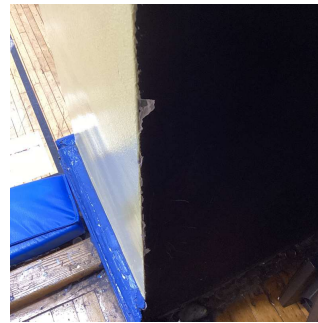
Violations	Left Side No violations recorded.
Walls	
Instance on 1st Floor	Inspected
Condition	3 - Fair
Deficiency	GYPSON BOARD: DETERIORATED
Deficiency Location/Instance	Right Side
Deficiency Quantity	10
Quantity Uom	S.F.
Potential Action	REPLACE
Urgency of Action	PRIORITY 3
Purpose of Action	LEVEL 2

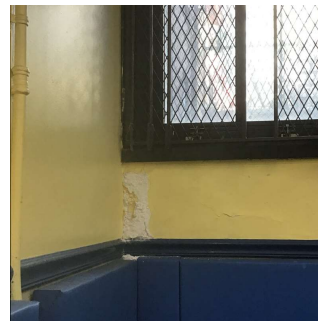
Right Side near Windows

PLASTER: CRACKS/SPALLING - ACTIVE LEAK

REPLACE

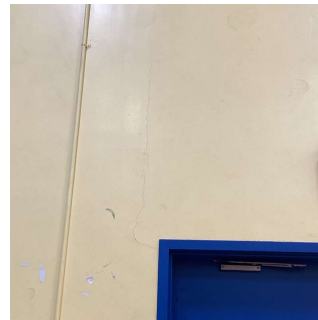
Near Stair B/1

PLASTER: CRACKS/SPALLING

REPLACE

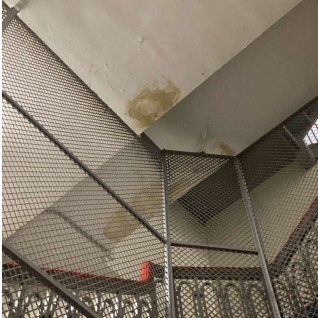
Question	Response
INTERIOR	
STAIRS/RAMPS: INTERIOR	
Ceiling	
Condition	2 - Between Good and Fair
Deficiency	PLASTER: CRACKS/SPALLING
Deficiency Location/Instance	Stairs B/2, 1
Deficiency Quantity	30
Quantity Uom	S.F.
Potential Action	REPLACE
Urgency of Action	PRIORITY 3
Purpose of Action	LEVEL 2
Deficiency Photo1

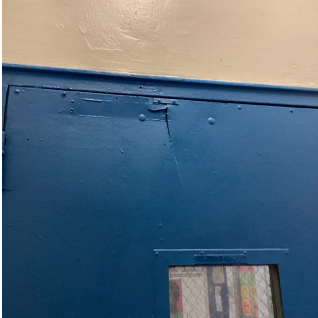
Violations	Stair B/1 No violations recorded.
Door(s)	
Condition	Inspected
Condition	3 - Fair
Deficiency	METAL: DETERIORATED DOOR
Deficiency Location/Instance	Stair A/4
Deficiency Quantity	1
Quantity Uom	EACH
Potential Action	MAINTENANCE
Urgency of Action	PRIORITY 3
Purpose of Action	LEVEL 2
Deficiency Photo1

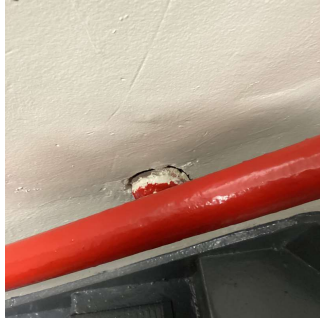
Violations	Stair A/4 No violations recorded.
Partition	Does not Exist
Railings	
Condition	Inspected
Condition	3 - Fair
Deficiency	METAL: BROKEN BRACKET
Deficiency Location/Instance	Stair B/1
Deficiency Quantity	1
Quantity Uom	EACH
Potential Action	REPLACE

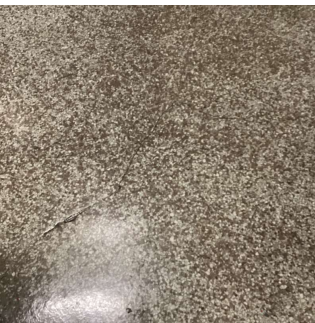
Violations	Room 102 No violations recorded.
Deficiency	TERRAZZO: CRACKS
Deficiency Location/Instance	Stairs A/1, B/1, Exit 2 - Vestibule
Deficiency Quantity	50
Quantity Uom	S.F.
Potential Action	REPLACE
Urgency of Action	PRIORITY 3
Purpose of Action	LEVEL 2

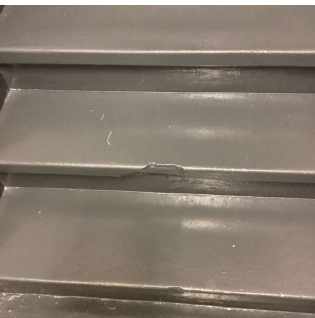
Stair B/Basement No violations recorded.

Stair B/1 No violations recorded.
Deficiency Deficiency Location/Instance Deficiency Quantity Quantity Uom Potential Action Urgency of Action Purpose of Action Deficiency Photo1 Violations	STONE: WORN-OUT TREAD/NOSINGS Stairs A/Basement, 1, 2 120 S.F. REPLACE PRIORITY 3 LEVEL 2   Stair A/1 No violations recorded.
Deficiency Deficiency Location/Instance Deficiency Quantity Quantity Uom Potential Action Urgency of Action Purpose of Action Deficiency Photo1 Violations	STONE: BROKEN/MISSING Stairs A/1, Bulkhead, B/Basement, 1, Bulkhead 100 S.F. REPLACE PRIORITY 3 LEVEL 2

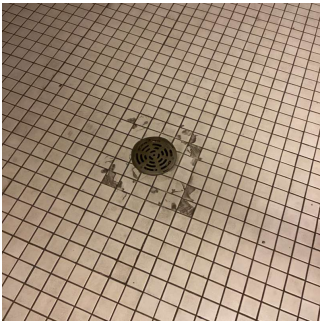
Question	Response
INTERIOR	
TOILET ROOMS - STUDENTS	
Door(s)	
Quantity Uom	EACH
Potential Action	MAINTENANCE
Urgency of Action	PRIORITY 3
Purpose of Action	LEVEL 2
Deficiency Photo1	 
	Room 004
Violations	No violations recorded.
Deficiency	WOOD: DAMAGED LOUVER
Deficiency Location/Instance	Rooms 003, 004, 306
Deficiency Quantity	3
Quantity Uom	EACH
Potential Action	MAINTENANCE
Urgency of Action	PRIORITY 3
Purpose of Action	LEVEL 2
Deficiency Photo1	 
	Room 003
Violations	No violations recorded.
Floor Finish	Inspected
Condition	2 - Between Good and Fair
Deficiency	CERAMIC TILE: BROKEN/MISSING TILES
Deficiency Location/Instance	Room 004
Deficiency Quantity	10
Quantity Uom	S.F.
Potential Action	REPLACE
Urgency of Action	PRIORITY 3
Purpose of Action	LEVEL 2

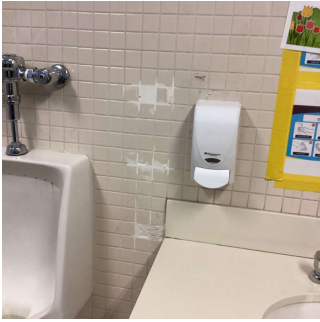
Room 004
Violations	No violations recorded.
Stalls	Inspected
Condition	2 - Between Good and Fair
Deficiency	No deficiencies recorded
Walls	Inspected
Condition	2 - Between Good and Fair
Deficiency	CERAMIC TILE: BROKEN/ MISSING
Deficiency Location/Instance	Room 306
Deficiency Quantity	10
Quantity Uom	S.F.
Potential Action	REPLACE
Urgency of Action	PRIORITY 3
Purpose of Action	LEVEL 2
Deficiency Photo1

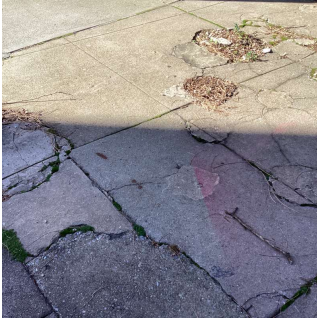
Question	Response
SITE	
PAVING	
Student Use	
Concrete	Inspected
Condition	4 - Between Fair and Poor
Deficiency	DAMAGED/DETERIORATED/MISSING SECTIONS
Deficiency Location/Instance	Schoolyard
Deficiency Quantity	600
Quantity Uom	S.F.
Potential Action	REPLACE
Urgency of Action	PRIORITY 3
Purpose of Action	LEVEL 2
Deficiency Photo1

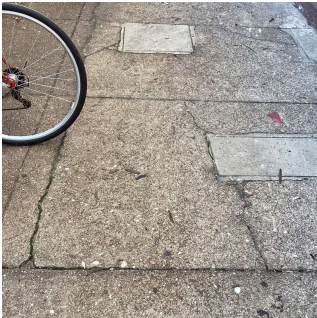
Violations	Schoolyard No violations recorded.
Pavers	Does not Exist
Site Sidewalks & Walkways	Inspected
Asphalt	Does not Exist
Concrete	Inspected
Condition	3 - Fair
Deficiency	DAMAGED/DETERIORATED/MISSING SECTIONS
Deficiency Location/Instance	Near Exit 3, Hopper Street
Deficiency Quantity	300
Quantity Uom	S.F.
Potential Action	REPLACE
Urgency of Action	PRIORITY 3
Purpose of Action	LEVEL 2
Deficiency Photo1

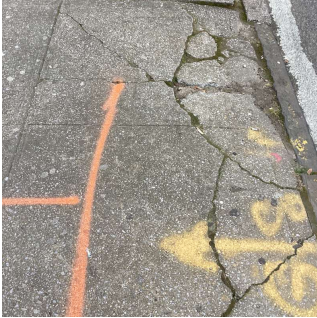
Question	Response
SITE	
PAVING	
DOT Sidewalk	
Concrete	Inspected
Condition	4 - Between Fair and Poor
Deficiency	DAMAGED/DETERIORATED/MISSING SECTIONS
Deficiency Location/Instance	Hooper Street
Deficiency Quantity	450
Quantity Uom	S.F.
Potential Action	REPLACE
Urgency of Action	PRIORITY 3
Purpose of Action	LEVEL 2
Deficiency Photo1

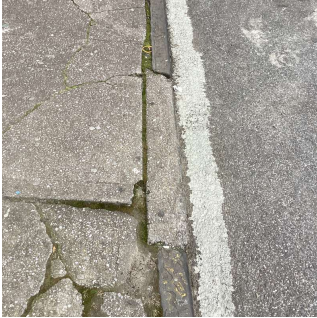
Violations	Hooper Street No violations recorded.
Deficiency	DAMAGED CURBS
Deficiency Location/Instance	Hooper Street
Deficiency Quantity	50
Quantity Uom	L.F.
Potential Action	REPLACE
Urgency of Action	PRIORITY 3
Purpose of Action	LEVEL 2
Deficiency Photo1
