**NYC Department of Education**  
**Building Condition Assessment Survey 2023 - 2024**

Architectural Inspection

**K781**

**Asset:**           **WEST BROOKLYN COMMUNITY HS - K, 1053 41ST STREET, New York, 11219**

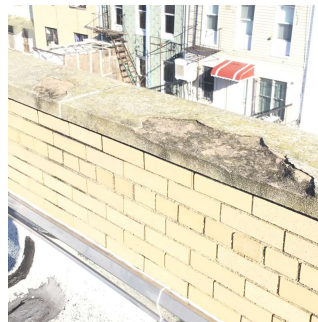
Roof 1

Deficiency

REPLACE-IN-KIND

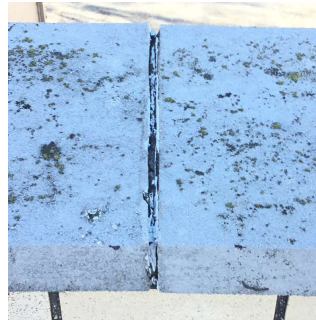
Roof 1

CAST STONE: DETERIORATED TRANSVERSE JOINTS

180  
L.F.  
MAINTENANCE  
PRIORITY 3  
LEVEL 2

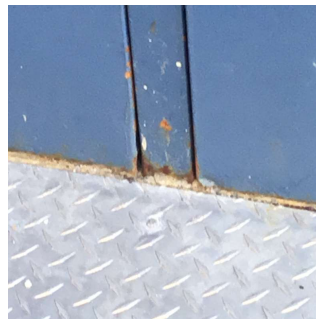
Facade B

METAL: DETERIORATED DOOR AND FRAME - MINOR DETERIORATION

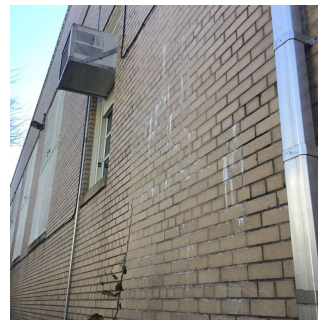
Facade E

<p>Facade K</p>
Violations	No violations recorded.
<b>DOOR HARDWARE</b>	Inspected
Condition	3 - Fair
Deficiency	No deficiencies recorded
<b>LINTELS</b>	Inspected
Condition	2 - Between Good and Fair
Deficiency	No deficiencies recorded
<b>TRANSOM/SIDE LIGHT</b>	Inspected
Condition	2 - Between Good and Fair
Deficiency	No deficiencies recorded
<b>EXTERIOR WALLS</b>	Inspected
Material Type(s)	Masonry
Replacement Quantity	11,700
Replacement Uom	S.F.
Instance on All Facades	Inspected
Instance Condition	3 - Fair
Instance Quantity	11,700
Instance Quantity Uom	S.F.
Deficiency	BRICK: EFFLORESCENCE

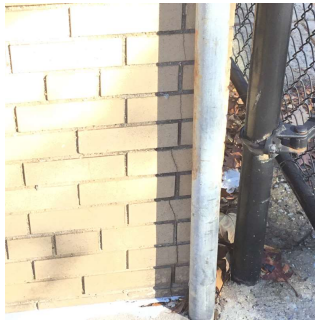
Facade A

BRICK: CRACKS/DISPLACED/SPALLED BRICK AT BUILDING CORNERS

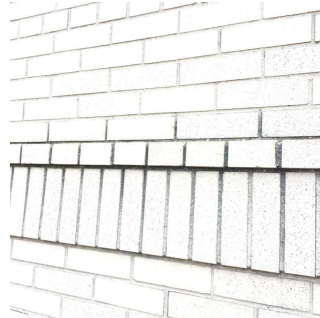
Facade A

BRICK: DETERIORATED JOINTS

PRIORITY 3  
LEVEL 2

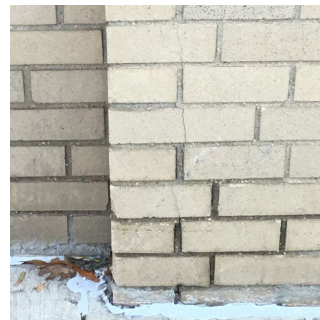
Facade A

BRICK: MINOR CRACKS AND SPALLING

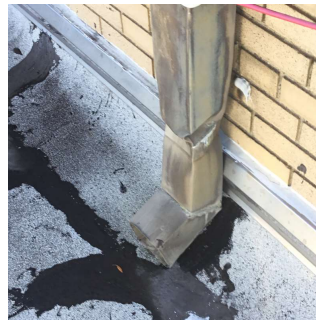
BH2  
No violations recorded.

Violations	Roof 1 No violations recorded.
<b>PLAZA DECK</b>	Does not Exist
<b>ROOF</b>	Inspected
<b>Roofing</b>	Inspected
Replacement Quantity	15,000
Replacement Uom	S.F.
<b>ROOF HATCH/SMOKE HATCH</b>	Does not Exist
<b>LEADERS, GUTTERS, DOWNSPOUTS, SCUPPERS</b>	Inspected
Condition	3 - Fair
Deficiency	DAMAGED/MISSING

K781  
10  
L.F.  
REPLACE  
PRIORITY 4  
LEVEL 2

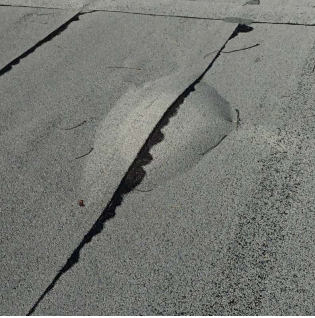
Question	Response
<b>EXTERIOR</b>	
<b>ROOF</b>	
<b>Roofing</b>	
<b>ROOFING</b>	
Source of Installation	Custodial Staff
Deficiency	MODIFIED BITUMEN: ROOFING: DELAMINATION
Roof Plan reference	K781

Deficiency Quantity	180
Quantity Uom	S.F.
Potential Action	REPLACE ROOFING WITHOUT MAJOR EQUIPMENT REMOVAL
Urgency of Action	PRIORITY 4
Purpose of Action	LEVEL 2
Deficiency Photo1

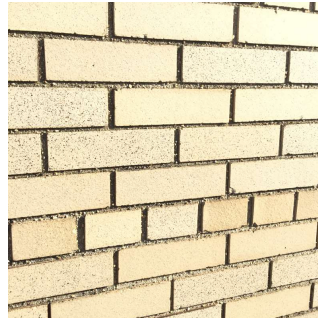
BH2

**BULKHEAD/PENTHOUSE WALLS/EXTERIOR: DETERIORATED JOINTS**

320  
S.F.  
REPOINT  
PRIORITY 3  
LEVEL 2

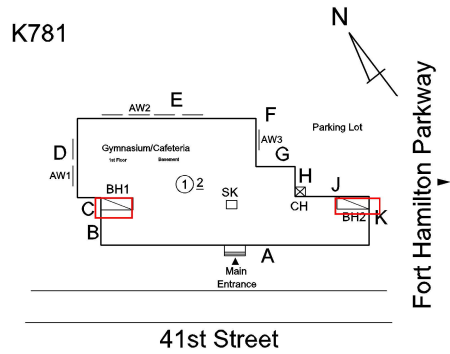
BH1  
No violations recorded.

**BULKHEAD/PENTHOUSE ROOF: MAJOR LEAKAGE**

200  
S.F.  
REPLACE  
PRIORITY 5  
LEVEL 2

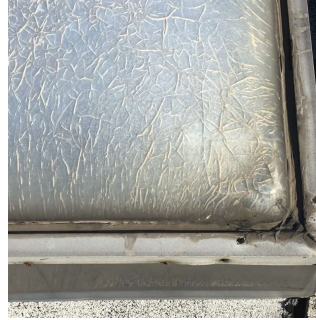
SK

BROKEN GLASS

20  
S.F.  
MAINTENANCE

PRIORITY 3  
LEVEL 2

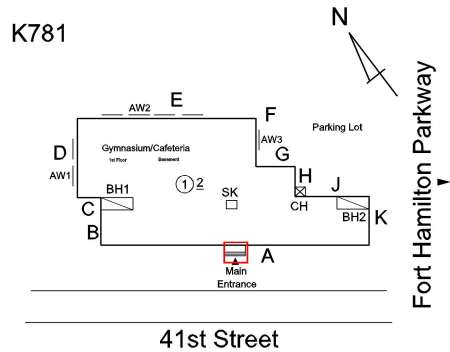
STONE: DETERIORATED JOINTS

10  
L.F.  
REPOINT  
PRIORITY 4  
LEVEL 2

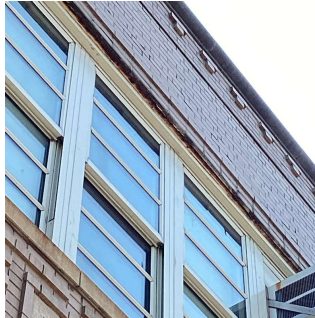
Facade A  
No violations recorded.

STEEL: MAJOR RUSTING

150  
L.F.  
REPLACE  
PRIORITY 4  
LEVEL 2

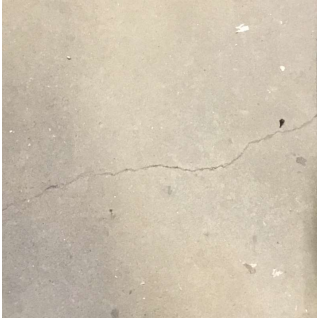
Boiler Room
Violations	No violations recorded.
Deficiency	CONCRETE SLAB ON GRADE: THRU CRACKS
Deficiency Location/Instance	Basement
Deficiency Quantity	10
Quantity Uom	S.F.
Potential Action	REPLACE
Urgency of Action	PRIORITY 4
Purpose of Action	LEVEL 5
Deficiency Photo1

Question	Response
<b>INTERIOR</b>	
<b>STRUCTURAL</b>	
<b>FLOOR STRUCTURE</b>	Inspected
Condition	3 - Fair
Deficiency	CONCRETE SLAB ON GRADE: THRU CRACKS
Deficiency Location/Instance	Basement
Deficiency Quantity	35
Quantity Uom	S.F.
Potential Action	REPAIR
Urgency of Action	PRIORITY 3
Purpose of Action	LEVEL 5
Deficiency Photo1

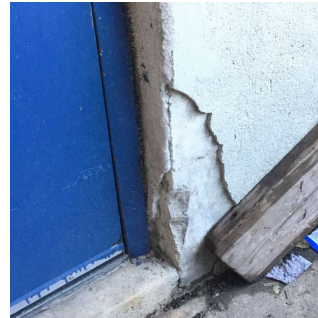
AW3

Boiler Room
Violations	No violations recorded.
<b>FOUNDATION WALLS</b>	Inspected
Material Type(s)	Concrete
Condition	4 - Between Fair and Poor
Deficiency	CONCRETE: CRACKED/SPALLED/REINFORCEMENT EXPOSED
Deficiency Location/Instance	Basement
Deficiency Quantity	15
Quantity Uom	S.F.
Potential Action	REPAIR
Urgency of Action	PRIORITY 3

LEVEL 5

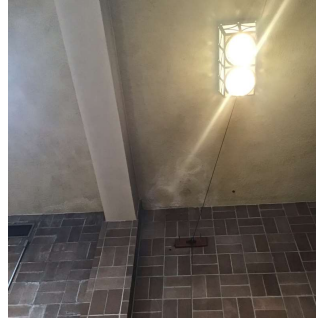
Near Entrance

Room 202
Violations	No violations recorded.
<b>Specialties</b>	Does not Exist
<b>GYMNASIUM</b>	Inspected
Instance on 1st Floor	Inspected
<b>Ceiling</b>	
Instance on 1st Floor	Inspected
Condition	2 - Between Good and Fair
Deficiency	PLASTER: CRACKS/SPALLING - ACTIVE LEAK

Deficiency Location/Instance	Near Windows , Entrance, Stage
Deficiency Quantity	50
Quantity Uom	S.F.

Potential Action	REPLACE
Urgency of Action	PRIORITY 5
Purpose of Action	LEVEL 2
Deficiency Photo1

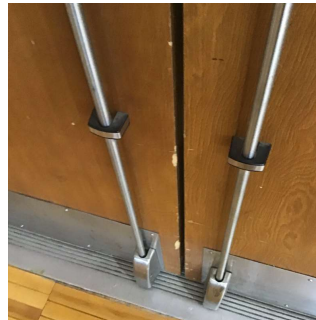
Near Entrance

Instance on 1st Floor	Inspected
Condition	5 - Poor
Deficiency	WOOD: DETERIORATED DOOR
Deficiency Location/Instance	Near Entrance, stage
Deficiency Quantity	8
Quantity Uom	EACH
Potential Action	MAINTENANCE
Urgency of Action	PRIORITY 3
Purpose of Action	LEVEL 2
Deficiency Photo1

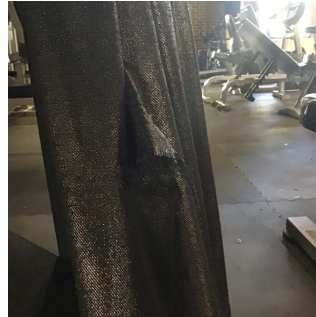
Right side  
 No violations recorded.

Instance on 1st Floor	Inspected
Condition	4 - Between Fair and Poor
Deficiency	WORN/DETERIORATED
Deficiency Location/Instance	Right side, left side
Deficiency Quantity	300
Quantity Uom	S.F.
Potential Action	REPLACE
Urgency of Action	PRIORITY 3
Purpose of Action	LEVEL 2
Deficiency Photo1

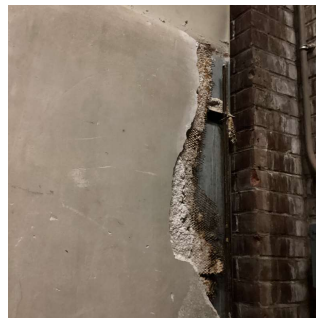
Instance on 1st Floor	Inspected
Condition	2 - Between Good and Fair
Deficiency	PLASTER: CRACKS/SPALLING
Deficiency Location/Instance	Rear of Stage
Deficiency Quantity	30
Quantity Uom	S.F.
Potential Action	REPLACE
Urgency of Action	PRIORITY 5
Purpose of Action	LEVEL 6
Deficiency Photo1

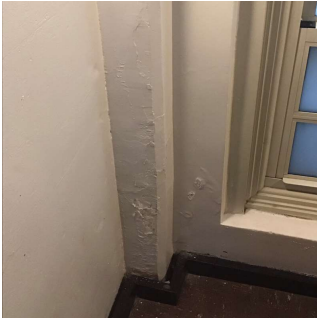
Question	Response
<b>INTERIOR</b>	
<b>GYMNASIUM</b>	
<b>Walls</b>	
Violations	No violations recorded.
Deficiency	PLASTER: CRACKS/SPALLING
Deficiency Location/Instance	Near exit 6
Deficiency Quantity	10
Quantity Uom	S.F.
Potential Action	REPLACE
Urgency of Action	PRIORITY 3
Purpose of Action	LEVEL 2
Deficiency Photo1

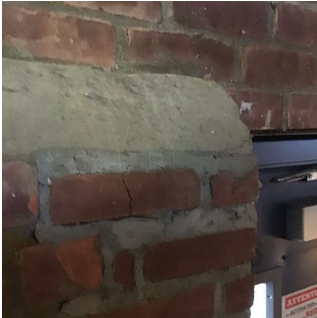
Violations	Near exit 6 No violations recorded.
Deficiency	BRICK: CRACKS/SPALLING
Deficiency Location/Instance	Near exit 6
Deficiency Quantity	10
Quantity Uom	S.F.
Potential Action	REPLACE
Urgency of Action	PRIORITY 3
Purpose of Action	LEVEL 2
Deficiency Photo1

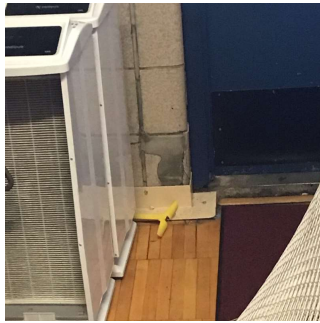
Violations	Near exit 6 No violations recorded.
Deficiency	GLAZED BLOCK: CRACKS/SPALLING
Deficiency Location/Instance	Near exit 3
Deficiency Quantity	10
Quantity Uom	S.F.
Potential Action	REPLACE
Urgency of Action	PRIORITY 3
Purpose of Action	LEVEL 2

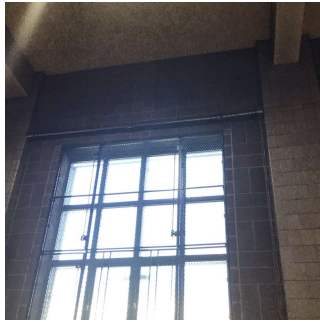
Violations	Near exit 3 No violations recorded.
<b>Window Curtains/Shades/Blinds</b>	
Instance on 1st Floor	Inspected
Condition	4 - Between Fair and Poor
Deficiency	WORN/DAMAGED CURTAINS
Deficiency Location/Instance	Windows
Deficiency Quantity	600
Quantity Uom	S.F.
Potential Action	MAINTENANCE
Urgency of Action	PRIORITY 3
Purpose of Action	LEVEL 2
Deficiency Photo1

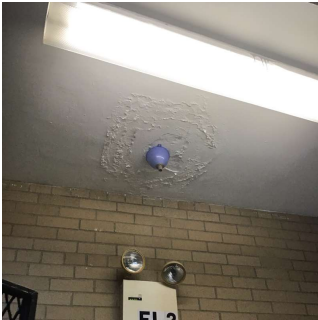
Question	Response
<b>INTERIOR</b>	
<b>STAIRS/RAMPS: INTERIOR</b>	
Do Letter Stair Signs Exist?	Partially
<b>Ceiling</b>	Inspected
Condition	2 - Between Good and Fair
Deficiency	PLASTER: CRACKS/SPALLING
Deficiency Location/Instance	Stair A/2, B/2
Deficiency Quantity	20
Quantity Uom	S.F.
Potential Action	REPLACE
Urgency of Action	PRIORITY 3
Purpose of Action	LEVEL 2
Deficiency Photo1

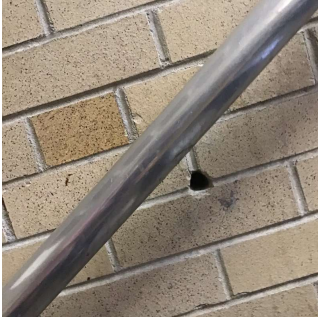
Violations	Stair A/2 No violations recorded.
<b>Door(s)</b>	Inspected
Condition	2 - Between Good and Fair
Deficiency	No deficiencies recorded
<b>Partition</b>	Does not Exist
<b>Railings</b>	Inspected
Condition	3 - Fair
Deficiency	METAL: BROKEN BRACKET
Deficiency Location/Instance	Stair A/1, Basement, B/2,1, Basement, and others
Deficiency Quantity	6
Quantity Uom	EACH
Potential Action	REPLACE
Urgency of Action	PRIORITY 3
Purpose of Action	LEVEL 2
Deficiency Photo1

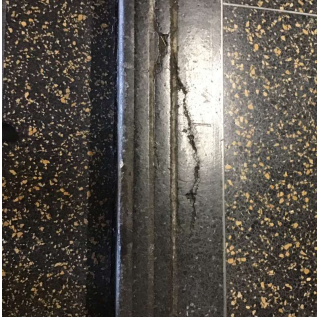
Condition	2 - Between Good and Fair
Deficiency	TERRAZZO: CRACKS

Question	Response
<b>INTERIOR</b>	
<b>STAIRS/RAMPS: INTERIOR</b>	
<b>Stairs and Landings</b>	
Deficiency Location/Instance	Stairs A/Basement, B/1, Basement
Deficiency Quantity	20
Quantity Uom	S.F.
Potential Action	REPLACE
Urgency of Action	PRIORITY 3
Purpose of Action	LEVEL 2
Deficiency Photo1

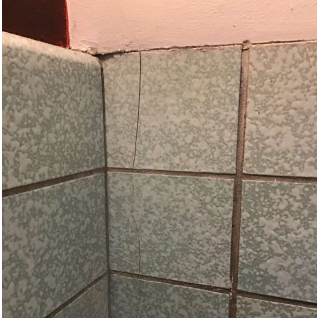
Violations	Stair A/Basement No violations recorded.
<b>Walls</b>	Inspected
Condition	2 - Between Good and Fair
Deficiency	GLAZED BLOCK: CRACKS/SPALLING
Deficiency Location/Instance	Stair C/1
Deficiency Quantity	10
Quantity Uom	S.F.
Potential Action	REPLACE
Urgency of Action	PRIORITY 3
Purpose of Action	LEVEL 2
Deficiency Photo1

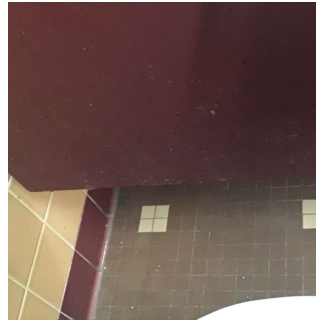
2nd Floor - Women

RUST - MAJOR

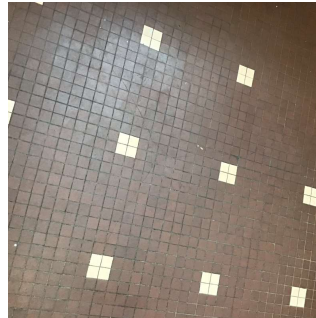
1st Floor - Girls

CERAMIC TILE: BROKEN/MISSING TILES

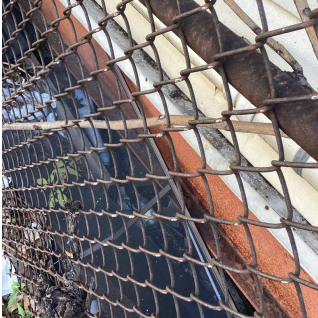
Question	Response
<b>SITE</b>	
<b>FENCES</b>	
Deficiency	CHAIN LINK: RUST - MAJOR
Deficiency Location/Instance	Parking Lot
Deficiency Quantity	1,500
Quantity Uom	S.F.
Potential Action	REPLACE
Urgency of Action	PRIORITY 3
Purpose of Action	LEVEL 2
Deficiency Photo1

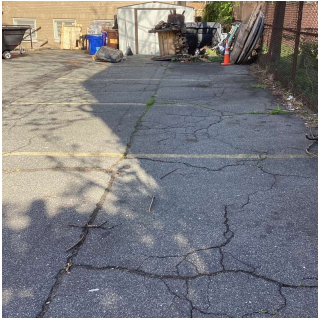
Violations	Parking Lot No violations recorded.
<b>IRRIGATION SYSTEM</b>	
	Does not Exist
<b>PAVING</b>	
	Inspected
<b>Student Non-Use</b>	
Gravel Exists?	Inspected No
<b>Asphalt</b>	
Condition	Inspected 4 - Between Fair and Poor
Deficiency	CRACKS - MAJOR
Deficiency Location/Instance	Parking lot
Deficiency Quantity	1,600
Quantity Uom	S.F.
Potential Action	REPLACE
Urgency of Action	PRIORITY 3
Purpose of Action	LEVEL 2
Deficiency Photo1

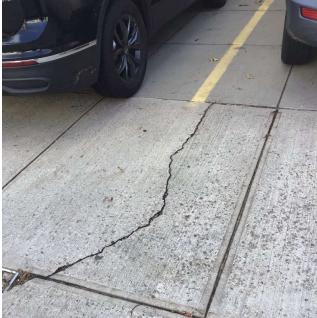
Violations	Parking Lot No violations recorded.
<b>Concrete</b>	
Condition	Inspected 3 - Fair
Deficiency	DAMAGED/DETERIORATED/MISSING SECTIONS
Deficiency Location/Instance	Parking lot
Deficiency Quantity	250
Quantity Uom	S.F.

Question	Response
<b>SITE</b>	
<b>PAVING</b>	
<b>Student Non-Use</b>	
<b>Concrete</b>	
Potential Action	REPLACE
Urgency of Action	PRIORITY 3
Purpose of Action	LEVEL 2
Deficiency Photo1

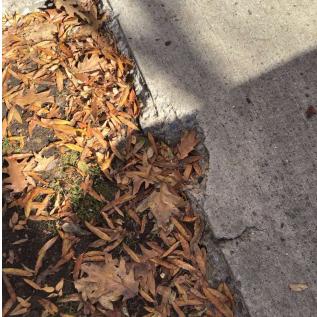
Violations	Parking lot No violations recorded.
<b>Pavers</b>	Does not Exist
<b>Student Use</b>	Does not Exist
<b>Site Sidewalks &amp; Walkways</b>	Inspected
<b>Asphalt</b>	Does not Exist
<b>Concrete</b>	Inspected
Condition	2 - Between Good and Fair
Deficiency	DAMAGED/DETERIORATED/MISSING SECTIONS
Deficiency Location/Instance	Near exit 6
Deficiency Quantity	25
Quantity Uom	S.F.
Potential Action	REPLACE
Urgency of Action	PRIORITY 3
Purpose of Action	LEVEL 2
Deficiency Photo1	 
Violations	Near exit 6 No violations recorded.
<b>Pavers</b>	Does not Exist
<b>DOT Sidewalk</b>	Inspected
<b>Asphalt</b>	Does not Exist
<b>Concrete</b>	Inspected
Condition	3 - Fair
Deficiency	DAMAGED/DETERIORATED/MISSING SECTIONS
Deficiency Location/Instance	Along 41st Street

Question	Response
<b>SITE</b>	
<b>PAVING</b>	
<b>DOT Sidewalk</b>	
<b>Concrete</b>	
Deficiency Quantity	425
Quantity Uom	S.F.
Potential Action	REPLACE
Urgency of Action	PRIORITY 3
Purpose of Action	LEVEL 2
Deficiency Photo1

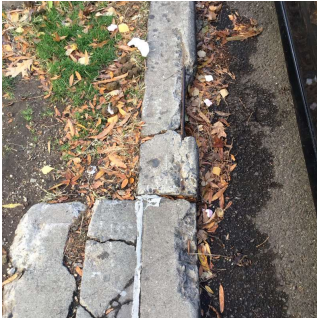
Violations	Along 41st Street No violations recorded.
Deficiency	DAMAGED CURBS
Deficiency Location/Instance	Along 41st Street
Deficiency Quantity	60
Quantity Uom	L.F.
Potential Action	REPLACE
Urgency of Action	PRIORITY 3
Purpose of Action	LEVEL 2
Deficiency Photo1
