NYC Department of Education
Building Condition Assessment Survey 2023 - 2024

Architectural Inspection

K783

Asset: CHARTER SCHOOL FOR EXCELLENCE -K, 239 PATCHEN AVENUE, New York, 11233

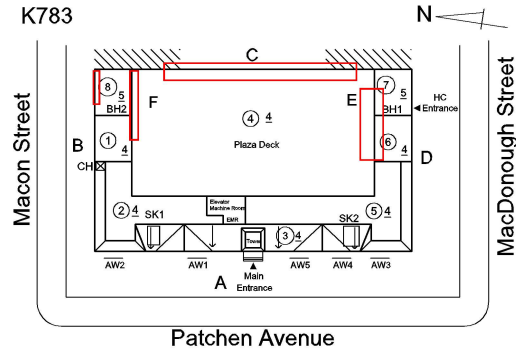
CAST STONE: DETERIORATED TRANSVERSE JOINTS

40
 L.F.
 MAINTENANCE
 PRIORITY 3
 LEVEL 2

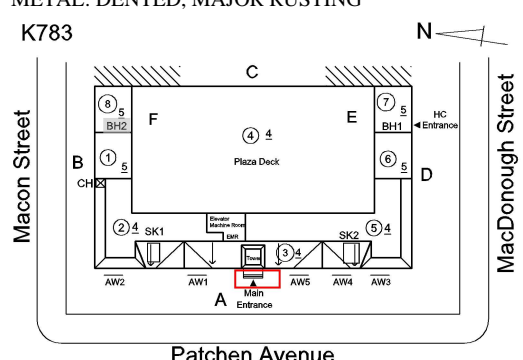
Question	Response
EXTERIOR	
CORNICE	Inspected
Condition	2 - Between Good and Fair
Deficiency	No deficiencies recorded
DOORS	Inspected
DOORS AND FRAMES	Inspected
Condition	2 - Between Good and Fair
Deficiency	No deficiencies recorded
DOOR HARDWARE	Inspected
Condition	3 - Fair
Deficiency	No deficiencies recorded
LINTELS	Inspected
Condition	2 - Between Good and Fair
Deficiency	No deficiencies recorded
TRANSOM/SIDE LIGHT	Inspected
Condition	3 - Fair
Deficiency	METAL: DENTED, MAJOR RUSTING
Roof Plan reference	<p>K783</p>

Deficiency Quantity	10
Quantity Uom	S.F.
Potential Action	REPLACE
Urgency of Action	PRIORITY 4
Purpose of Action	LEVEL 2
Deficiency Photo1

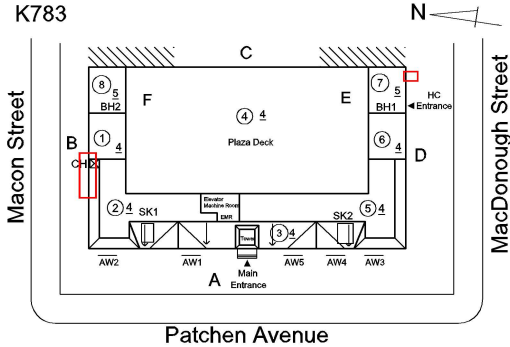
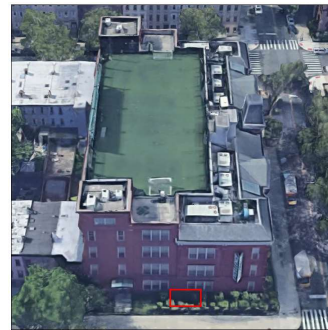
STONE: CHIPPED/SPALLED/BROKEN PIECES - MAJOR

20

REPLACE

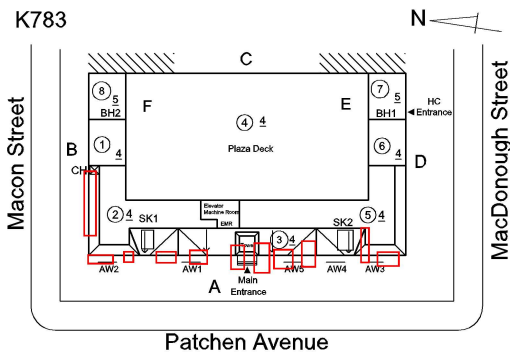
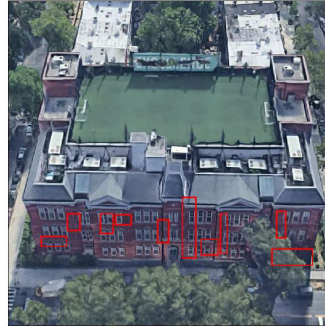
BRICK: EFFLORESCENCE

150

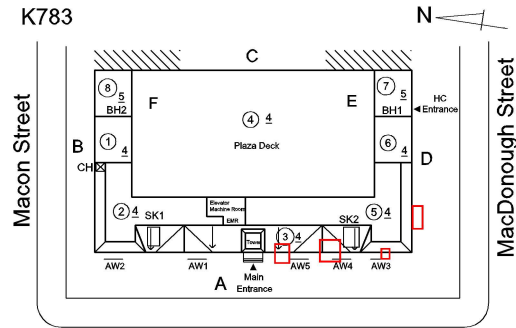
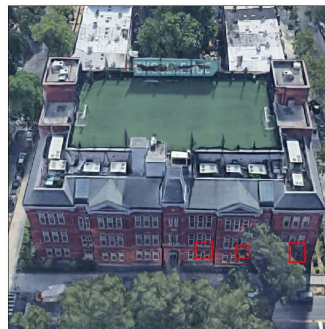
BRICK: DETERIORATED JOINTS

40

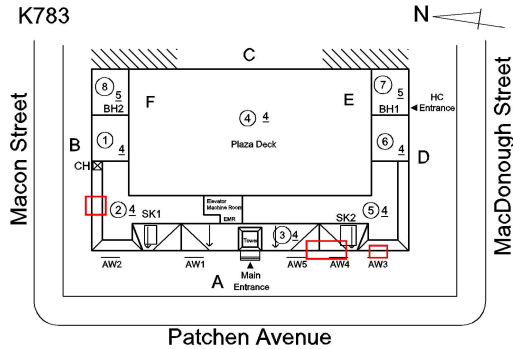
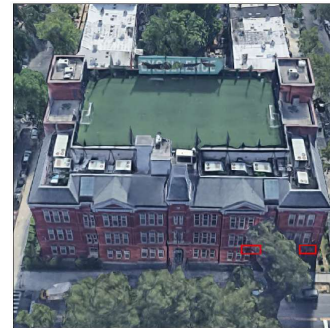
STONE: CHIPPED/SPALLED/BROKEN PIECES - MINOR

30

REPAIR

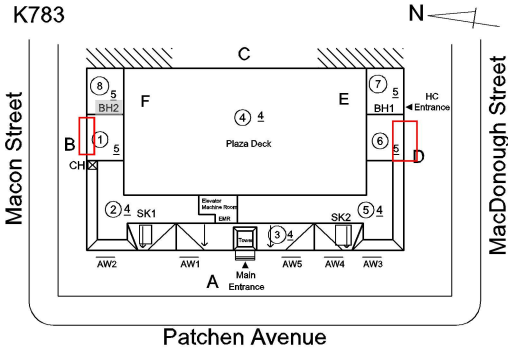
Deficiency	CONCRETE: MINOR CRACKS, SPALLING
------------	----------------------------------

90

REPAIR

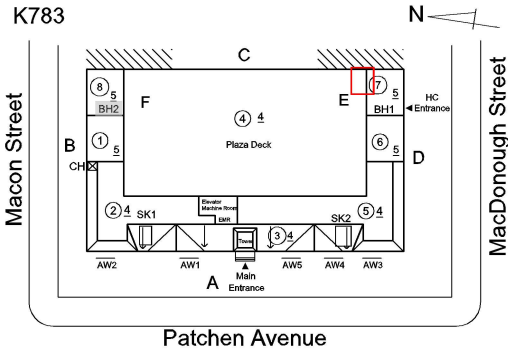
Deficiency	DAMAGED/MISSING
------------	-----------------

Deficiency Quantity	10
Quantity Uom	L.F.
Potential Action	REPLACE
Urgency of Action	PRIORITY 4
Purpose of Action	LEVEL 2
Deficiency Photo1

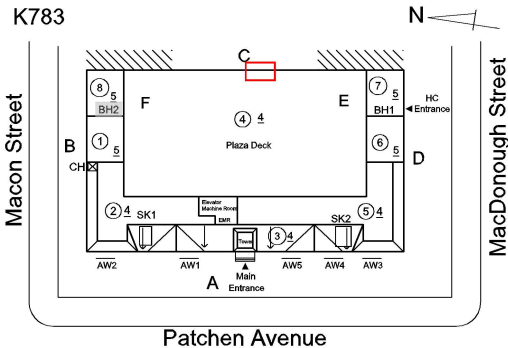
Deficiency	CHAIN LINK: DETERIORATED, MAJOR RUSTING
------------	---

Deficiency Quantity	10
Quantity Uom	S.F.

REPLACE
 PRIORITY 4
 LEVEL 2

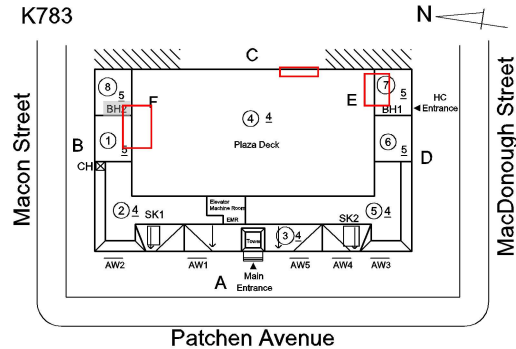
MESH: DETERIORATED

150
 S.F.
 REPLACE
 PRIORITY 4
 LEVEL 2

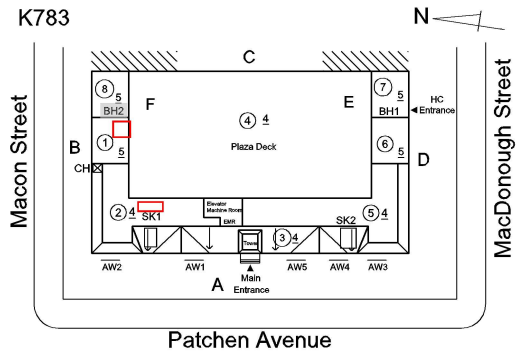
Installation Year	2006
Source of Installation	Custodial Staff
Deficiency	IRMA: ROOFING: DETERIORATED PAVERS WITH INTEGRAL INSULATION
Roof Plan reference	<p>K783</p>

Deficiency Quantity	20

S.F.
REPLACE
PRIORITY 4
LEVEL 2

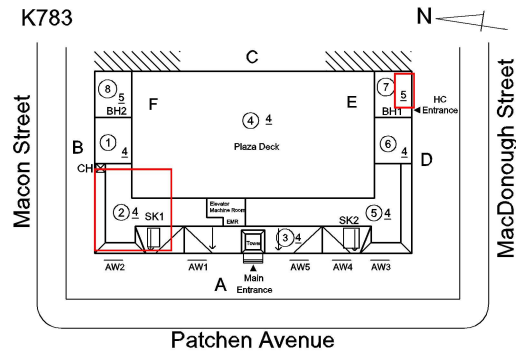
IRMA: ROOFING: DAMAGED INSULATION
K783

110
S.F.
REPLACE
PRIORITY 4
LEVEL 2

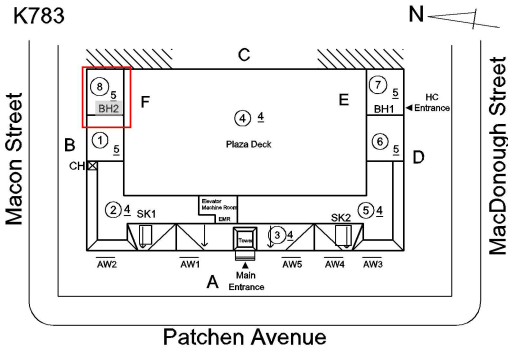
**BULKHEAD/PENTHOUSE WALLS/EXTERIOR:
CRACKS/SPALLING - MAJOR**

25
S.F.
REPLACE
PRIORITY 4
LEVEL 2

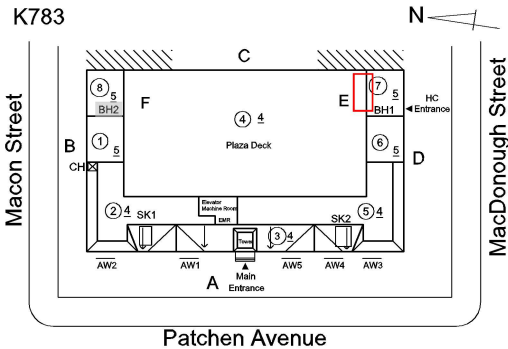
**BULKHEAD/PENTHOUSE WALLS/EXTERIOR: DAMAGED
METAL SIDING**

60
S.F.
REPLACE
PRIORITY 4
LEVEL 2

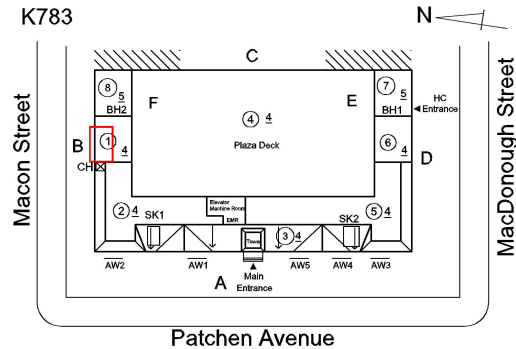
CAST IN PLACE CONCRETE: CRACKS/SPALLING - MINOR
K783

15

REPAIR

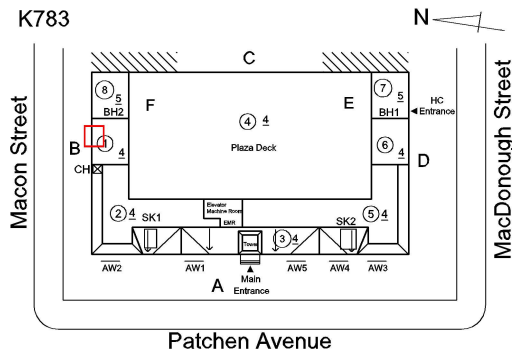
Violations	Facade B No violations recorded.
RAILINGS	Does not Exist
STAIRS/RAMPS	Inspected
Condition	3 - Fair
Deficiency	CONCRETE: CRACKS/SPALLING - MAJOR
Roof Plan reference	K783

Deficiency Quantity	10
Quantity Uom	S.F.
Potential Action	REPLACE
Urgency of Action	PRIORITY 4
Purpose of Action	LEVEL 2
Deficiency Photo1

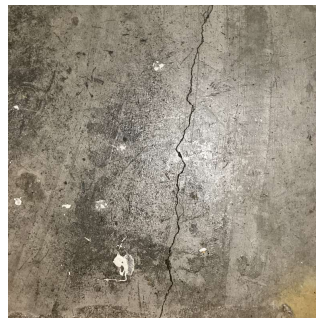
CONCRETE SLAB ON GRADE: THRU CRACKS

REPAIR

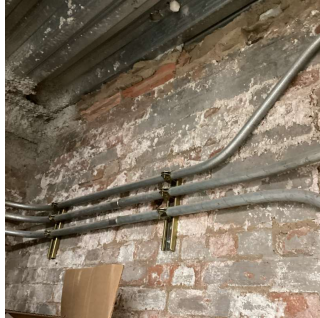
Violations	Basement - Electrical Room No violations recorded.
Deficiency	BRICK: CRACKED/SPALLED
Deficiency Location/Instance	Basement - Boiler Room
Deficiency Quantity	60

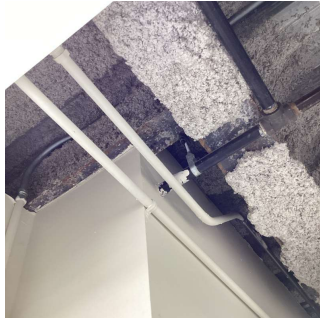
Violations	Basement - Electrical Room No violations recorded.
ROOF STRUCTURE	
Condition	Inspected
Deficiency	3 - Fair
Deficiency Location/Instance	STEEL COLUMNS/BEAMS: DETERIORATED/MISSING SPRAY-ON FIREPROOFING
Deficiency Quantity	Elevator Machine Room, Room 404
Quantity Uom	20
Potential Action	S.F.
Urgency of Action	REPLACE
Purpose of Action	PRIORITY 4
Deficiency Photo1	LEVEL 5
Violations

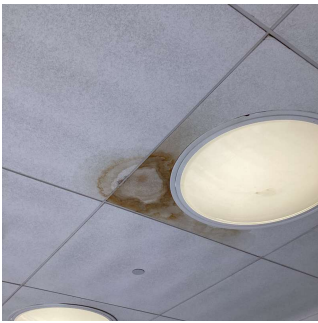
Question	Response
INTERIOR	
AUDITORIUM	
Stage	
Stage	Inspected
	Left Side
Violations	No violations recorded.
Stage Curtain Rigging	
Instance on Basement (500 Seats)	Inspected
Condition	2 - Between Good and Fair
Deficiency	No deficiencies recorded
Stage Curtains	
Instance on Basement (500 Seats)	Inspected
Condition	2 - Between Good and Fair
Deficiency	No deficiencies recorded
Walls	
Instance on Basement (500 Seats)	Inspected
Condition	2 - Between Good and Fair
Deficiency	No deficiencies recorded
Window Curtains/Shades/Blinds	
Instance on Basement (500 Seats)	Does not Exist
CAFETERIA	
Instance on 1st Floor	Inspected
Ceiling	
Instance on 1st Floor	Inspected
Condition	2 - Between Good and Fair
Deficiency	ACOUSTIC TILES: DAMAGED/MISSING
Deficiency Location/Instance	Near Windows
Deficiency Quantity	10
Quantity Uom	S.F.
Potential Action	REPLACE
Urgency of Action	PRIORITY 3
Purpose of Action	LEVEL 2
Deficiency Photo1

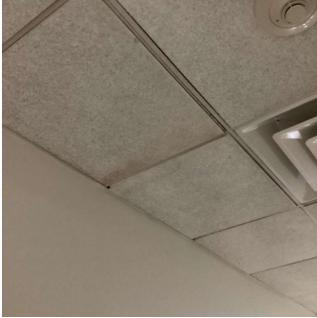
Question	Response
INTERIOR	
CAFETERIA	Inspected
Window Curtains/Shades/Blinds	
Instance on 1st Floor	Does not Exist
CLASSROOMS/CORRIDORS/ADMIN SPACES	
Ceiling	Inspected
Condition	2 - Between Good and Fair
Deficiency	GYPSUM BOARD: DAMAGED/DETERIORATED
Deficiency Location/Instance	Rooms 216, 108
Deficiency Quantity	20
Quantity Uom	S.F.
Potential Action	REPLACE
Urgency of Action	PRIORITY 3
Purpose of Action	LEVEL 2
Deficiency Photo1	 
Violations	Room 216 No violations recorded.
Deficiency	ACOUSTIC TILES: DAMAGED/MISSING
Deficiency Location/Instance	Corridor near Rooms 416, 412, 402, 304, 302 and others
Deficiency Quantity	70
Quantity Uom	S.F.
Potential Action	REPLACE
Urgency of Action	PRIORITY 3
Purpose of Action	LEVEL 2
Deficiency Photo1

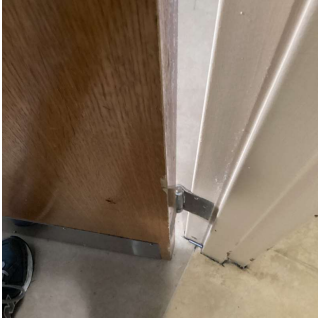
Violations	Corridor near Room 416 No violations recorded.
Door(s)	Inspected
Condition	5 - Poor
Deficiency	WOOD: DETERIORATED DOOR
Deficiency Location/Instance	Rooms 424, 414, 304, 302, 220 and others

Deficiency Quantity	8
Quantity Uom	EACH
Potential Action	MAINTENANCE

Question	Response
INTERIOR	
CLASSROOMS/CORRIDORS/ADMIN SPACES	Inspected
Door(s)	
Urgency of Action	PRIORITY 3
Purpose of Action	LEVEL 2
Deficiency Photo1

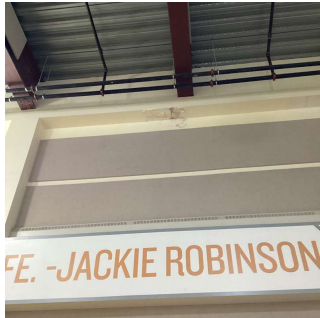
Question	Response
INTERIOR	
GYMNASIUM	
Floor Finish	
Condition	2 - Between Good and Fair
Deficiency	No deficiencies recorded
Seating	
Instance on 3rd Floor	Inspected
Condition	2 - Between Good and Fair
Deficiency	No deficiencies recorded
Sliding-folding Partition	
Instance on 3rd Floor	Does not Exist
Stage	
Instance on 3rd Floor	Does not Exist
Walls	
Instance on 3rd Floor	Inspected
Condition	2 - Between Good and Fair
Deficiency	GYPSUM BOARD: DETERIORATED
Deficiency Location/Instance	Near Windows, Left and Right Side, Near Entrance
Deficiency Quantity	60
Quantity Uom	S.F.
Potential Action	REPLACE
Urgency of Action	PRIORITY 3
Purpose of Action	LEVEL 2
Deficiency Photo1

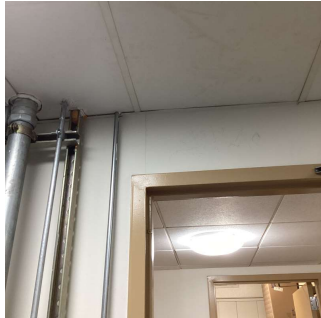
Question	Response
INTERIOR	
KITCHEN	
Floor Finish	
Instance on 1st Floor	Inspected
Condition	2 - Between Good and Fair
Deficiency	No deficiencies recorded
Walls	
Instance on 1st Floor	Inspected
Condition	2 - Between Good and Fair
Deficiency	GYPSUM BOARD: DETERIORATED
Deficiency Location/Instance	Near Entrance
Deficiency Quantity	10
Quantity Uom	S.F.
Potential Action	REPLACE
Urgency of Action	PRIORITY 3
Purpose of Action	LEVEL 2
Deficiency Photo1

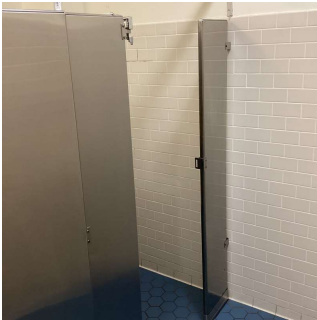
Room 301
Violations	No violations recorded.
Floor Finish	Inspected
Condition	2 - Between Good and Fair
Deficiency	No deficiencies recorded
Stalls	Inspected
Condition	5 - Poor
Deficiency	BROKEN/MISSING
Deficiency Location/Instance	Rooms 301, 224A, Boys Near Stairs B/1, C/1, 2 and others
Deficiency Quantity	12
Quantity Uom	EACH
Potential Action	REPLACE
Urgency of Action	PRIORITY 3
Purpose of Action	LEVEL 2
Deficiency Photo1

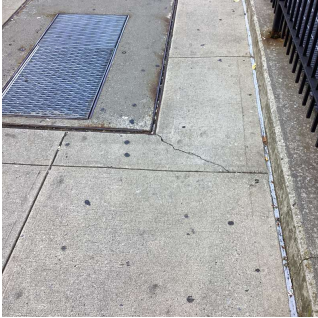
Question	Response
SITE	
PAVING	
Site Sidewalks & Walkways	Inspected
Asphalt	Does not Exist
Concrete	Inspected
Condition	2 - Between Good and Fair
Deficiency	No deficiencies recorded
Pavers	Does not Exist
DOT Sidewalk	Inspected
Asphalt	Does not Exist
Concrete	Inspected
Condition	3 - Fair
Deficiency	DAMAGED/DETERIORATED/MISSING SECTIONS
Deficiency Location/Instance	Patchen Avenue, McDonough Street
Deficiency Quantity	425
Quantity Uom	S.F.
Potential Action	REPLACE
Urgency of Action	PRIORITY 3
Purpose of Action	LEVEL 2
Deficiency Photo1
