NYC Department of Education
Building Condition Assessment Survey 2023 - 2024

Architectural Inspection

K787

Asset: **PRE-K CENTER @ 1215 AVENUE X-BROOKLYN, 1215 AVENUE X, New York, 11235**

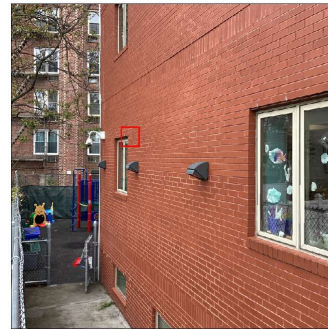
Elevation

Question	Response
EXTERIOR	
DOORS	
DOORS AND FRAMES	
Roof Plan reference	
Deficiency Quantity	10
Quantity Uom	L.F.
Potential Action	MAINTENANCE
Urgency of Action	PRIORITY 3
Purpose of Action	LEVEL 2
Deficiency Photo1	
Violations	Facade A - Main Entrance No violations recorded.
DOOR HARDWARE	Inspected
Condition	2 - Between Good and Fair
Deficiency	No deficiencies recorded
LINTELS	Inspected
Condition	2 - Between Good and Fair
Deficiency	No deficiencies recorded
TRANSOM/SIDE LIGHT	Inspected
Condition	2 - Between Good and Fair
Deficiency	No deficiencies recorded
EXTERIOR WALLS	Inspected
Material Type(s)	Masonry, Steel
Replacement Quantity	12,000
Replacement Uom	S.F.
Instance on All Facades	Inspected
Instance Condition	2 - Between Good and Fair
Instance Quantity	12,000
Instance Quantity Uom	S.F.
Deficiency	BRICK: MINOR CRACKS AND SPALLING
