NYC Department of Education
Building Condition Assessment Survey 2023 - 2024

Architectural Inspection

K798

Asset: CESIAH TORO MULLANE SCHOOL - K, 696 JAMAICA AVENUE, New York, 11208

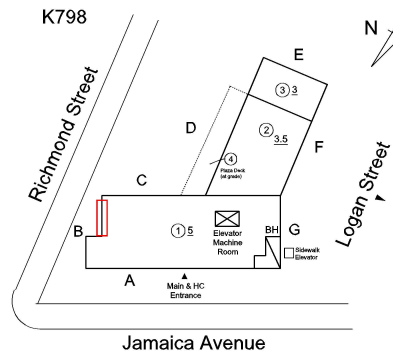
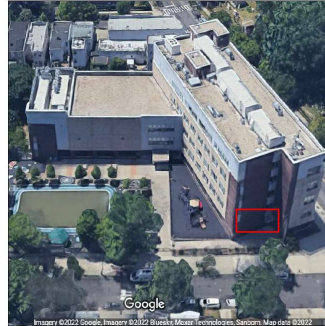
BRICK: EFFLORESCENCE

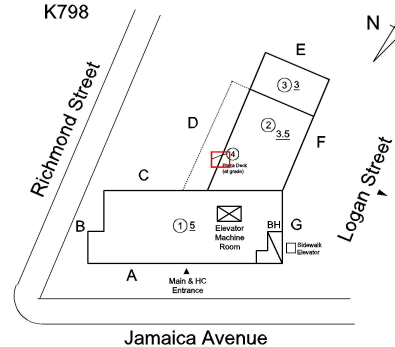
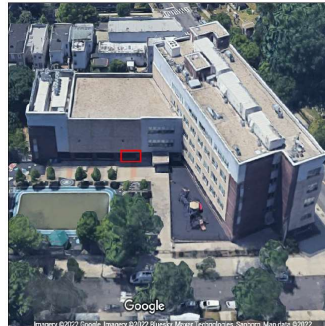
BRICK: DETERIORATED MASONRY SILLS - MINOR

REPAIR

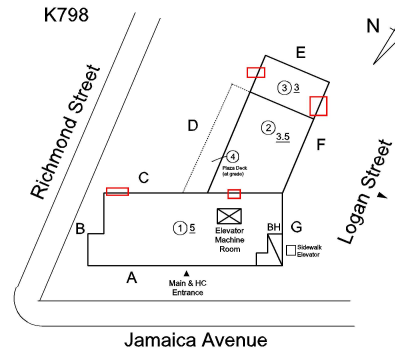
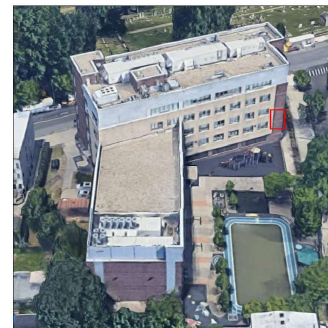
BRICK: DETERIORATED JOINTS

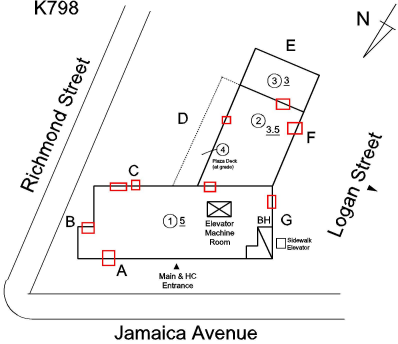
Question	Response
EXTERIOR	
EXTERIOR SOFFITS	Inspected
Condition	2 - Between Good and Fair
Deficiency	No deficiencies recorded
LOADING DOCK	Does not Exist
LOUVER	Inspected
Condition	2 - Between Good and Fair
Deficiency	No deficiencies recorded
PARAPETS	Inspected
Material Type(s)	Concrete
Replacement Quantity	4,500
Replacement Uom	C.F.
Instance on All Roofs	Inspected
Instance Condition	3 - Fair
Instance Quantity	4,500
Instance Quantity Uom	C.F.
Deficiency	CONCRETE: MINOR CRACKS, SPALLING
Roof Plan reference

Deficiency Quantity	80
Quantity Uom	S.F.
Potential Action	REPAIR
Urgency of Action	PRIORITY 3
Purpose of Action	LEVEL 2
Deficiency Photo1

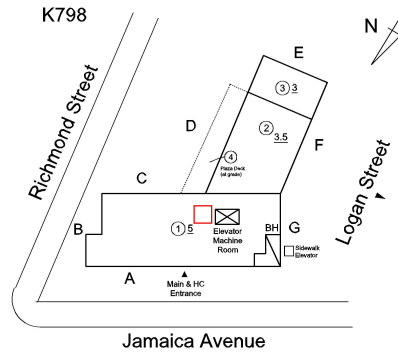
Deficiency	IRMA: ROOFING: MAJOR ACTIVE ROOF LEAKS IN NON-INSTRUCTIONAL SPACE

100
S.F.
REPLACE ROOFING WITHOUT MAJOR EQUIPMENT REMOVAL
PRIORITY 5
LEVEL 2

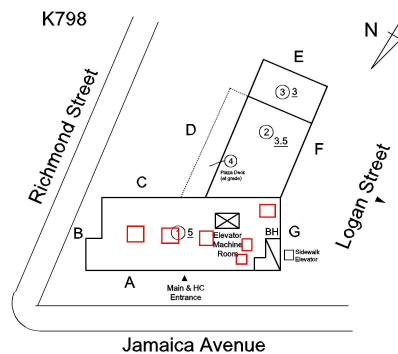
IRMA: ROOFING: MAJOR ACTIVE ROOF LEAKS IN INSTRUCTIONAL SPACE

600
S.F.
REPLACE ROOFING WITHOUT MAJOR EQUIPMENT REMOVAL
PRIORITY 5
LEVEL 2

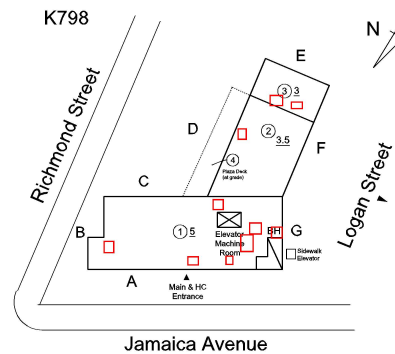
IRMA: ROOFING: DETERIORATED PAVERS WITH INTEGRAL INSULATION

REPLACE

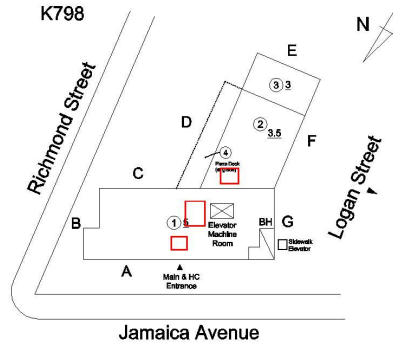
IRMA: ROOFING: MAJOR ACTIVE ROOF LEAKS IN INSTRUCTIONAL SPACE

300
 S.F.
 REPLACE ROOFING WITHOUT MAJOR EQUIPMENT
 REMOVAL
 PRIORITY 5
 LEVEL 4

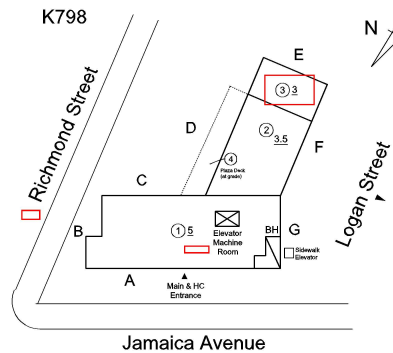
IRMA: FLASHING: BASE FLASHING DETERIORATED

20
 S.F.
 REPLACE
 PRIORITY 4
 LEVEL 2

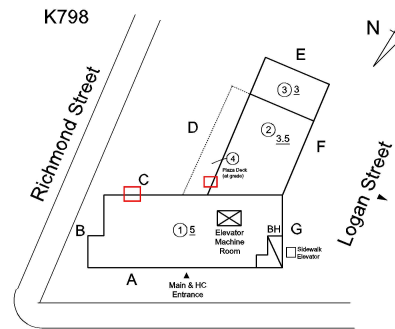
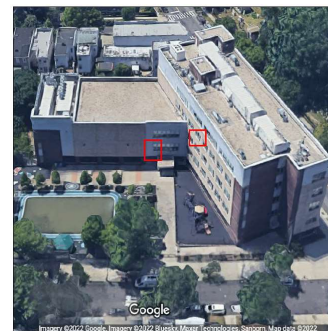
ALUMINUM - OTHER: AIR/WATER INFILTRATION, DETERIORATED JOINTS WITH DAMAGED CAULKING

100
L.F.
MAINTENANCE
PRIORITY 3
LEVEL 2

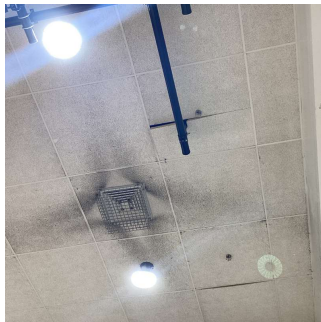
Violations	Corridor near Room 515 No violations recorded.
Specialties	Does not Exist
GYMNASIUM	
Instance on Basement	Inspected
Ceiling	
Instance on Basement	Inspected
Condition	2 - Between Good and Fair
Deficiency	TECTUM: DAMAGED/MISSING
Deficiency Location/Instance	Near Storage Room B02D
Deficiency Quantity	10
Quantity Uom	S.F.
Potential Action	REPLACE
Urgency of Action	PRIORITY 3
Purpose of Action	LEVEL 2
Deficiency Photo1

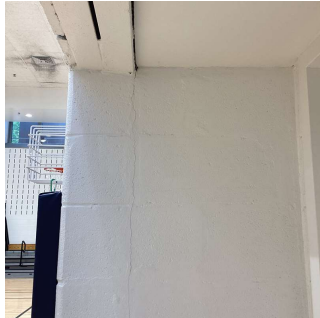
Question	Response
INTERIOR	
GYMNASIUM	
Sliding-folding Partition	
Deficiency	No deficiencies recorded
Stage	
Instance on Basement	Does not Exist
Walls	
Instance on Basement	Inspected
Condition	2 - Between Good and Fair
Deficiency	WALL PADDING: DETERIORATED
Deficiency Location/Instance	Near Storage Room B02D, Near Entrance, Near Room B02A
Deficiency Quantity	80
Quantity Uom	S.F.
Potential Action	REPLACE
Urgency of Action	PRIORITY 3
Purpose of Action	LEVEL 2
Deficiency Photo1	 
	Near Room B02A
Violations	No violations recorded.
Deficiency	MASONRY: CRACKS/SPALLING
Deficiency Location/Instance	Near Entrance
Deficiency Quantity	10
Quantity Uom	S.F.
Potential Action	REPLACE
Urgency of Action	PRIORITY 3
Purpose of Action	LEVEL 2
Deficiency Photo1

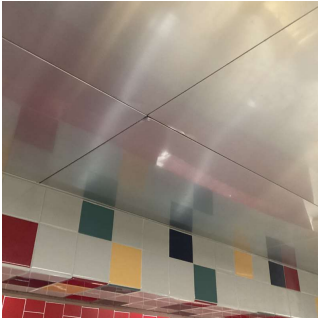
Violations	Stair A/5 No violations recorded.
KITCHEN	Inspected
Instance on Basement	Inspected
Ceiling	Inspected
Instance on Basement	Inspected
Condition	2 - Between Good and Fair
Deficiency	METAL PAN: DAMAGED/MISSING
Deficiency Location/Instance	Serving Area
Deficiency Quantity	10
Quantity Uom	S.F.
Potential Action	REPLACE
Urgency of Action	PRIORITY 3
Purpose of Action	LEVEL 2
Deficiency Photo1
