**NYC Department of Education
Building Condition Assessment Survey 2023 - 2024**

Architectural Inspection

K802

Asset: CENT HEADQTRS (131 LIV) - K, 131 LIVINGSTON STREET, New York, 11201

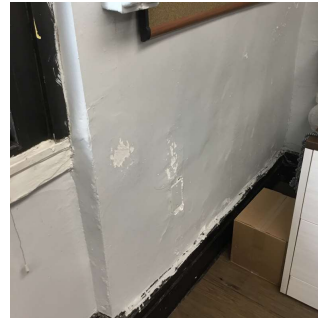
BRICK: WATER INFILTRATION IN INSTRUCTIONAL SPACE

Facade A - Room 501B (Facade A - Room 401B similar)

REPAIR

PRIORITY 5
LEVEL 2

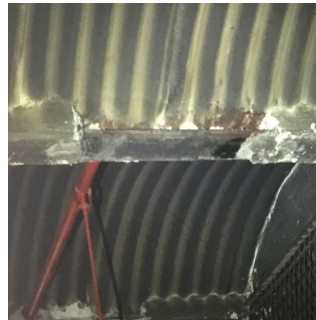
**STEEL COLUMNS/BEAMS: DETERIORATED/MISSING
PLASTER FIREPROOFING**

Basement Storage Room (Parking Garage, Oil Tank Room similar)

REPLACE

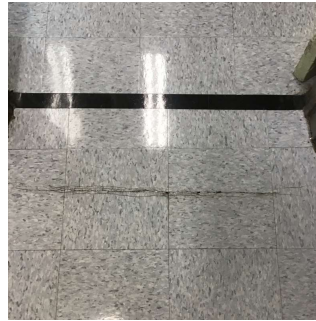
Corridor near Room 607

Violations	Room 604A No violations recorded.
Deficiency	VINYL TILES: DETERIORATED SUBSTRATE
Deficiency Location/Instance	Room 612,604, Corridor near Room 609,607,604, and others
Deficiency Quantity	120
Quantity Uom	S.F.
Potential Action	REPLACE
Urgency of Action	PRIORITY 3
Purpose of Action	LEVEL 2
