NYC Department of Education
Building Condition Assessment Survey 2023 - 2024

Architectural Inspection

K804

Asset: COBBLE HILL SCL OF AMR STD (OL6)-K, 347 BALTIC STREET, New York, 11201

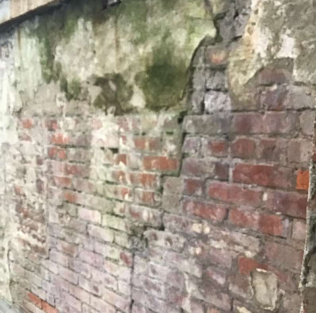
Violations	AW8 No violations recorded.
AWNINGS AND CANOPIES	Does not Exist
CHIMNEY	Inspected
Material Type(s)	Masonry
Condition	2 - Between Good and Fair
Deficiency	No deficiencies recorded
COPING	Inspected
Condition	3 - Fair
Deficiency	CAST STONE: DETERIORATED TRANSVERSE JOINTS

Question	Response
Architectural	
EXTERIOR	Inspected
AREAWAY	Inspected
Instance on AW1-AW10	Inspected
Instance Condition	3 - Fair
Instance Quantity	10
Instance Quantity Uom	EACH
Deficiency	AREAWAY WALLS: CRACKS AND SPALLING
Roof Plan reference

Deficiency Quantity	300
Quantity Uom	S.F.
Potential Action	REPAIR
Urgency of Action	PRIORITY 3
Purpose of Action	LEVEL 2
Deficiency Photo1

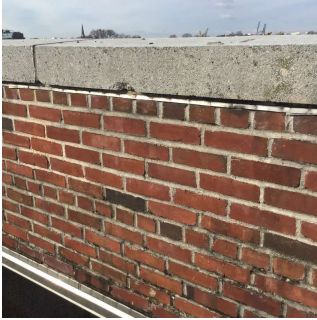
Violations	Facade J No violations recorded.
CORNICE	Inspected
Condition	2 - Between Good and Fair
Deficiency	No deficiencies recorded
DOORS	Inspected
DOORS AND FRAMES	Inspected
Condition	5 - Poor
Deficiency	METAL: DETERIORATED DOOR AND FRAME - MINOR DETERIORATION
Roof Plan reference

CAST STONE: CRACKED/BROKEN PIECES

REPLACE-IN-KIND

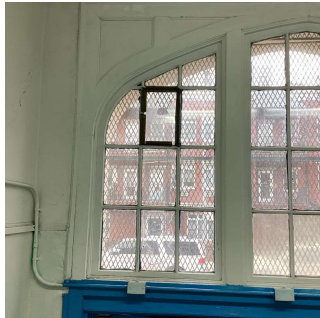
Violations	Facade E - Exit 2 No violations recorded.
EXTERIOR WALLS	Inspected

Violations	Facade L - Exit 4 No violations recorded.
DOOR HARDWARE	Inspected
Condition	3 - Fair
Deficiency	No deficiencies recorded
LINTELS	Inspected
Condition	2 - Between Good and Fair
Deficiency	No deficiencies recorded
TRANSOM/SIDE LIGHT	Inspected
Condition	3 - Fair
Deficiency	WOOD: BROKEN GLASS
Roof Plan reference	 
Deficiency Quantity	20
Quantity Uom	S.F.
Potential Action	MAINTENANCE
Urgency of Action	PRIORITY 3
Purpose of Action	LEVEL 2
Deficiency Photo1

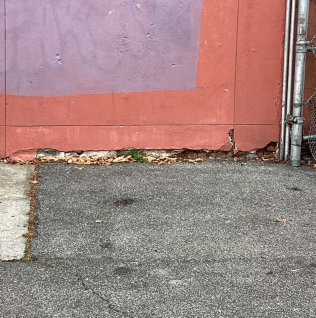
Violations	Facade J No violations recorded.
Deficiency	BRICK: EFFLORESCENCE

Question	Response
EXTERIOR	
EXTERIOR WALLS	
Material Type(s)	Concrete, Masonry
Replacement Quantity	52,000
Replacement Uom	S.F.
Instance on All Facades	Inspected
Instance Condition	4 - Between Fair and Poor
Instance Quantity	52,000
Instance Quantity Uom	S.F.
Deficiency	STUCCO CEMENT SURFACE: CRACKS, SPALLING
Roof Plan reference

Deficiency Quantity	50
Quantity Uom	S.F.
Potential Action	REPLACE
Urgency of Action	PRIORITY 4
Purpose of Action	LEVEL 2
Deficiency Photo1

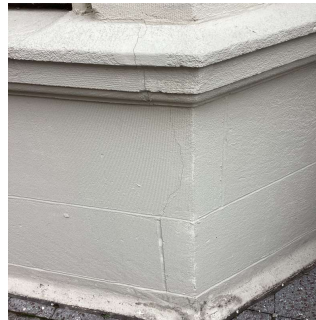
Facade L

STONE: CHIPPED/SPALLED/BROKEN PIECES - MINOR

REPAIR

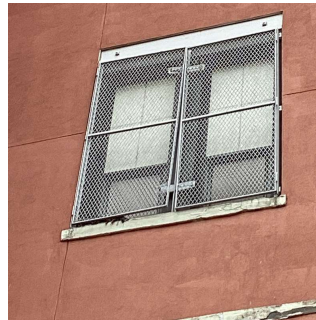
Facade J

BRICK: DETERIORATED MASONRY SILLS - MAJOR

REMOVE AND REPLACE

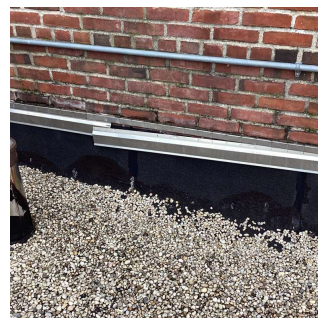
BUILT-UP: FLASHING: CAP FLASHING DAMAGED

REPLACE

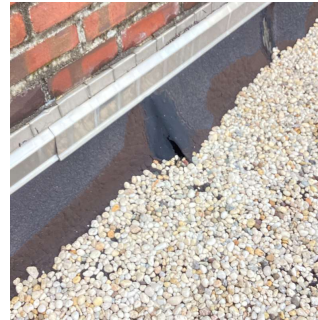
Facade D

BUILT-UP: FLASHING: BASE FLASHING DETERIORATED

REMOVE AND REPLACE

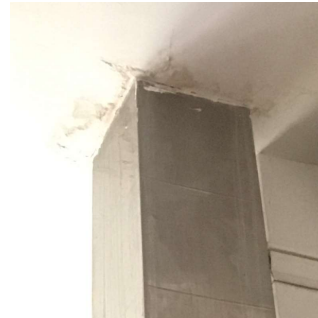
BUILT-UP: ROOFING: MAJOR ACTIVE ROOF LEAKS IN INSTRUCTIONAL SPACE

Roof 1 - 4th Floor Corridor near Room 411 (shown), Roof 1 - Room 406, Roof 2 - Cafeteria (similar)

REPLACE ROOFING WITHOUT MAJOR EQUIPMENT REMOVAL

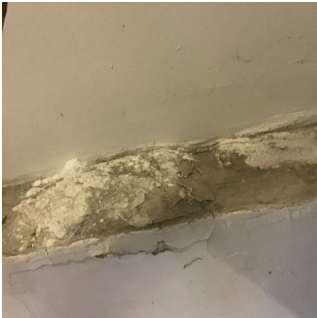
Violations	BH No violations recorded.
Deficiency	BULKHEAD/PENTHOUSE WINDOWS: AIR/WATER INFILTRATION WITH DAMAGED CAULKING
Roof Plan reference	 
Deficiency Quantity	30
Quantity Uom	L.F.
Potential Action	MAINTENANCE
Urgency of Action	PRIORITY 3
Purpose of Action	LEVEL 2
Deficiency Photo1

**BULKHEAD/PENTHOUSE WALLS/INTERIOR: PLASTER
CRACKS/SPALLING**

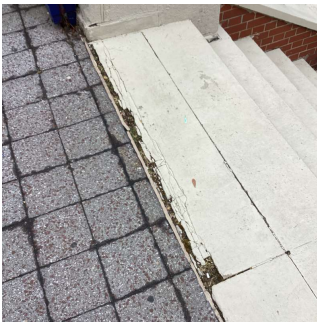
Violations	Baltic Street No violations recorded.
WINDOWS	Inspected
Replacement Quantity	13,000
Replacement Uom	S.F.
EXTERIOR GUARDS	Inspected
Condition	3 - Fair
Deficiency	DETERIORATED/TORN-OUT/MISSING

Violations	Baltic Street No violations recorded.
Deficiency	STONE: CRACKS/SPALLING - MAJOR
Roof Plan reference

Deficiency Quantity	40
Quantity Uom	S.F.
Potential Action	REPLACE
Urgency of Action	PRIORITY 4
Purpose of Action	LEVEL 2
Deficiency Photo1

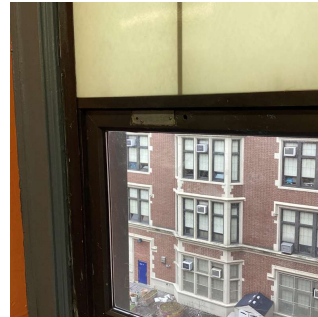
Facade L - Corridor near Room 415

ALUMINUM - OTHER: AIR/WATER INFILTRATION

20
L.F.
REPLACE TRIM, SILLS OR WEATHERSTRIPPING
PRIORITY 5
LEVEL 2

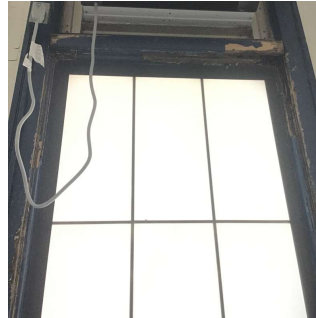
Facade L -Room 314

ALUMINUM - OTHER: BROKEN PANE

Question	Response
EXTERIOR	
WINDOWS	
WINDOWS	
Potential Action	MAINTENANCE
Urgency of Action	PRIORITY 3
Purpose of Action	LEVEL 2
Deficiency Photo1

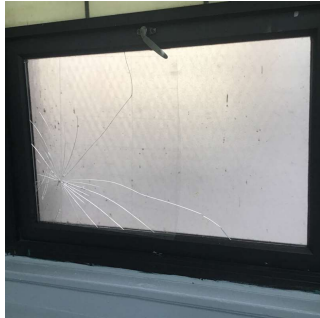
Facade L - Room 100
Violations	No violations recorded.
Instance on Steel: Boiler Room	Inspected
Instance Condition	5 - Poor
Instance Quantity	100
Instance Quantity Uom	S.F.
Are these windows insulated	No
Installation Year	1905
Source of Installation	Custodial Staff
Deficiency	STEEL: DETERIORATED
Roof Plan reference

Deficiency Quantity	100
Quantity Uom	S.F.
Potential Action	REPLACE WINDOW
Urgency of Action	PRIORITY 4
Purpose of Action	LEVEL 2

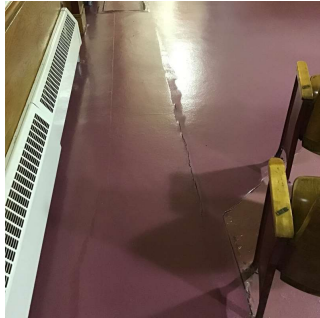
Question	Response
INTERIOR	
AUDITORIUM	
Fixed Seating	
Violations	No violations recorded.
Floor Finish	
Instance on Basement (842 Seats)	Inspected
Condition	2 - Between Good and Fair
Deficiency	SHEET VINYL: DETERIORATED SUBSTRATE
Deficiency Location/Instance	Right Aisle, Left Aisle
Deficiency Quantity	80
Quantity Uom	S.F.
Potential Action	REPLACE
Urgency of Action	PRIORITY 3
Purpose of Action	LEVEL 2
Deficiency Photo1

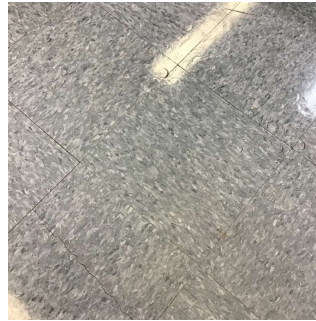
Center

VINYL TILES: DETERIORATED SUBSTRATE

REPLACE

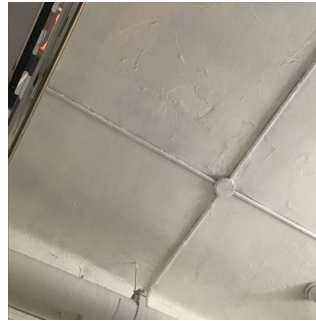
Room 418

PLASTER: CRACKS/SPALLING - ACTIVE LEAK

REPLACE

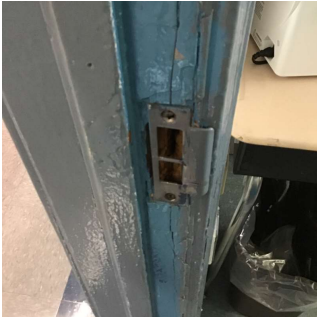
Question	Response
INTERIOR	
CLASSROOMS/CORRIDORS/ADMIN SPACES	
Door(s)	
Violations	Corridor near Room 104 No violations recorded.
Deficiency	WOOD: DETERIORATED DOOR AND FRAME
Deficiency Location/Instance	Room 400
Deficiency Quantity	1
Quantity Uom	EACH
Potential Action	MAINTENANCE
Urgency of Action	PRIORITY 3
Purpose of Action	LEVEL 2
Deficiency Photo1

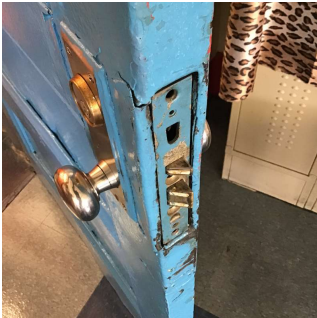
Violations	Room 400 No violations recorded.
Deficiency	METAL CLAD WOOD: DETERIORATED DOOR
Deficiency Location/Instance	Room 413
Deficiency Quantity	1
Quantity Uom	EACH
Potential Action	MAINTENANCE
Urgency of Action	PRIORITY 3
Purpose of Action	LEVEL 2
Deficiency Photo1

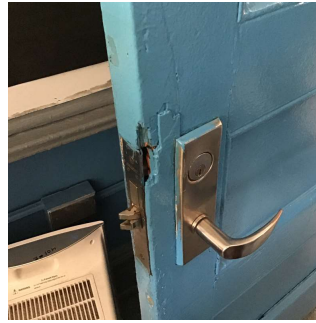
Room 401

WOOD: DAMAGED/DETERIORATED

REPLACE

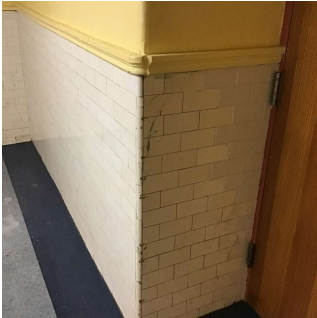
Question	Response
INTERIOR	
CLASSROOMS/CORRIDORS/ADMIN SPACES	
Walls	
Deficiency	CERAMIC TILE: BROKEN/ MISSING
Deficiency Location/Instance	Corridor near Auditorium
Deficiency Quantity	40
Quantity Uom	S.F.
Potential Action	REPLACE
Urgency of Action	PRIORITY 3
Purpose of Action	LEVEL 2
Deficiency Photo1

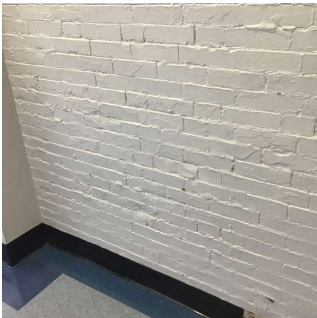
Violations	Corridor near Auditorium No violations recorded.
Deficiency	BRICK: CRACKS/SPALLING
Deficiency Location/Instance	Corridor near Room 103
Deficiency Quantity	50
Quantity Uom	S.F.
Potential Action	REPLACE
Urgency of Action	PRIORITY 3
Purpose of Action	LEVEL 2
Deficiency Photo1

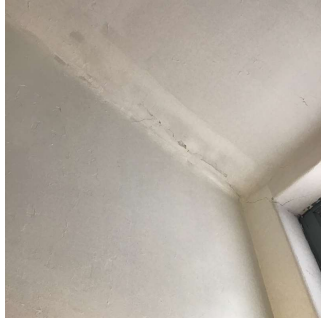
Question	Response
INTERIOR	
SCIENCE PREP ROOM	
Alternative use	Yes
Fixed Equipment	
Instance on Room 410	Inspected
Condition	2 - Between Good and Fair
Deficiency	No deficiencies recorded
SHOWER ROOM	
	Does not Exist
STAIRS/RAMPS: INTERIOR	
Do Letter Stair Signs Exist?	Inspected
	Partially
Ceiling	
Condition	Inspected
	2 - Between Good and Fair
Deficiency	PLASTER: CRACKS/SPALLING
Deficiency Location/Instance	Stair AB/4
Deficiency Quantity	20
Quantity Uom	S.F.
Potential Action	REPLACE
Urgency of Action	PRIORITY 3
Purpose of Action	LEVEL 2
Deficiency Photo1

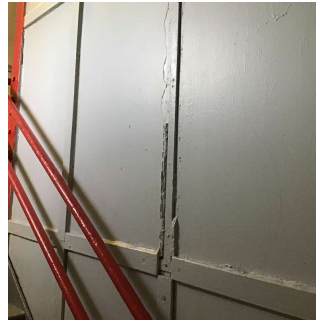
Stair EF/2

Stair AB/4
Violations	No violations recorded.
Door(s)	
	Inspected
Condition	2 - Between Good and Fair
Deficiency	No deficiencies recorded
Partition	
	Inspected
Condition	3 - Fair
Deficiency	METAL FRAME: DAMAGED/DETERIORATED
Deficiency Location/Instance	Stairs CD/3, EF/2,3
Deficiency Quantity	10
Quantity Uom	L.F.
Potential Action	REPLACE
Urgency of Action	PRIORITY 3
Purpose of Action	LEVEL 2

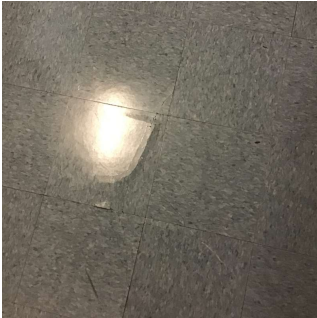
Violations	Stair N/1 No violations recorded.
Stairs and Landings	Inspected
Condition	2 - Between Good and Fair
Deficiency	VINYL TILES: DETERIORATED SUBSTRATE
Deficiency Location/Instance	Stair GH/2, Exit 1 Vestibule
Deficiency Quantity	20
Quantity Uom	S.F.
Potential Action	REPLACE
Urgency of Action	PRIORITY 3
Purpose of Action	LEVEL 2
Deficiency Photo1

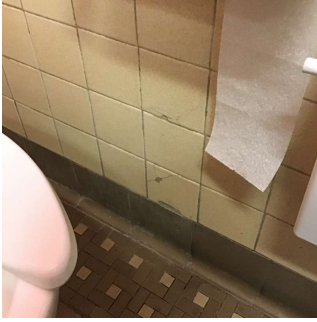
Question	Response
INTERIOR	
TOILET ROOMS - STAFF	
Walls	
Deficiency Photo1	 
Violations	In Room 101 No violations recorded.
Deficiency	CERAMIC TILE: BROKEN/ MISSING
Deficiency Location/Instance	In Rooms 101, 300, 318, Rooms 110H, 200
Deficiency Quantity	35
Quantity Uom	S.F.
Potential Action	REPLACE
Urgency of Action	PRIORITY 3
Purpose of Action	LEVEL 2
Deficiency Photo1

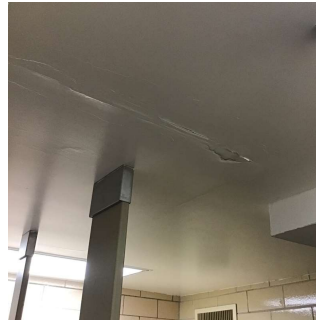
Violations	Room 110H No violations recorded.
TOILET ROOMS - STUDENTS	
Ceiling	Inspected
Condition	Inspected 2 - Between Good and Fair
Deficiency	GYPSUM BOARD: DAMAGED/DETERIORATED
Deficiency Location/Instance	Room B03
Deficiency Quantity	10
Quantity Uom	S.F.
Potential Action	REPLACE
Urgency of Action	PRIORITY 3
Purpose of Action	LEVEL 2

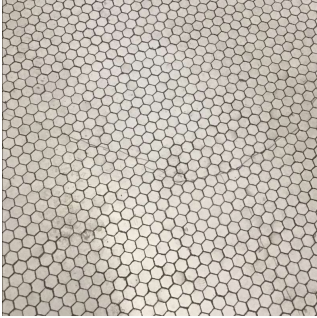
Question	Response
INTERIOR	
TOILET ROOMS - STUDENTS	
Door(s)	Inspected 3rd Floor Girls
Violations	No violations recorded.
Floor Finish	Inspected
Condition	2 - Between Good and Fair
Deficiency	CERAMIC TILE: BROKEN/MISSING TILES
Deficiency Location/Instance	Room 419, 2nd Floor Girls, 4th Floor Girls, In Room 206
Deficiency Quantity	45
Quantity Uom	S.F.
Potential Action	REPLACE
Urgency of Action	PRIORITY 3
Purpose of Action	LEVEL 2
Deficiency Photo1

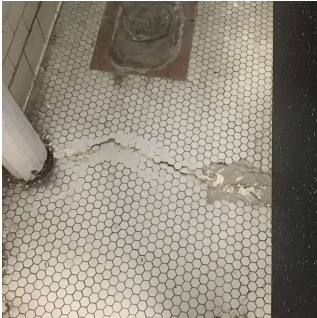
Violations	Room 419 No violations recorded.
Deficiency	CERAMIC TILE: DETERIORATED SUBSTRATE
Deficiency Location/Instance	Room 419
Deficiency Quantity	20
Quantity Uom	S.F.
Potential Action	REPLACE
Urgency of Action	PRIORITY 3
Purpose of Action	LEVEL 2
Deficiency Photo1

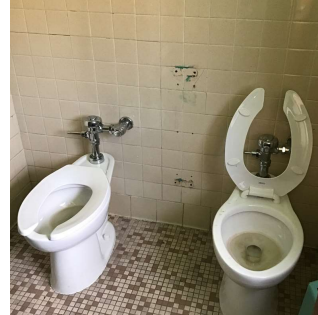
Violations	Room 419 No violations recorded.
Stalls	Inspected
Condition	3 - Fair
Deficiency	BROKEN/MISSING
Deficiency Location/Instance	In Room 206
Deficiency Quantity	2
Quantity Uom	EACH
Potential Action	REPLACE

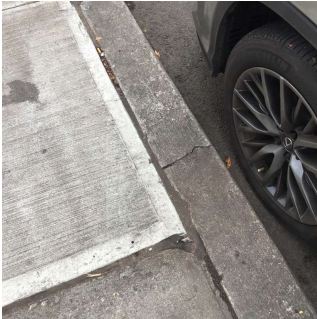
Question	Response
SITE	
PAVING	
DOT Sidewalk	
Asphalt	Does not Exist
Concrete	Inspected
Condition	2 - Between Good and Fair
Deficiency	DAMAGED CURBS
Deficiency Location/Instance	Baltic Street
Deficiency Quantity	10
Quantity Uom	L.F.
Potential Action	REPLACE
Urgency of Action	PRIORITY 3
Purpose of Action	LEVEL 2
Deficiency Photo1
