NYC Department of Education
Building Condition Assessment Survey 2023 - 2024

Architectural Inspection

K805

Asset: WATERS EDGE EDUCATIONAL COMPLEX - K, 49 FLATBUSH AVENUE EXT., New York, 11201

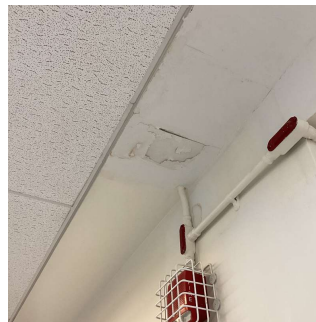
| Deficiency | IRMA: ROOFING: MAJOR ACTIVE ROOF LEAKS IN INSTRUCTIONAL SPACE |

Roof 1 - Corridor near Room 814 shown, Roof 1 - Rooms 812, 819, Corridor near Rooms 804, 806 similar

| Potential Action | REPLACE ROOFING WITHOUT MAJOR EQUIPMENT REMOVAL |

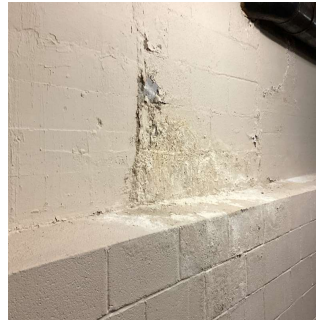
Oil Tank Room

| Question | Response |
|---|--|
| Deficiency | CONCRETE: WATER INFILTRATION IN NON- INSTRUCTIONAL SPACE |
