NYC Department of Education
Building Condition Assessment Survey 2023 - 2024

Architectural Inspection

K814

Asset: CYPRESS HILLS COMMUNITY SCHOOL - BROOKLYN, 265 WARWICK STREET, New York, 11207

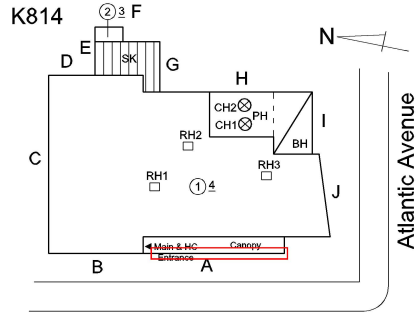
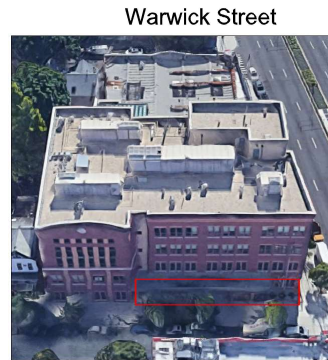
Deficiency	METAL PANEL: DETERIORATED JOINTS
Roof Plan reference	K814

Deficiency Quantity	10
Quantity Uom	L.F.
Potential Action	REPAIR
Urgency of Action	PRIORITY 3
Purpose of Action	LEVEL 2
Deficiency Photo1

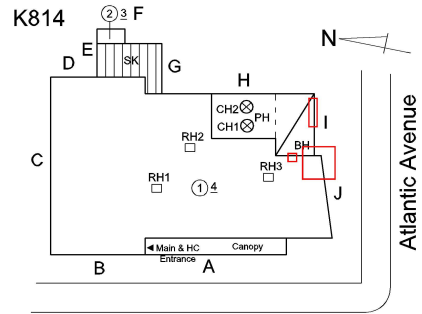
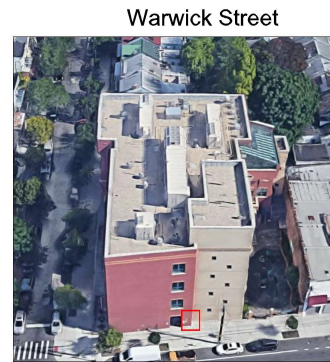
Deficiency	CAST IN PLACE / PRE-CAST CONCRETE: DETERIORATED JOINTS
------------	--

Deficiency Quantity

20

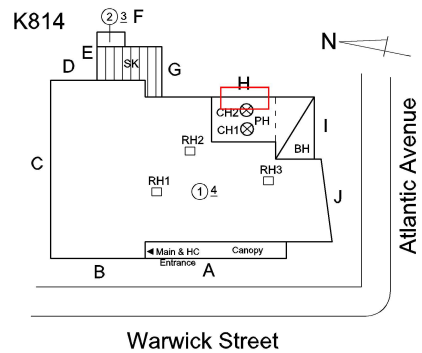
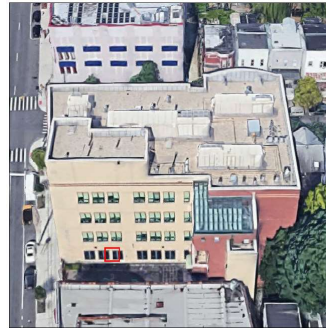
BRICK: MINOR CRACKS AND SPALLING

Deficiency Quantity

10

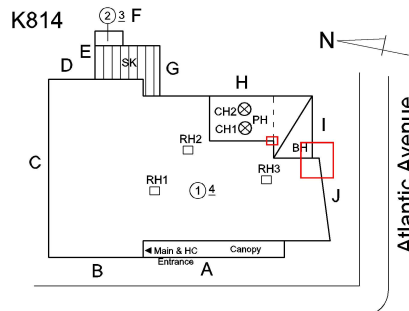
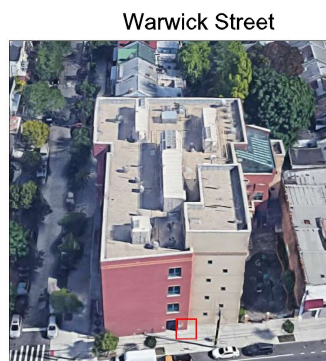
CAST IN PLACE / PRE-CAST CONCRETE: MAJOR CRACKS/SPALLING

Deficiency Quantity

10

Potential Action
Urgency of Action
Purpose of Action
Deficiency Photo1

REPLACE
PRIORITY 4
LEVEL 2

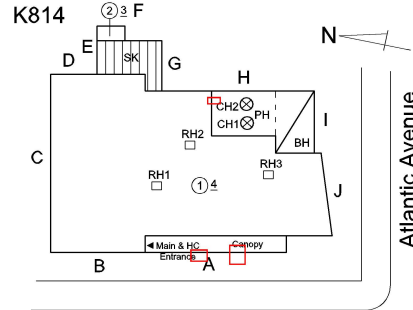
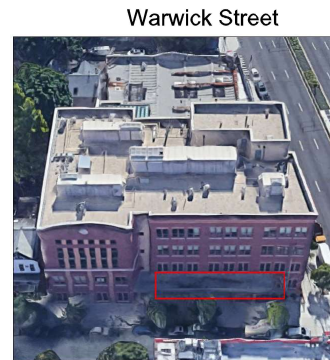
BRICK: DETERIORATED JOINTS

Deficiency Quantity
Quantity Uom
Potential Action
Urgency of Action
Purpose of Action
Deficiency Photo1

20
S.F.
REPOINT
PRIORITY 3
LEVEL 2
