NYC Department of Education
Building Condition Assessment Survey 2023 - 2024

Architectural Inspection

K819

Asset: EAST NY FAMILY ACADEMY - K, 2057 LINDEN BLVD, New York, 11207

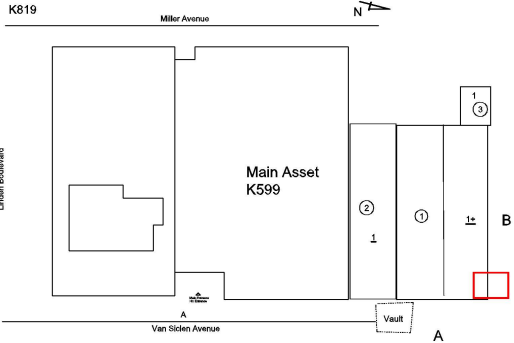
Question	Response
EXTERIOR	
STAIRS/RAMPS: EXTERIOR	
STAIRS/RAMPS	Inspected
Condition	3 - Fair
Deficiency	CONCRETE: CRACKS/SPALLING - MAJOR
Roof Plan reference

Deficiency Quantity	10
Quantity Uom	S.F.
Potential Action	REPLACE
Urgency of Action	PRIORITY 4
Purpose of Action	LEVEL 2
Deficiency Photo1
