NYC Department of Education
Building Condition Assessment Survey 2023 - 2024

Architectural Inspection

K834

Asset: P.S. 372 (OUR LADY OF PEACE)-K, 512 CARROLL STREET, New York, 11215

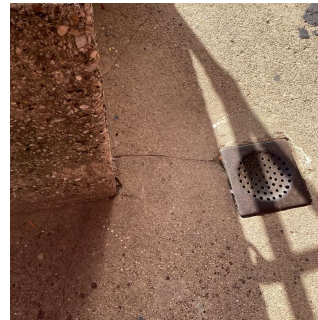
AW1
No violations recorded.

AREAWAY SLAB: CRACKS AND SPALLING

30
S.F.
REPAIR
PRIORITY 3
LEVEL 2

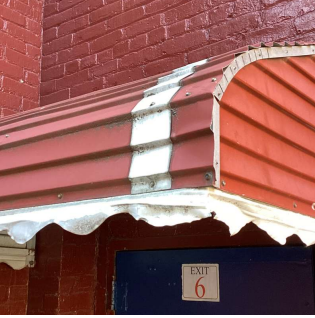
Question	Response
EXTERIOR	
AWNINGS AND CANOPIES	
Deficiency Photo1 Violations

<p>Facade B - Exit 6</p> <p>No violations recorded.</p>
CHIMNEY	
Material Type(s)	Inspected Masonry
Condition	3 - Fair
Deficiency Roof Plan reference Deficiency Quantity Quantity Uom Potential Action Urgency of Action Purpose of Action Deficiency Photo1	<p>BRICK: DETERIORATED JOINTS</p>

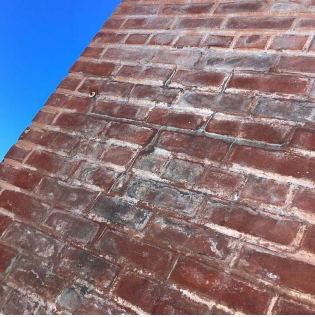
<p>CH</p>
Violations	<p>No violations recorded.</p>
Deficiency	BRICK: MINOR CRACKS AND SPALLING

Deficiency Quantity	15
Quantity Uom	S.F.
Potential Action	RESTITCH
Urgency of Action	PRIORITY 3
Purpose of Action	LEVEL 2
Deficiency Photo1

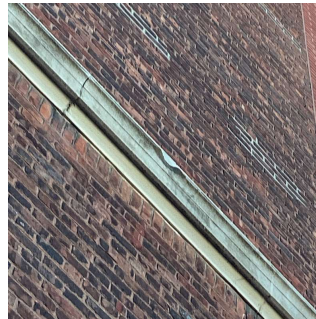
Facade D - Near Exit 9

STONE: MINOR CRACKS, SPALLING

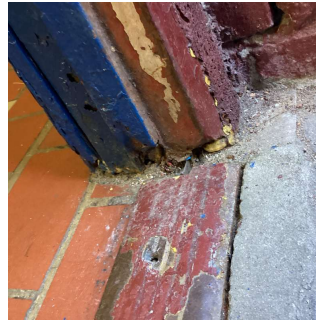
Facade B - Exit 6

METAL: DETERIORATED DOOR AND FRAME - MAJOR DETERIORATION

2
EACH
REPLACE
PRIORITY 4
LEVEL 2

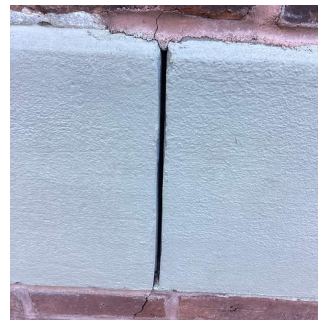
Facade D

STONE: DETERIORATED JOINTS

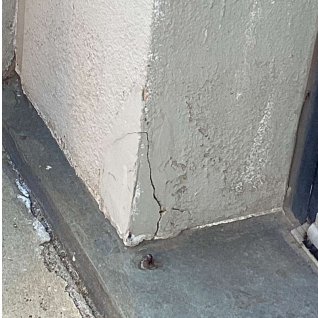
Question	Response
EXTERIOR	
EXTERIOR WALLS	
Urgency of Action	PRIORITY 3
Purpose of Action	LEVEL 2
Deficiency Photo1

Violations	Facade A - Main Entrance No violations recorded.
EXTERIOR SOFFITS	Does not Exist
LOADING DOCK	Does not Exist
LOUVER	Inspected
Condition	2 - Between Good and Fair
Deficiency	No deficiencies recorded
PARAPETS	Inspected
Material Type(s)	Masonry, Metal
Replacement Quantity	5,000
Replacement Uom	C.F.
Instance on All Facades	Inspected
Instance Condition	5 - Poor
Instance Quantity	5,000
Instance Quantity Uom	C.F.
Deficiency	BRICK: OUT OF PLUMB
Roof Plan reference

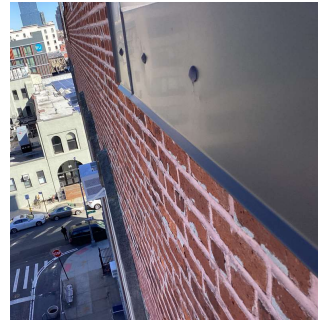
Facade D

Deficiency Quantity	220
Quantity Uom	C.F.
Potential Action	REMOVE AND REBUILD
Urgency of Action	PRIORITY 4
Purpose of Action	LEVEL 2

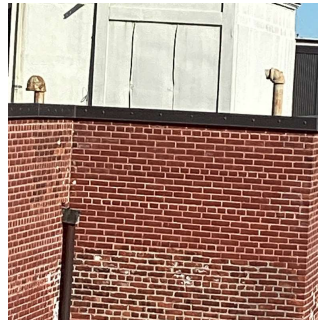
Facade B
No violations recorded.

BRICK: DETERIORATED JOINTS

600
S.F.
REPOINT
PRIORITY 3
LEVEL 2

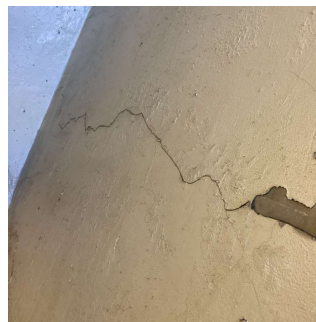
BH2
No violations recorded.

BULKHEAD/PENTHOUSE WALLS/INTERIOR: PLASTER CRACKS/SPALLING

50
S.F.
REPLACE
PRIORITY 3
LEVEL 2

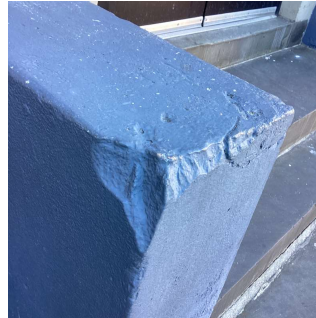
Facade D - Exit 8
No violations recorded.

CAST IN PLACE CONCRETE: CRACKS/SPALLING - MAJOR

Quantity Uom	S.F.
Potential Action	REPLACE
Urgency of Action	PRIORITY 4
Purpose of Action	LEVEL 2
Deficiency Photo1

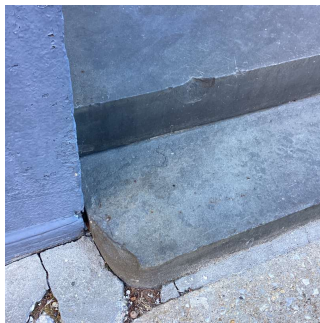
Question	Response
EXTERIOR	
STAIRS/RAMPS: EXTERIOR	
STAIRS/RAMPS	
Deficiency Photo1

Violations	Facade D - Exit 9 No violations recorded.
WINDOWS	
Replacement Quantity	Inspected 4,000
Replacement Uom	S.F.
EXTERIOR GUARDS	
Condition	Inspected 3 - Fair
Deficiency	RUST - MAJOR
Roof Plan reference

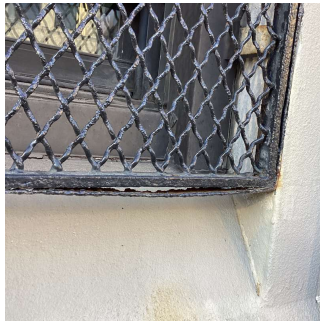
Deficiency Quantity	90
Quantity Uom	S.F.
Potential Action	REPLACE
Urgency of Action	PRIORITY 4
Purpose of Action	LEVEL 2

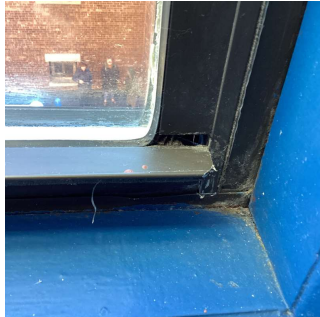
Violations	Facade A - Main Entrance No violations recorded.
LINTELS	Inspected
Condition	2 - Between Good and Fair
Deficiency	No deficiencies recorded
WINDOWS	Inspected
Material Type(s)	Aluminum, Solid Wood
Instance on Aluminum - Double Hung: All Facades	Inspected
Instance Condition	3 - Fair
Instance Quantity	3,900
Instance Quantity Uom	S.F.
Are these windows insulated	Yes
Installation Year	1992
Source of Installation	Custodial Staff
Deficiency	ALUMINUM - DOUBLE HUNG: DETERIORATED
Roof Plan reference	K834 C

Deficiency Quantity	30
Quantity Uom	S.F.
Potential Action	REPLACE WINDOW
Urgency of Action	PRIORITY 4

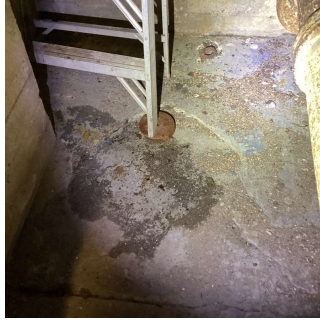
Violations	Basement - Near Vaults-Bunkers No violations recorded.
Deficiency	CONCRETE SLAB ON GRADE: THRU CRACKS
Deficiency Location/Instance	Basement - Boiler Room, Near Vaults-Bunkers
Deficiency Quantity	40
Quantity Uom	S.F.
Potential Action	REPAIR
Urgency of Action	PRIORITY 3
Purpose of Action	LEVEL 5
Deficiency Photo1

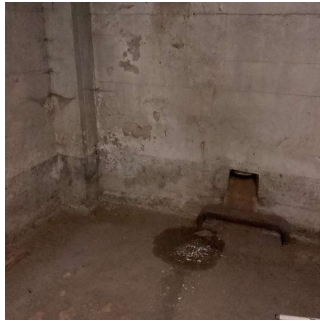
Violations	Basement - Boiler Room No violations recorded.
Deficiency	CONCRETE: WATER INFILTRATION IN NON- INSTRUCTIONAL SPACE
Deficiency Location/Instance	Basement - Corridor near the Oil Tank Room
Deficiency Quantity	100
Quantity Uom	S.F.
Potential Action	INSTALL WATERPROOFING
Urgency of Action	PRIORITY 5
Purpose of Action	LEVEL 5
Deficiency Photo1

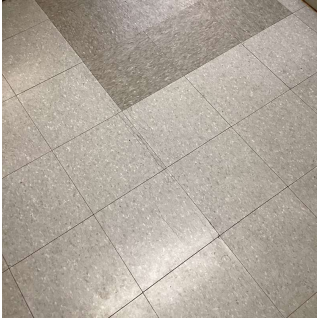
Question	Response
INTERIOR	
KITCHEN	
Floor Finish	
Instance on Ground Floor (400 SF)	Inspected
Condition	5 - Poor
Deficiency	VINYL TILES: DETERIORATED SUBSTRATE
Deficiency Location/Instance	Near Entrance, center, window
Deficiency Quantity	80
Quantity Uom	S.F.
Potential Action	REPLACE
Urgency of Action	PRIORITY 3
Purpose of Action	LEVEL 2
Deficiency Photo1

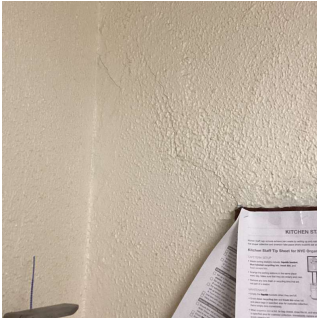
Violations	Near center No violations recorded.
Walls	
Instance on Ground Floor (400 SF)	Inspected
Condition	3 - Fair
Deficiency	PLASTER: CRACKS/SPALLING
Deficiency Location/Instance	Near Entrance
Deficiency Quantity	20
Quantity Uom	S.F.
Potential Action	REPLACE
Urgency of Action	PRIORITY 3
Purpose of Action	LEVEL 2
Deficiency Photo1

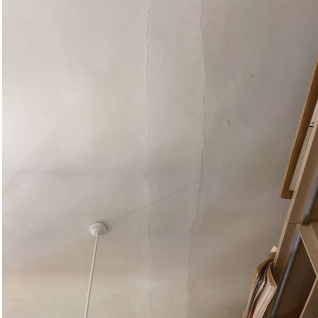
Question	Response
INTERIOR	
LIBRARY	
Ceiling	
Condition	5 - Poor
Deficiency	PLASTER: CRACKS/SPALLING
Deficiency Location/Instance	Near Entrance, storage
Deficiency Quantity	150
Quantity Uom	S.F.
Potential Action	REPLACE
Urgency of Action	PRIORITY 3
Purpose of Action	LEVEL 2
Deficiency Photo1

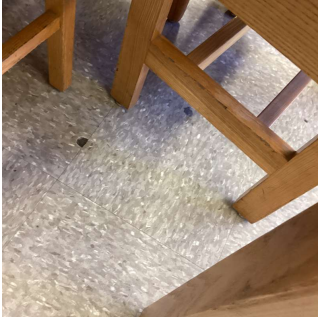
Violations	Near Entrance No violations recorded.
Door(s)	
Instance on Room 301	Inspected
Condition	2 - Between Good and Fair
Deficiency	No deficiencies recorded
Floor Finish	
Instance on Room 301	Inspected
Condition	2 - Between Good and Fair
Deficiency	VINYL TILES: BROKEN/DETERIORATED/MISSING TILES
Deficiency Location/Instance	Near center
Deficiency Quantity	10
Quantity Uom	S.F.
Potential Action	REPLACE
Urgency of Action	PRIORITY 3
Purpose of Action	LEVEL 2
Deficiency Photo1

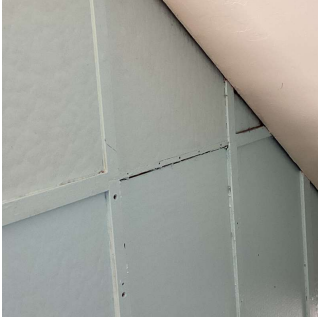
Question	Response
INTERIOR	
STAIRS/RAMPS: INTERIOR	
Door(s)	Inspected
Condition	4 - Between Fair and Poor
Deficiency	METAL: DETERIORATED DOOR AND FRAME
Deficiency Location/Instance	Stair AB/Ground Floor
Deficiency Quantity	2
Quantity Uom	EACH
Potential Action	MAINTENANCE
Urgency of Action	PRIORITY 3
Purpose of Action	LEVEL 2
Deficiency Photo1	 
	Stair AB/Ground Floor
Violations	No violations recorded.
Partition	Inspected
Condition	3 - Fair
Deficiency	METAL FRAME: DAMAGED/DETERIORATED
Deficiency Location/Instance	Stair AB/1
Deficiency Quantity	10
Quantity Uom	L.F.
Potential Action	REPLACE
Urgency of Action	PRIORITY 3
Purpose of Action	LEVEL 2
Deficiency Photo1

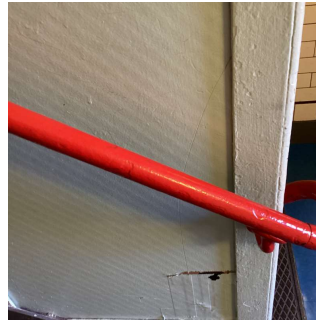
Stair AB/1
Violations	No violations recorded.
Deficiency	GLASS PANEL: DAMAGED/DETERIORATED
Deficiency Location/Instance	Stair CD/1
Deficiency Quantity	10
Quantity Uom	S.F.
Potential Action	REPLACE
Urgency of Action	PRIORITY 3
Purpose of Action	LEVEL 2

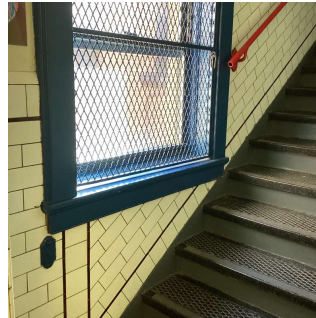
Stair AB/Ground Floor

METAL: DAMAGED

REPLACE

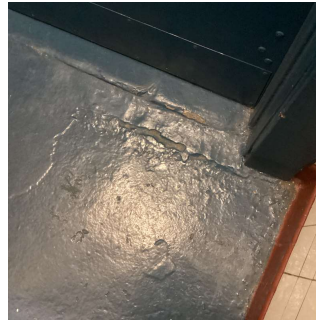
Stair AB/Ground

ROLLED ASPHALT: CRACKS

REPLACE

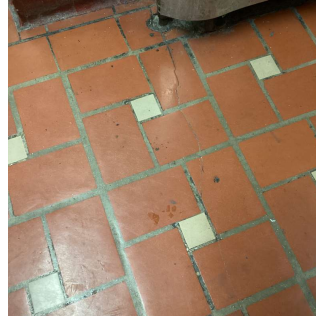
Stair CD/Basement

QUARRY TILE: DETERIORATED SUBSTRATE

REPLACE

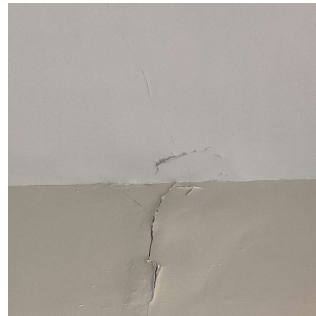
PLASTER: CRACKS/SPALLING

REPLACE

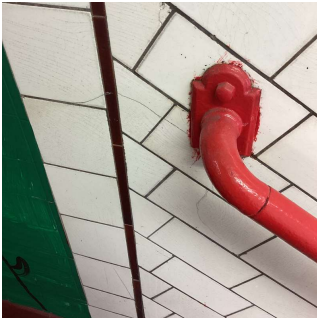
Question	Response
INTERIOR	
STAIRS/RAMPS: INTERIOR	
Walls	
Violations	Stair AB/3 No violations recorded.
Deficiency	CERAMIC TILE: BROKEN/ MISSING
Deficiency Location/Instance	Main Entrance Stairs, AB/Ground Floor, 2, 3, CD/3, and others
Deficiency Quantity	200
Quantity Uom	S.F.
Potential Action	REPLACE
Urgency of Action	PRIORITY 3
Purpose of Action	LEVEL 2
Deficiency Photo1

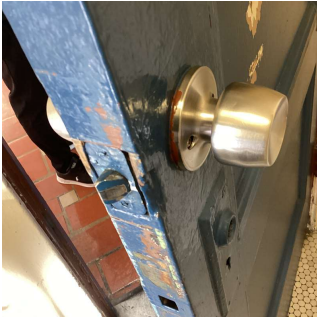
Violations	Main Entrance Stairs No violations recorded.
TOILET ROOMS - STAFF	
Ceiling	Inspected
Condition	2 - Between Good and Fair
Deficiency	No deficiencies recorded
Door(s)	Inspected
Condition	5 - Poor
Deficiency	WOOD: DETERIORATED DOOR
Deficiency Location/Instance	3rd Floor - Staff, 1st Floor - Staff
Deficiency Quantity	2
Quantity Uom	EACH
Potential Action	MAINTENANCE
Urgency of Action	PRIORITY 3
Purpose of Action	LEVEL 2
Deficiency Photo1

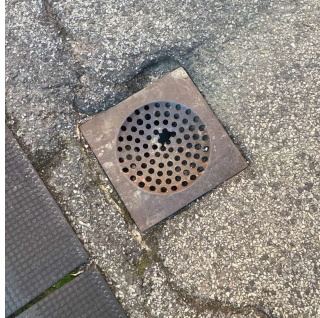
Courtyard
Violations	No violations recorded.

Question	Response
INTERIOR	
TOILET ROOMS - STAFF	
Stalls	Inspected
Condition	2 - Between Good and Fair
Deficiency	No deficiencies recorded
Walls	Inspected
Condition	2 - Between Good and Fair
Deficiency	No deficiencies recorded
TOILET ROOMS - STUDENTS	
Ceiling	Inspected
Condition	2 - Between Good and Fair
Deficiency	No deficiencies recorded
Door(s)	Inspected
Condition	2 - Between Good and Fair
Deficiency	No deficiencies recorded
Floor Finish	Inspected
Condition	2 - Between Good and Fair
Deficiency	No deficiencies recorded
Stalls	Inspected
Condition	2 - Between Good and Fair
Deficiency	No deficiencies recorded
Walls	Inspected
Condition	2 - Between Good and Fair
Deficiency	No deficiencies recorded
LIFE SAFETY	
F.D. HOLDING AREA	Does not Exist
STEEL STAIRS	Does not Exist
SITE	
CONTAINERIZATION	Does not Exist
Drainage System for Asphalt	Inspected
Catch Basins/Manhole - Surrounded by asphalt	Inspected
Condition	3 - Fair
Deficiency	DAMAGED COVER

Deficiency Location/Instance	Courtyard
Deficiency Quantity	1
Quantity Uom	EACH
Potential Action	REPLACE
Urgency of Action	PRIORITY 3
Purpose of Action	LEVEL 2
Deficiency Photo1

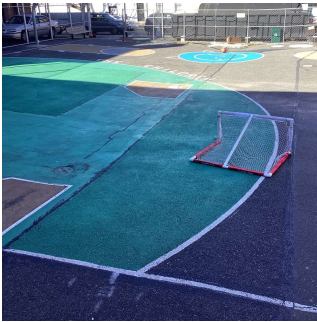
Question	Response
SITE	
PAVING	
Student Use	
Asphalt	
Condition	4 - Between Fair and Poor
Deficiency	CRACKS - MAJOR
Deficiency Location/Instance	Courtyard
Deficiency Quantity	700
Quantity Uom	S.F.
Potential Action	REPLACE
Urgency of Action	PRIORITY 3
Purpose of Action	LEVEL 2
Deficiency Photo1

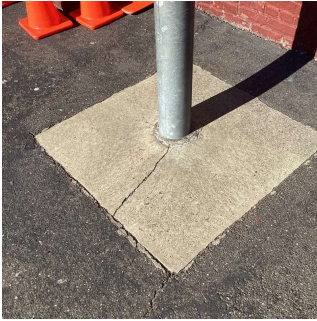
Violations	Courtyard No violations recorded.
Concrete	Inspected
Condition	2 - Between Good and Fair
Deficiency	DAMAGED/DETERIORATED/MISSING SECTIONS
Deficiency Location/Instance	Schoolyard
Deficiency Quantity	25
Quantity Uom	S.F.
Potential Action	REPLACE
Urgency of Action	PRIORITY 3
Purpose of Action	LEVEL 2
Deficiency Photo1

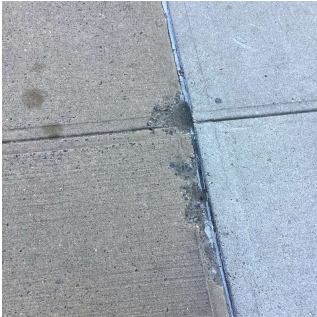
Question	Response
SITE	
PAVING	
DOT Sidewalk	
Concrete	
Deficiency Photo1

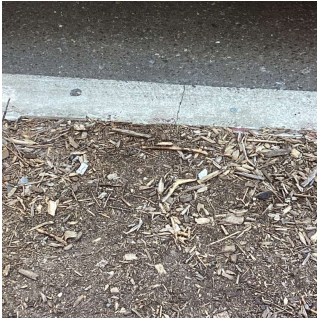
Violations	Along Carroll Street No violations recorded.
Deficiency	DAMAGED CURBS
Deficiency Location/Instance	Along Carroll Street, Whitwell Place
Deficiency Quantity	100
Quantity Uom	L.F.
Potential Action	REPLACE
Urgency of Action	PRIORITY 3
Purpose of Action	LEVEL 2
Deficiency Photo1
