NYC Department of Education
Building Condition Assessment Survey 2023 - 2024

Architectural Inspection

Asset: P.S. 235 MINISCHOOL - BROOKLYN, 525 LENOX ROAD, New York, 11203

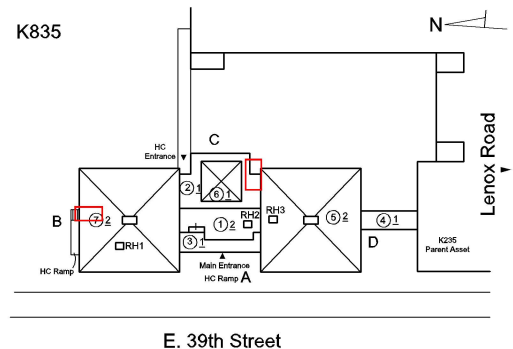
Question	Response
Architectural	
EXTERIOR	Inspected
AREAWAY	Does not Exist
AWNINGS AND CANOPIES	Inspected
Condition	2 - Between Good and Fair
Deficiency	No deficiencies recorded
CHIMNEY	Does not Exist
COPING	Inspected
Condition	2 - Between Good and Fair
Deficiency	No deficiencies recorded
CORNICE	Does not Exist
DOORS	Inspected
DOORS AND FRAMES	Inspected
Condition	5 - Poor
Deficiency	METAL: DETERIORATED DOOR AND FRAME - MAJOR DETERIORATION
Roof Plan reference

Deficiency Quantity
Quantity Uom
Potential Action
Urgency of Action

3
EACH
REPLACE
PRIORITY 4

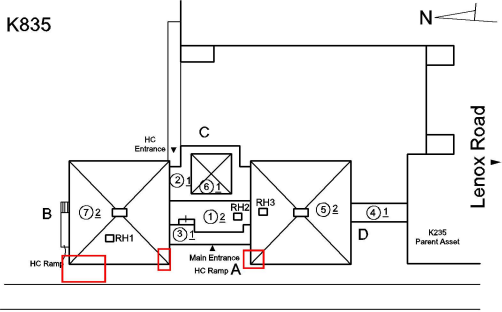
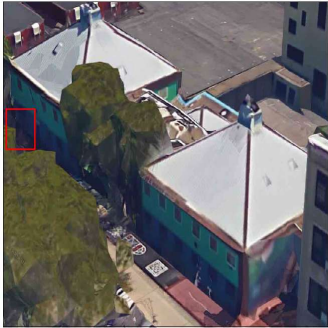
Elevation

Question	Response
EXTERIOR	
EXTERIOR WALLS	Inspected
Material Type(s)	Steel
Replacement Quantity	9,000
Replacement Uom	S.F.
Instance on All Facades	Inspected
Instance Condition	4 - Between Fair and Poor
Instance Quantity	9,000
Instance Quantity Uom	S.F.
Deficiency	METAL PANEL: DAMAGED TRIM
Roof Plan reference	<p>K835</p>

Deficiency Quantity	30
Quantity Uom	L.F.
Potential Action	REPLACE
Urgency of Action	PRIORITY 4
Purpose of Action	LEVEL 2
Deficiency Photo1

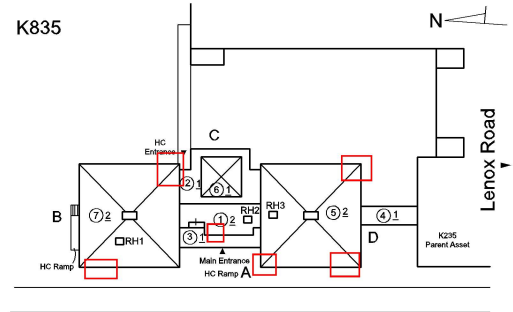
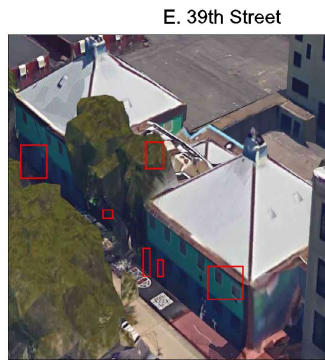
Elevation

<p>Facade A</p>
Violations	No violations recorded.
Deficiency	METAL PANEL: SEVERE DENTS

Deficiency Quantity

80

REPLACE

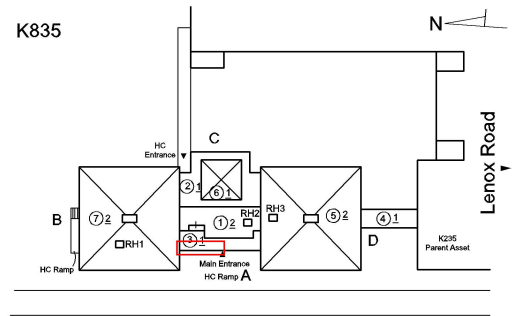
Roof 1
Instance Quantity	2,500
Instance Quantity Uom	S.F.
Does the roof have major mechanical equipment sitting on Dunnage Steel less than 18" above the Roofing?	No
Does this roof instance have a Sustainable Roof System?	No
Do solar panels exist on these roofs?	No
Is/Are the roof(s) suitable for Solar Panel installation?	No
Installation Year	1991
Source of Installation	Custodial Staff
Deficiency	IRMA: ROOFING: MAJOR ACTIVE ROOF LEAKS IN INSTRUCTIONAL SPACE
Roof Plan reference

<p align="center">K835</p> <p align="center">E. 39th Street</p>
Deficiency Quantity	100
Quantity Uom	S.F.
Potential Action	REPLACE ROOFING WITHOUT MAJOR EQUIPMENT REMOVAL
Urgency of Action	PRIORITY 5
Purpose of Action	LEVEL 2
Deficiency Photo1

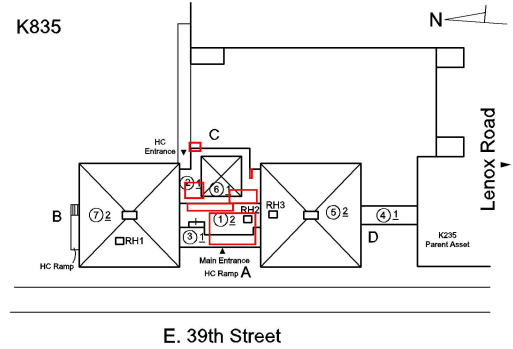
Roof 2 - Cafeteria
Violations	No violations recorded.
Deficiency	IRMA: ROOFING: DAMAGED INSULATION

Deficiency Quantity
Quantity Uom
Potential Action
Urgency of Action
Purpose of Action
Deficiency Photo1

120
S.F.
REPLACE
PRIORITY 4
LEVEL 2

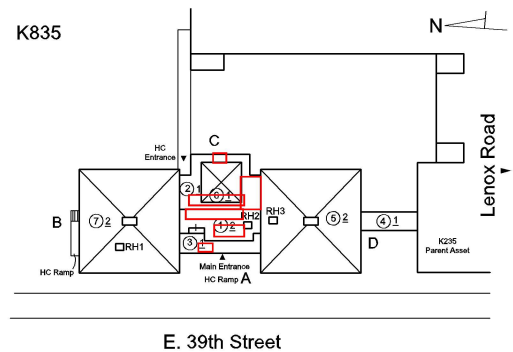
IRMA: ROOFING: LOSS OF GRAVEL

Deficiency Quantity
Quantity Uom
Potential Action
Urgency of Action
Purpose of Action

200
S.F.
MAINTENANCE
PRIORITY 3
LEVEL 2

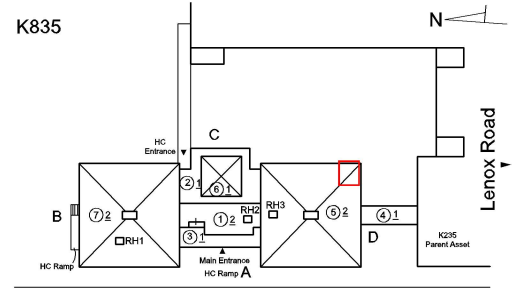
Roof 5
Instance Quantity	7,000
Instance Quantity Uom	S.F.
Does the roof have major mechanical equipment sitting on Dunnage Steel less than 18" above the Roofing?	No
Does this roof instance have a Sustainable Roof System?	No
Do solar panels exist on these roofs?	No
Is/Are the roof(s) suitable for Solar Panel installation?	No
Installation Year	1991
Source of Installation	Custodial Staff
Deficiency	METAL: ROOFING: MAJOR ACTIVE ROOF LEAKS IN INSTRUCTIONAL SPACE
Roof Plan reference

<p>K835</p> <p>E. 39th Street</p> <p>Lenox Road</p>
Deficiency Quantity	100
Quantity Uom	S.F.
Potential Action	REPLACE
Urgency of Action	PRIORITY 5
Purpose of Action	LEVEL 2

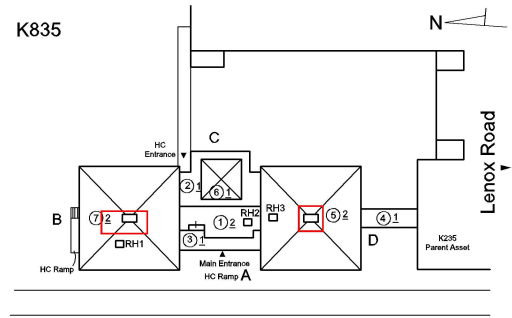
Violations	Roof 5 - Staff Lounge Room No violations recorded.
Deficiency	METAL: ROOFING: MAJOR ACTIVE ROOF LEAKS IN NON-INSTRUCTIONAL SPACE
Roof Plan reference	K835

E. 39th Street Lenox Road
Deficiency Quantity	200
Quantity Uom	S.F.
Potential Action	REPLACE
Urgency of Action	PRIORITY 5
Purpose of Action	LEVEL 2
Deficiency Photo1

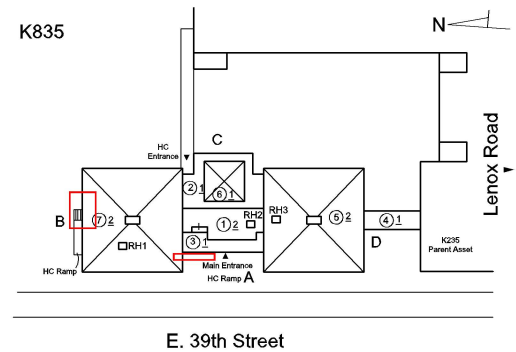
CAST IN PLACE CONCRETE: DETERIORATED CONTROL/EXPANSION JOINT

Deficiency Quantity
Quantity Uom
Potential Action
Urgency of Action
Purpose of Action
Deficiency Photo1

20
L.F.
REPLACE
PRIORITY 3
LEVEL 2

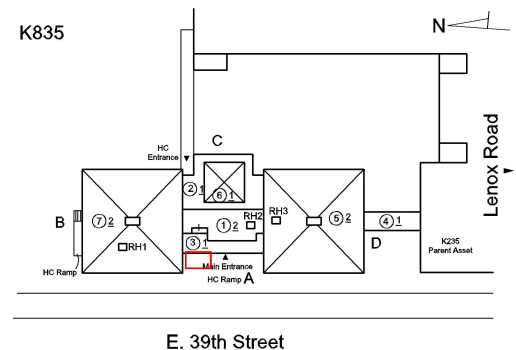
STONE: CRACKS/SPALLING - MAJOR

Question	Response
EXTERIOR	
STAIRS/RAMPS: EXTERIOR	
BUILDING CHEEK/FLANK WALLS	
Quantity Uom	S.F.
Potential Action	REPLACE
Urgency of Action	PRIORITY 4
Purpose of Action	LEVEL 2
Deficiency Photo1

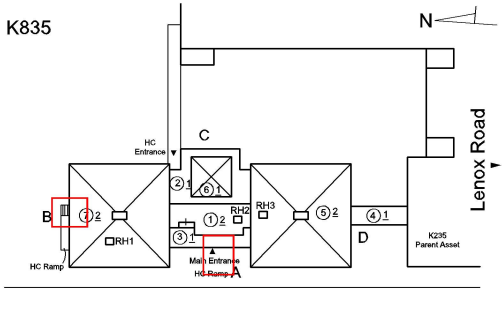
Violations	Facade C No violations recorded.
RAILINGS	Inspected
Condition	2 - Between Good and Fair
Deficiency	No deficiencies recorded
STAIRS/RAMPS	Inspected
Condition	4 - Between Fair and Poor
Deficiency	CONCRETE: CRACKS/SPALLING - MAJOR
Roof Plan reference

K835 HC Ramp HC Entrance C RH1 RH2 RH3 Main Entrance HC Ramps A D K296 Parcel Asset Lenox Road N E. 39th Street
Deficiency Quantity	20
Quantity Uom	S.F.
Potential Action	REPLACE
Urgency of Action	PRIORITY 4
Purpose of Action	LEVEL 2
Deficiency Photo1

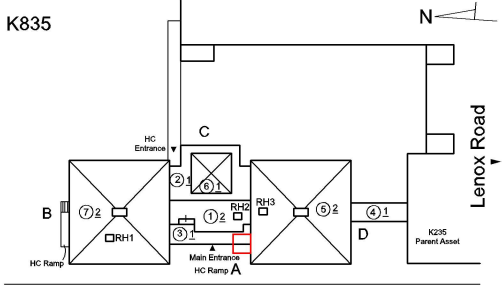
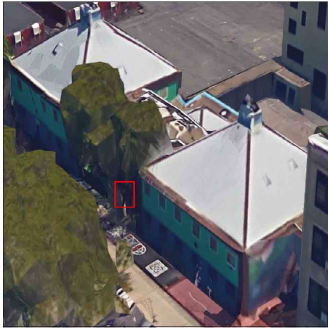
Elevation	<p>E. 39th Street</p>

Question	Response
EXTERIOR	
WINDOWS	Inspected
Replacement Quantity	1,300
Replacement Uom	S.F.
EXTERIOR GUARDS	Inspected
Condition	3 - Fair
Deficiency	RUST - MAJOR
Roof Plan reference	<p>K835</p>

Deficiency Quantity	30
Quantity Uom	S.F.
Potential Action	REPLACE
Urgency of Action	PRIORITY 4
Purpose of Action	LEVEL 2
Deficiency Photo1

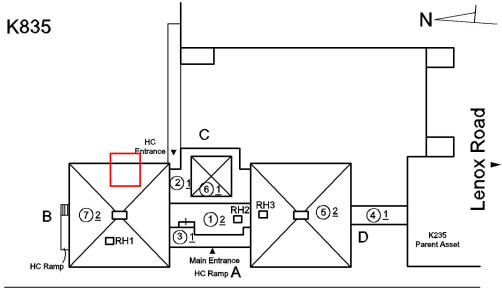
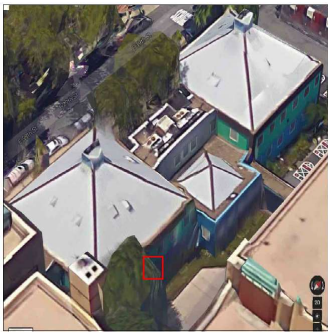
Elevation

Question	Response
EXTERIOR	
WINDOWS	
WINDOWS	
Installation Year	1991
Source of Installation	Custodial Staff
Deficiency	ALUMINUM - DOUBLE HUNG: BROKEN PANE
Roof Plan reference

Deficiency Quantity	30
Quantity Uom	S.F.
Potential Action	MAINTENANCE
Urgency of Action	PRIORITY 3
Purpose of Action	LEVEL 2
Deficiency Photo1

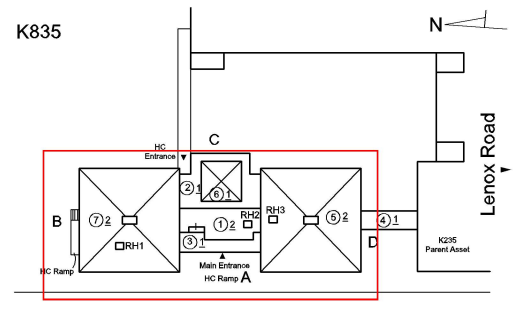
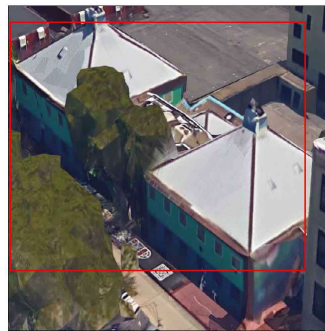
Elevation

Violations	No violations recorded.
Deficiency	ALUMINUM - DOUBLE HUNG: INOPERABLE BALANCE

Deficiency Quantity
Quantity Uom
Potential Action
Urgency of Action
Purpose of Action
Deficiency Photo1
Violations

20
EACH
REPLACE BALANCES
PRIORITY 3
LEVEL 2
No photo recorded
No violations recorded.
