NYC Department of Education
Building Condition Assessment Survey 2023 - 2024

Architectural Inspection

K839

Asset: P.S. 134 MINISCHOOL - BROOKLYN, 4001 18TH AVENUE, New York, 11218

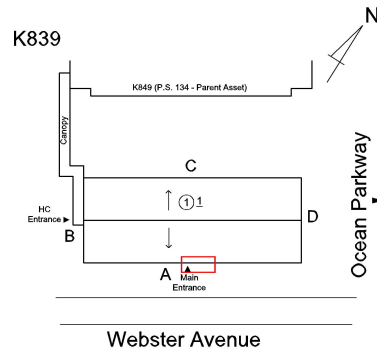
Question	Response
Architectural	
EXTERIOR	Inspected
AREAWAY	Does not Exist
AWNINGS AND CANOPIES	Inspected
Condition	2 - Between Good and Fair
Deficiency	No deficiencies recorded
CHIMNEY	Inspected
Material Type(s)	Metal
Condition	2 - Between Good and Fair
Deficiency	No deficiencies recorded
COPING	Does not Exist
CORNICE	Does not Exist
DOORS	Inspected
DOORS AND FRAMES	Inspected
Condition	5 - Poor
Deficiency	METAL: DETERIORATED DOOR - MINOR DETERIORATION
Roof Plan reference

Deficiency Quantity
Quantity Uom
Potential Action
Urgency of Action

2
EACH
MAINTENANCE
PRIORITY 3

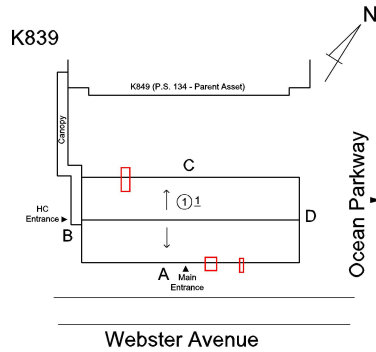
Condition	3 - Fair
-----------	----------

Deficiency	DAMAGED/MISSING
------------	-----------------

Deficiency Quantity

30

REPLACE

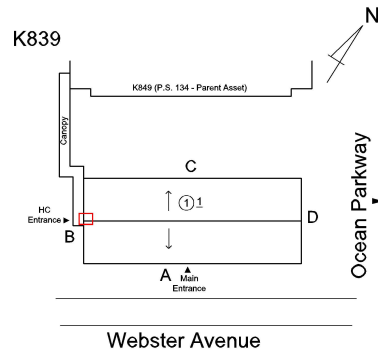
STAIRS/RAMPS

Deficiency Photo1	
Violations	Facade D
Deficiency	No violations recorded.
	CONCRETE: CRACKS/SPALLING - MAJOR

Deficiency Quantity
Quantity Uom
Potential Action
Urgency of Action
Purpose of Action
Deficiency Photo1

10
S.F.
REPLACE
PRIORITY 4
LEVEL 2

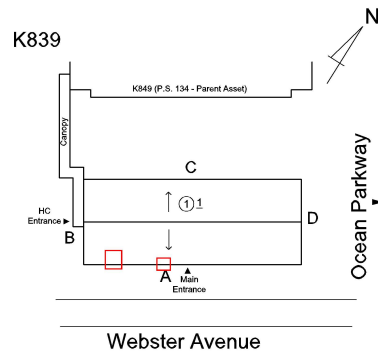
Deficiency

DETERIORATED/TORN-OUT/MISSING

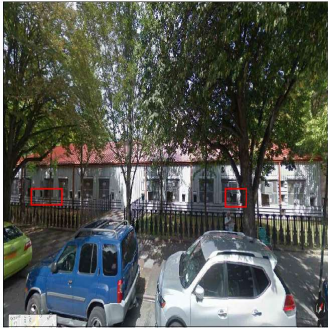
Question	Response
EXTERIOR	
WINDOWS	
EXTERIOR GUARDS	
Elevation

Deficiency Quantity	60
Quantity Uom	S.F.
Potential Action	REPLACE
Urgency of Action	PRIORITY 4
Purpose of Action	LEVEL 2
Deficiency Photo1
