NYC Department of Education
Building Condition Assessment Survey 2023 - 2024

Architectural Inspection

Asset: P.S. 241 MINISCHOOL - BROOKLYN, 976 PRESIDENT STREET, New York, 11225

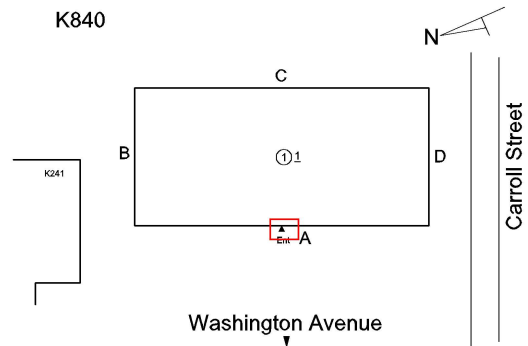
Question	Response
Architectural	
EXTERIOR	Inspected
AREAWAY	Does not Exist
AWNINGS AND CANOPIES	Does not Exist
CHIMNEY	Does not Exist
COPING	Does not Exist
CORNICE	Does not Exist
DOORS	Inspected
DOORS AND FRAMES	Inspected
Condition	5 - Poor

METAL: DETERIORATED DOOR - MAJOR DETERIORATION

REPLACE

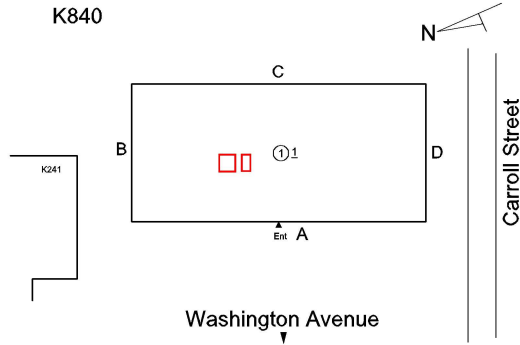
Question	Response
EXTERIOR	
ROOF	
Roofing	
ROOFING	
Instance Condition	4 - Between Fair and Poor
Instance Photo

Roof 1
Instance Quantity	8,300
Instance Quantity Uom	S.F.
Does the roof have major mechanical equipment sitting on Dunnage Steel less than 18" above the Roofing?	No
Does this roof instance have a Sustainable Roof System?	No
Do solar panels exist on these roofs?	No
Is/Are the roof(s) suitable for Solar Panel installation?	No
Installation Year	1969
Source of Installation	Custodial Staff
Deficiency	METAL: ROOFING: MAJOR ACTIVE ROOF LEAKS IN NON-INSTRUCTIONAL SPACE
Roof Plan reference	<p align="center">K840</p>

Deficiency Quantity	200
Quantity Uom	S.F.
Potential Action	REPLACE
Urgency of Action	PRIORITY 5
Purpose of Action	LEVEL 2
Deficiency Photo1

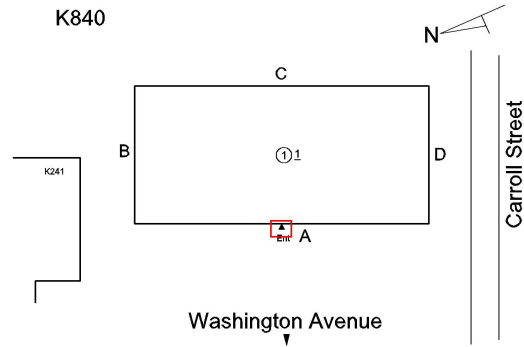
Condition	3 - Fair
-----------	----------

Deficiency	RUST - MAJOR
------------	--------------

REPLACE

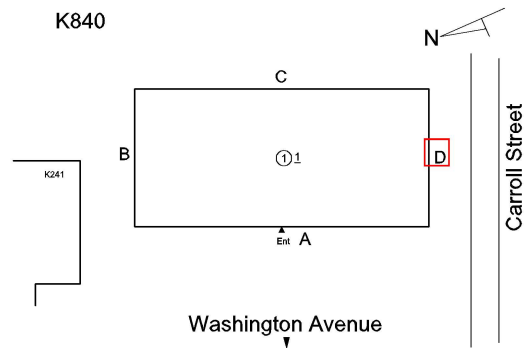
Condition	5 - Poor
-----------	----------

Deficiency	CONCRETE: WORN-OUT TREAD/RISER/NOSING
------------	---------------------------------------

REPLACE
