**NYC Department of Education**  
**Building Condition Assessment Survey 2023 - 2024**

Architectural Inspection

**K842**

**Asset: P.S. 45 AX (OLD BS RDGWD ECC1)-K, 1160 DECATUR STREET, New York, 11207**

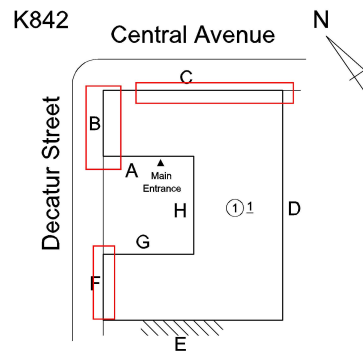
Question	Response
<b>Architectural</b>	
<b>EXTERIOR</b>	Inspected
<b>AREAWAY</b>	Does not Exist
<b>AWNINGS AND CANOPIES</b>	Inspected
Condition	2 - Between Good and Fair
Deficiency	No deficiencies recorded
<b>CHIMNEY</b>	Does not Exist
<b>COPING</b>	Inspected
Condition	3 - Fair
Deficiency	CAST STONE: DETERIORATED TRANSVERSE JOINTS
Roof Plan reference	K842

60  
 L.F.  
 MAINTENANCE  
 PRIORITY 3  
 LEVEL 2

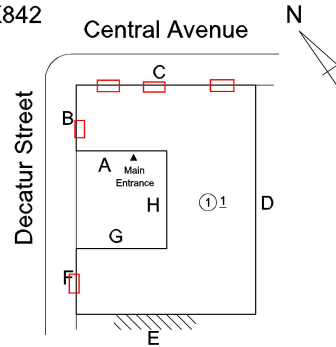
CAST STONE: DETERIORATED BED JOINT

10

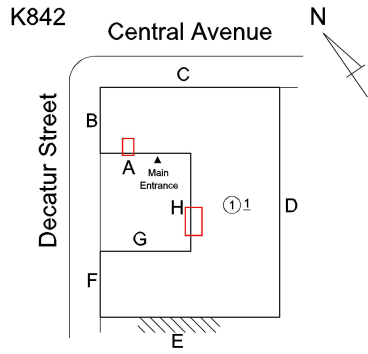
METAL CLAD: DETERIORATED DOOR AND FRAME - MINOR DETERIORATION

Deficiency Quantity	2
Quantity Uom	EACH
Potential Action	MAINTENANCE
Urgency of Action	PRIORITY 3
Purpose of Action	LEVEL 2
Deficiency Photo1

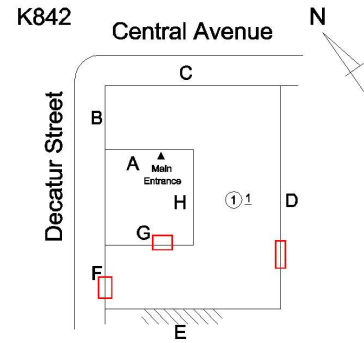
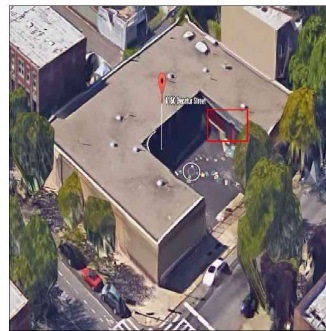
Violations	Exit 2, 4 No violations recorded.
<b>DOOR HARDWARE</b>	Inspected
Condition	2 - Between Good and Fair
Deficiency	No deficiencies recorded
<b>LINTELS</b>	Inspected
Condition	2 - Between Good and Fair
Deficiency	No deficiencies recorded
<b>TRANSOM/SIDE LIGHT</b>	Inspected
Condition	2 - Between Good and Fair
Deficiency	No deficiencies recorded
<b>EXTERIOR WALLS</b>	Inspected
Material Type(s)	Masonry, Steel
Replacement Quantity	6,500
Replacement Uom	S.F.
Instance on All Facades	Inspected
Instance Condition	3 - Fair
Instance Quantity	6,500
Instance Quantity Uom	S.F.
Deficiency	METAL PANEL: SEVERE DENTS

30

REPLACE

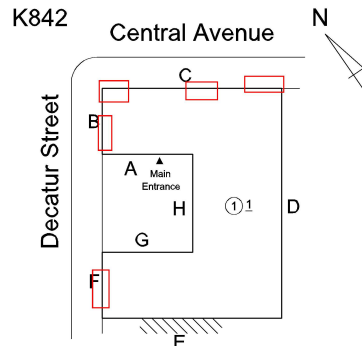
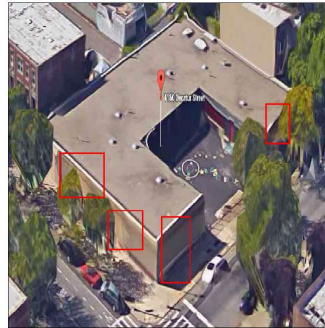
BRICK: DETERIORATED JOINTS

200

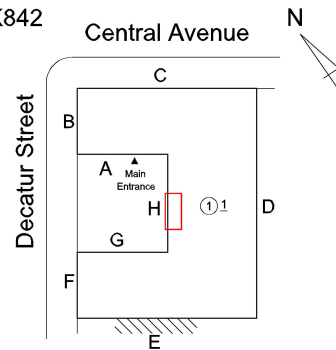
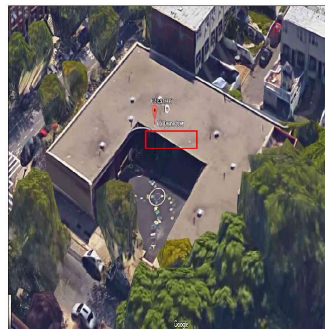
STUCCO/PLASTER: MINOR CRACKS/SPALLING

10

Quantity Uom	S.F.
Potential Action	REPAIR
Urgency of Action	PRIORITY 3
Purpose of Action	LEVEL 2
Deficiency Photo1

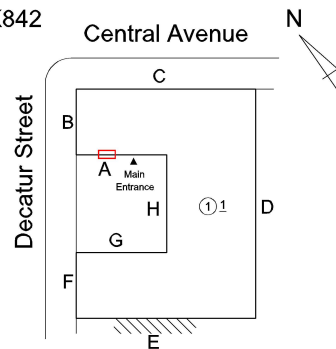
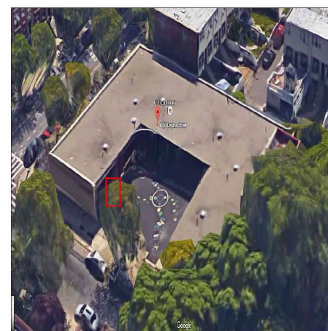
Deficiency	BROKEN/ DENTED BLADES
Roof Plan reference	K842

Deficiency Quantity	30
Quantity Uom	S.F.
Potential Action	REPLACE
Urgency of Action	PRIORITY 4
Purpose of Action	LEVEL 2

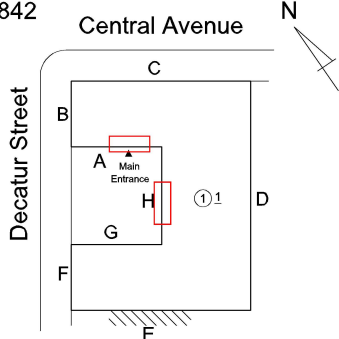
Question	Response
<b>EXTERIOR</b>	
<b>ROOF</b>	
<b>Roofing</b>	
<b>ROOFING</b>	
Deficiency	BUILT-UP: FLASHING: DRIP EDGE/GRAVEL STOP DAMAGED
Roof Plan reference	K842

Deficiency Quantity	10
Quantity Uom	L.F.
Potential Action	REPLACE
Urgency of Action	PRIORITY 4
Purpose of Action	LEVEL 2
Deficiency Photo1
