NYC Department of Education
Building Condition Assessment Survey 2023 - 2024

Architectural Inspection

Asset: P.S. 134 - BROOKLYN, 4001 18 AVENUE, New York, 11218

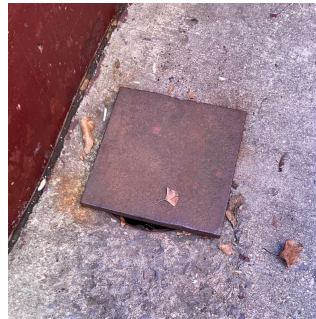
AW1

AREAWAY DRAINS: DETERIORATED

REPLACE

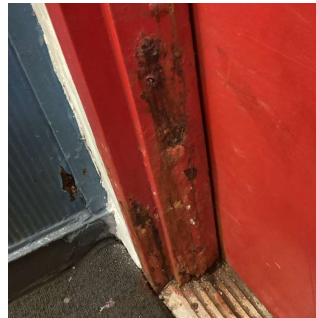
Facade D

METAL: DETERIORATED DOOR AND FRAME - MAJOR DETERIORATION

5
EACH
REPLACE
PRIORITY 4
LEVEL 2

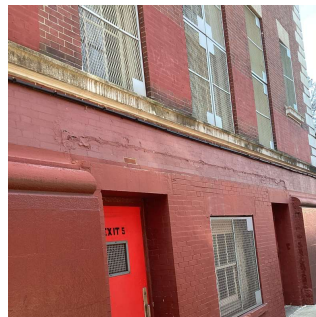
Facade B

BRICK: DETERIORATED JOINTS

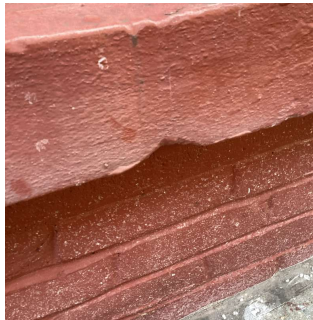
Facade D

BRICK: DETERIORATED MASONRY SILLS - MINOR

REPAIR

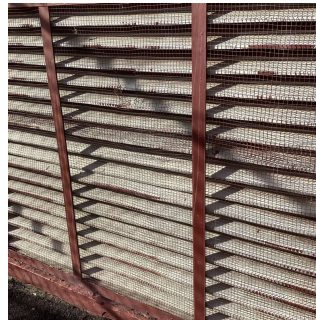
Facade C

Violations	Facade A No violations recorded.
EXTERIOR SOFFITS	Does not Exist
LOADING DOCK	Does not Exist
LOUVER	Inspected
Condition	3 - Fair
Deficiency	BROKEN/ DENTED BLADES

REPLACE

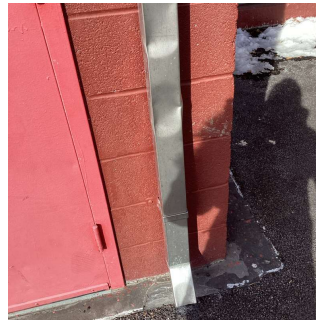
Facade C

Deficiency	DAMAGED/MISSING
------------	-----------------

REPLACE

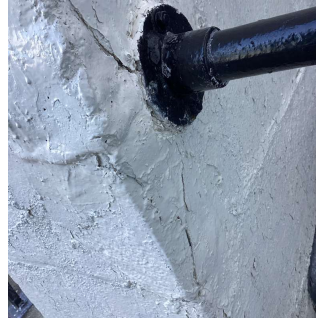
Facade A

Is/Are the roof(s) suitable for Solar Panel installation?	No
Installation Year	2016
Source of Installation	Custodial Staff
Deficiency	No deficiencies recorded
ROOFING DRAINS	Does not Exist
Specialties	Does not Exist
STAIRS/RAMPS: EXTERIOR	Inspected
BUILDING CHEEK/FLANK WALLS	Inspected
Condition	5 - Poor
Deficiency	STONE: CRACKS/SPALLING - MAJOR
Roof Plan reference

REPLACE
PRIORITY 4
LEVEL 2

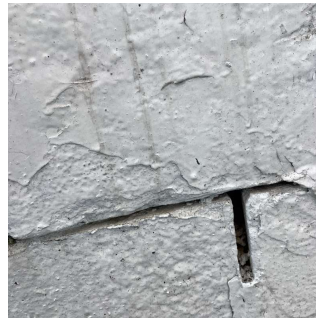
Facade A

STONE: DETERIORATED JOINTS

20
S.F.
REPOINT
PRIORITY 4
LEVEL 2

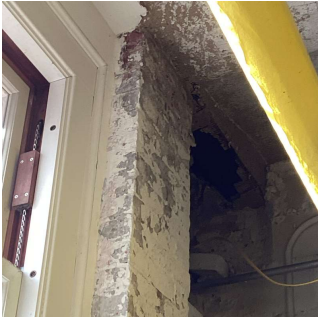
Question	Response
INTERIOR	
STRUCTURAL	
COLUMNS/BEAMS/BEARING WALLS	
Deficiency Quantity	10
Quantity Uom	S.F.
Potential Action	REPLACE
Urgency of Action	PRIORITY 4
Purpose of Action	LEVEL 5
Deficiency Photo1

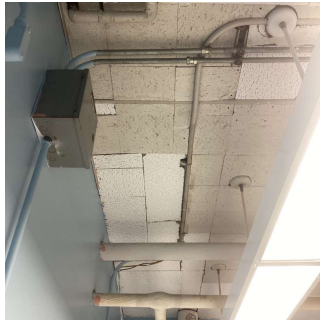
Attic
Violations	No violations recorded.
VAULTS-BUNKERS	Does not Exist
AUDITORIUM	Does not Exist
CAFETERIA	Inspected
Instance on Basement (2000 SF)	Inspected
Ceiling	
Instance on Basement (2000 SF)	Inspected
Condition	2 - Between Good and Fair
Deficiency	ACOUSTIC TILES ON PLASTER: DAMAGED/MISSING
Deficiency Location/Instance	Near Kitchen Locker Room
Deficiency Quantity	30
Quantity Uom	S.F.
Potential Action	REPLACE
Urgency of Action	PRIORITY 3
Purpose of Action	LEVEL 2
Deficiency Photo1

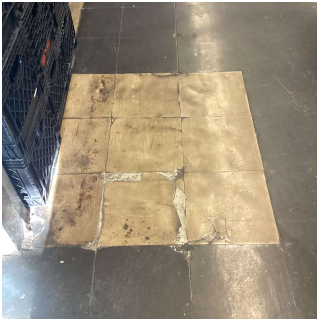
Question	Response
INTERIOR	
CAFETERIA	
Door(s)	
Deficiency Photo1	 
Violations	Exit 6 - Vestibule No violations recorded.
Fixed Equipment	
Instance on Basement (2000 SF)	Does not Exist
Floor Finish	
Instance on Basement (2000 SF)	Inspected
Condition	5 - Poor
Deficiency	VINYL TILES: BROKEN/DETERIORATED/MISSING TILES
Deficiency Location/Instance	By Kitchen, near Exit 4, close to Room M06, next to Servery, by Windows and others
Deficiency Quantity	250
Quantity Uom	S.F.
Potential Action	REPLACE
Urgency of Action	PRIORITY 3
Purpose of Action	LEVEL 2
Deficiency Photo1

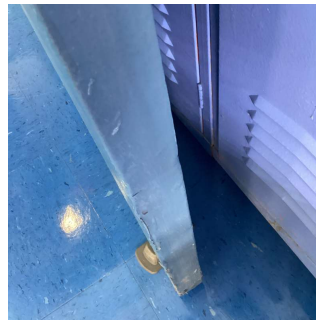
Room 301

METAL: DETERIORATED DOOR

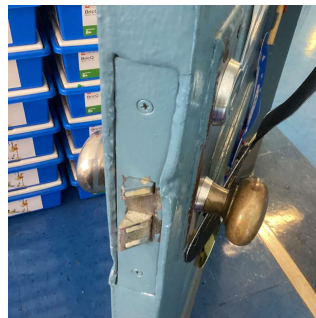
METAL CLAD WOOD: DETERIORATED DOOR

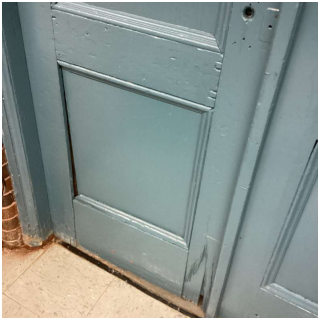
Question	Response
INTERIOR	
CLASSROOMS/CORRIDORS/ADMIN SPACES	
Door(s)	
Violations	Room 301 No violations recorded.
Deficiency	WOOD: DETERIORATED DOOR
Deficiency Location/Instance	Rooms 206, 203, 102, Exit 7 - Vestibule
Deficiency Quantity	4
Quantity Uom	EACH
Potential Action	MAINTENANCE
Urgency of Action	PRIORITY 3
Purpose of Action	LEVEL 2
Deficiency Photo1

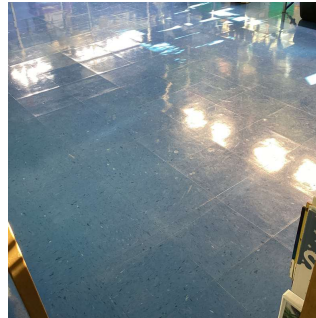
Room 301

VINYL TILES: BROKEN/DETERIORATED/MISSING TILES

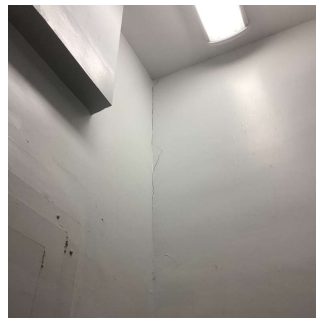
PLASTER: CRACKS/SPALLING

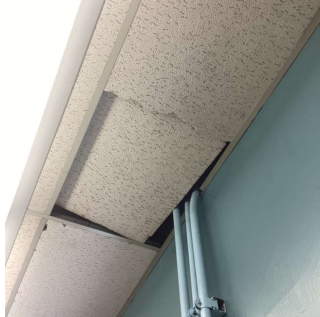
Question	Response
INTERIOR	
CLASSROOMS/CORRIDORS/ADMIN SPACES	
Walls	Inspected
Violations	Corridor by Gymnasium No violations recorded.
Specialties	Inspected
Classroom Locker(s)	Inspected
Condition	2 - Between Good and Fair
Deficiency	No deficiencies recorded
Fixed Seating	Does not Exist
GYMNASIUM	Inspected
Instance on 3rd Floor	Inspected
Ceiling	
Instance on 3rd Floor	Inspected
Condition	2 - Between Good and Fair
Deficiency	ACOUSTIC TILES: DAMAGED/MISSING
Deficiency Location/Instance	Office Room
Deficiency Quantity	10
Quantity Uom	S.F.
Potential Action	REPLACE
Urgency of Action	PRIORITY 3
Purpose of Action	LEVEL 2
Deficiency Photo1

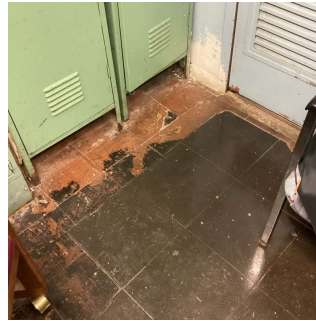
Instance on Basement	Inspected
Condition	3 - Fair
Deficiency	VINYL TILES: BROKEN/DETERIORATED/MISSING TILES
Deficiency Location/Instance	Kitchen Locker Room
Deficiency Quantity	30
Quantity Uom	S.F.
Potential Action	REPLACE
Urgency of Action	PRIORITY 3
Purpose of Action	LEVEL 2

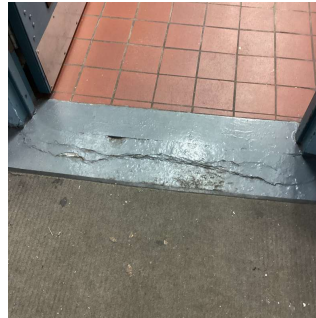
Near Office Room

CONCRETE: CRACKS

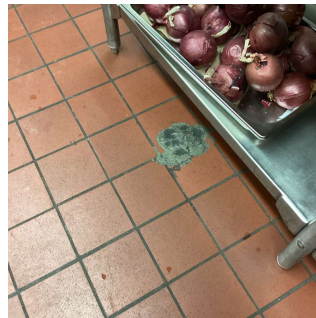
Preparation Area

QUARRY TILE: BROKEN/MISSING TILES

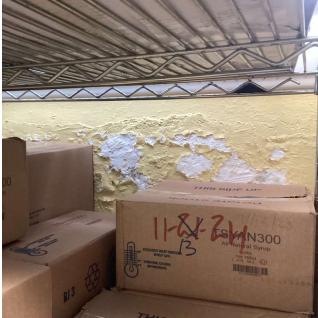
Question	Response
INTERIOR	
KITCHEN	
Walls	
Instance on Basement	Inspected
Condition	3 - Fair
Deficiency	PLASTER: CRACKS/SPALLING - ACTIVE LEAK
Deficiency Location/Instance	Office Room
Deficiency Quantity	50
Quantity Uom	S.F.
Potential Action	REPLACE
Urgency of Action	PRIORITY 5
Purpose of Action	LEVEL 2
Deficiency Photo1

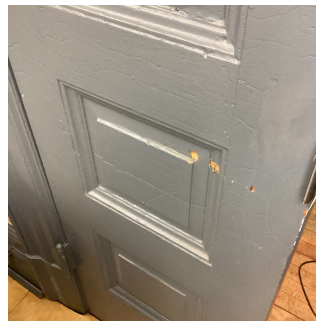
Storage Room

WOOD: DETERIORATED DOOR

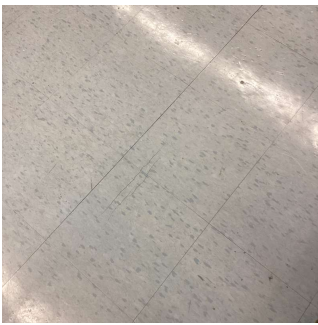
VINYL TILES: BROKEN/DETERIORATED/MISSING TILES

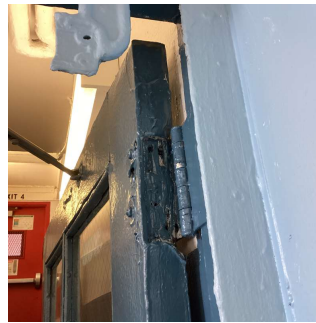
Exit 4 - Vestibule

Center	Center
Violations	No violations recorded.
Walls	
Instance on Room 205	Inspected
Condition	2 - Between Good and Fair
Deficiency	No deficiencies recorded
LOCKER ROOM	Does not Exist
MULTI-PURPOSE ROOM	Does not Exist
SCIENCE DEMO ROOM	Inspected
Instance on Room 301	Inspected
Alternative use	No
Fixed Equipment	
Instance on Room 301	Inspected
Condition	2 - Between Good and Fair
Deficiency	No deficiencies recorded
SCIENCE LAB	Does not Exist
SCIENCE PREP ROOM	Does not Exist
SHOWER ROOM	Does not Exist
STAIRS/RAMPS: INTERIOR	
Do Letter Stair Signs Exist?	Partially
Ceiling	
Condition	2 - Between Good and Fair
Deficiency	No deficiencies recorded
Door(s)	
Condition	5 - Poor
Deficiency	METAL CLAD WOOD: DETERIORATED DOOR
Deficiency Location/Instance	Exits 2, 4 - Vestibules, Stairs BD/3, EC/1
Deficiency Quantity	4
Quantity Uom	EACH
Potential Action	MAINTENANCE

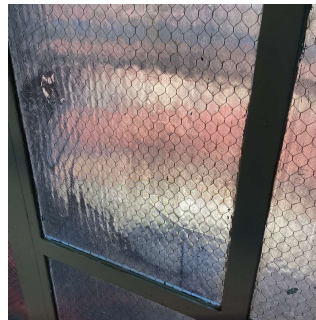
Stair EC/1

GLASS PANEL: DAMAGED/DETERIORATED

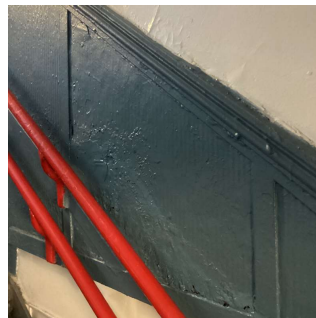
METAL PANEL: DAMAGED/DETERIORATED

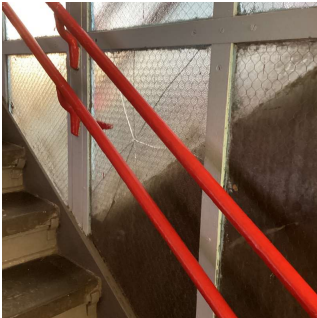
Question	Response
INTERIOR	
STAIRS/RAMPS: INTERIOR	
Partition	
Violations	Stair EC/Basement No violations recorded.
Deficiency	GLASS PANEL: DAMAGED/DETERIORATED
Deficiency Location/Instance	Stairs BD/Basement, EC/Basement
Deficiency Quantity	20
Quantity Uom	S.F.
Potential Action	REPLACE
Urgency of Action	PRIORITY 5
Purpose of Action	LEVEL 6
Deficiency Photo1

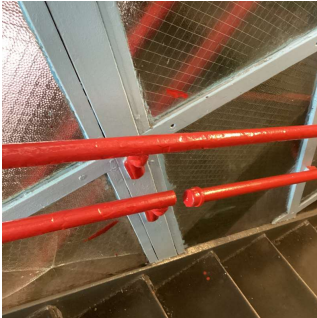
Violations	Stair BD/Basement No violations recorded.
Railings	Inspected
Condition	3 - Fair
Deficiency	METAL: DAMAGED
Deficiency Location/Instance	Stair BD/Basement
Deficiency Quantity	10
Quantity Uom	L.F.
Potential Action	REPLACE
Urgency of Action	PRIORITY 3
Purpose of Action	LEVEL 2
Deficiency Photo1

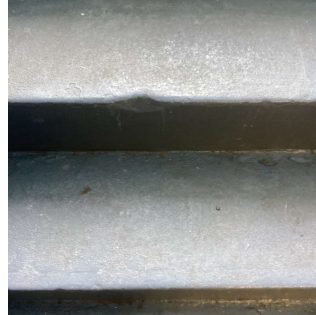
Violations	Stair BD/Basement No violations recorded.
Stairs and Landings	Inspected
Condition	2 - Between Good and Fair
Deficiency	STONE: BROKEN/MISSING
Deficiency Location/Instance	Exit 6 - Vestibule
Deficiency Quantity	20
Quantity Uom	S.F.
Potential Action	REPLACE

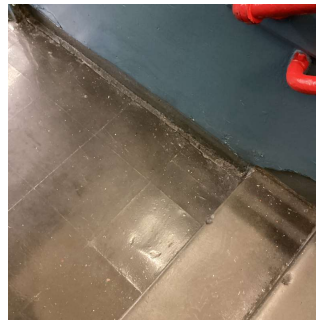
VINYL TILES: BROKEN/DETERIORATED/MISSING TILES
Stair BD/Basement
10
S.F.
MAINTENANCE
PRIORITY 3
LEVEL 2

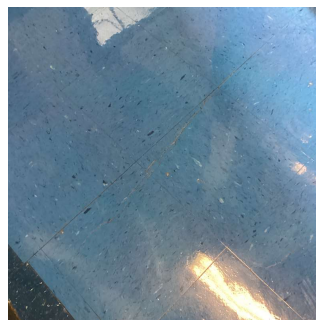
VINYL TILES: DETERIORATED SUBSTRATE
Near Room 100A
10
S.F.
REPLACE
PRIORITY 3
LEVEL 2

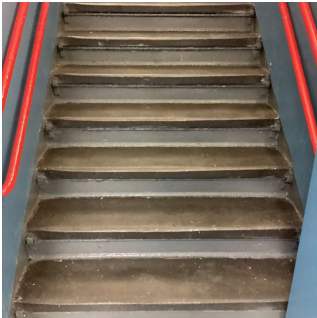
Question	Response
INTERIOR	
STAIRS/RAMPS: INTERIOR	
Stairs and Landings	
Violations	Near Room 100A No violations recorded.
Deficiency	STONE: WORN-OUT TREAD/NOSINGS
Deficiency Location/Instance	Exit 3
Deficiency Quantity	40
Quantity Uom	S.F.
Potential Action	REPLACE
Urgency of Action	PRIORITY 3
Purpose of Action	LEVEL 2
Deficiency Photo1

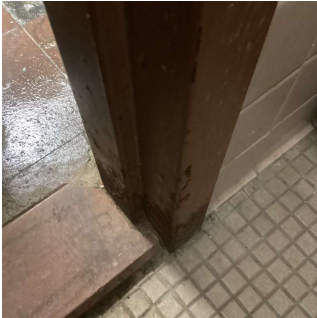
Question	Response
INTERIOR	
TOILET ROOMS - STAFF	
Ceiling	
Quantity Uom	S.F.
Potential Action	REPLACE
Urgency of Action	PRIORITY 3
Purpose of Action	LEVEL 2
Deficiency Photo1	 
Violations	In Kitchen Locker Room No violations recorded.
Door(s)	Inspected
Condition	5 - Poor
Deficiency	WOOD: DETERIORATED DOOR AND FRAME
Deficiency Location/Instance	In Kitchen Locker Room
Deficiency Quantity	1
Quantity Uom	EACH
Potential Action	MAINTENANCE
Urgency of Action	PRIORITY 3
Purpose of Action	LEVEL 2
Deficiency Photo1

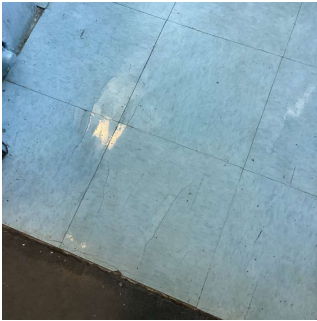
Violations	In Kitchen Locker Room No violations recorded.
Floor Finish	Inspected
Condition	5 - Poor
Deficiency	VINYL TILES: DETERIORATED SUBSTRATE
Deficiency Location/Instance	Rooms 310A, 252A
Deficiency Quantity	20
Quantity Uom	S.F.
Potential Action	REPLACE
Urgency of Action	PRIORITY 3
Purpose of Action	LEVEL 2

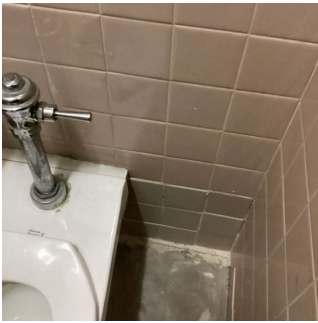
Violations	In Kitchen Locker Room No violations recorded.
Stalls	Does not Exist
Walls	Inspected
Condition	2 - Between Good and Fair
Deficiency	CERAMIC TILE: BROKEN/ MISSING
Deficiency Location/Instance	In Kitchen Locker Room
Deficiency Quantity	10
Quantity Uom	S.F.
Potential Action	REPLACE
Urgency of Action	PRIORITY 3
Purpose of Action	LEVEL 2

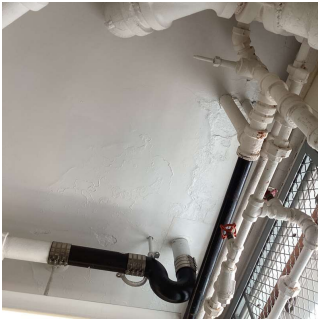
Violations	In Kitchen Locker Room No violations recorded.
TOILET ROOMS - STUDENTS	Inspected
Ceiling	Inspected
Condition	2 - Between Good and Fair
Deficiency	PLASTER: CRACKS/SPALLING
Deficiency Location/Instance	Room M06
Deficiency Quantity	20
Quantity Uom	S.F.
Potential Action	REPLACE
Urgency of Action	PRIORITY 3
Purpose of Action	LEVEL 2
Deficiency Photo1

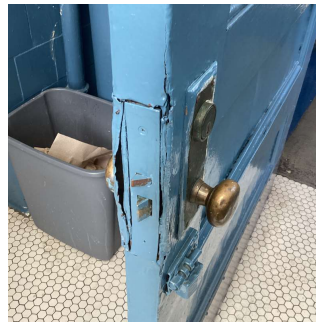
Room 252B

Violations	Room M06 No violations recorded.
Door(s)	Inspected
Condition	5 - Poor
Deficiency	METAL CLAD WOOD: DETERIORATED DOOR
Deficiency Location/Instance	Rooms 156, 252B, 310B
Deficiency Quantity	3
Quantity Uom	EACH
Potential Action	MAINTENANCE
Urgency of Action	PRIORITY 3
Purpose of Action	LEVEL 2

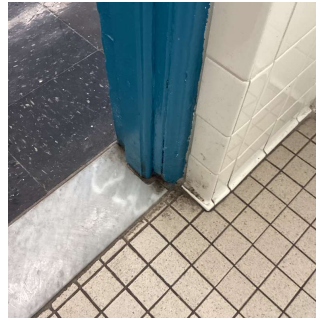
Room M06

WOOD: DETERIORATED DOOR AND FRAME

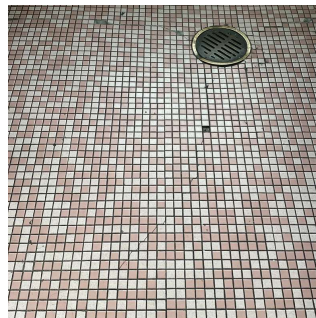
CERAMIC TILE: DETERIORATED SUBSTRATE

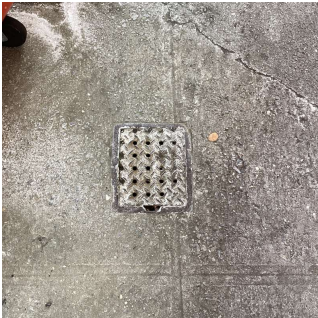
Deficiency	DAMAGED COVER
Deficiency Location/Instance	Near Exits 4, 5

Question	Response
SITE	
Drainage System for Concrete	
Catch Basins/Manhole - Surrounded by concrete	
Deficiency Quantity	2
Quantity Uom	EACH
Potential Action	REPLACE
Urgency of Action	PRIORITY 3
Purpose of Action	LEVEL 2
Deficiency Photo1

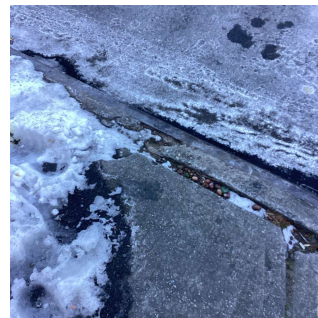
18th Avenue

DAMAGED CURBS

REPLACE

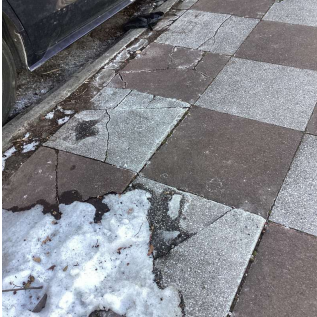
Webster Avenue
Violations	52221
Deficiency	DAMAGED/MISSING
Deficiency Location/Instance	Webster Avenue
Deficiency Quantity	150
Quantity Uom	S.F.
Potential Action	REPLACE
Urgency of Action	PRIORITY 4
Purpose of Action	LEVEL 4

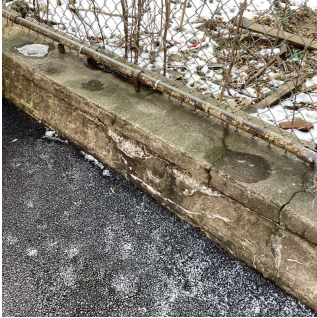
Webster Avenue 52221
Violations	
PLAYGROUNDS	Does not Exist
PLAYING SURFACE	Does not Exist
RETAINING WALLS	Inspected
Are there any Retaining Walls 6' OR higher facing public street/sidewalk?	No
Condition	3 - Fair
Deficiency	CAST IN PLACE CONCRETE: CRACKS/SPALLING - MAJOR
Deficiency Location/Instance	Near Exit 4, Schoolyard
Deficiency Quantity	30
Quantity Uom	S.F.
Potential Action	REPLACE
Urgency of Action	PRIORITY 3
Purpose of Action	LEVEL 2
Deficiency Photo1
