NYC Department of Education
Building Condition Assessment Survey 2023 - 2024

Architectural Inspection

Asset: P.S. 326 - BROOKLYN, 1800 UTICA AVENUE, New York, 11234

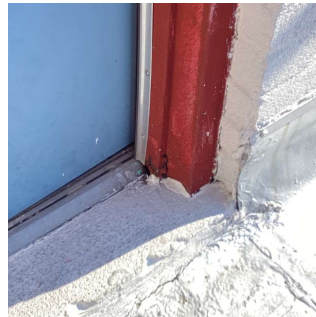
Facade C
No violations recorded.

METAL: DETERIORATED DOOR AND FRAME - MAJOR DETERIORATION

REPLACE

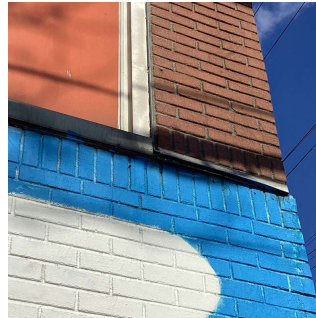
Facade B

METAL/GLASS CURT WALL: DAMAGED TRIM

REPLACE

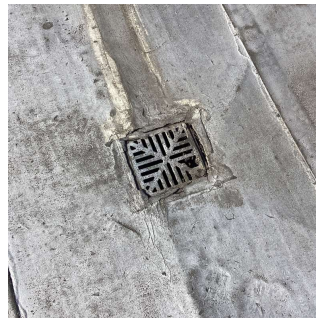
Roof 2
 No violations recorded.

Deficiency DETERIORATED

1
 EACH
 REPLACE
 PRIORITY 4
 LEVEL 2

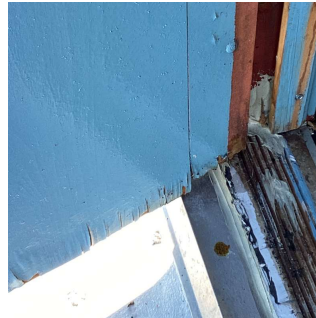
BH1

BULKHEAD/PENTHOUSE DOORS: DETERIORATED DOOR

1
 EACH
 REPLACE DOOR
 PRIORITY 4
 LEVEL 2

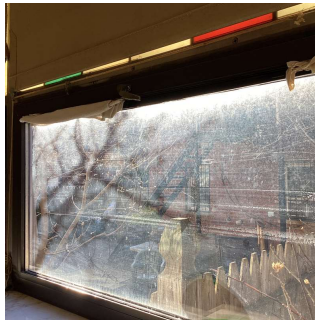
Facade C

ALUMINUM - OTHER: DETERIORATED

30
S.F.
REPLACE WINDOW
PRIORITY 4
LEVEL 2

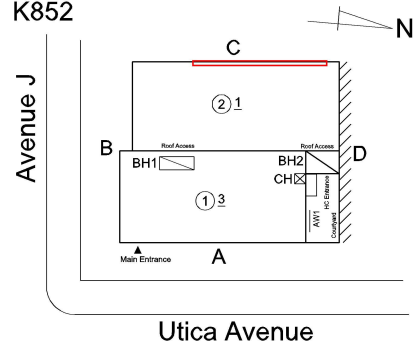
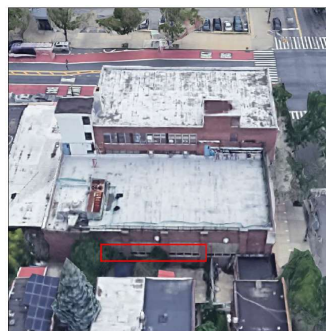
ALUMINUM - OTHER: HARDWARE POOR
CONDITION/MISSING

4

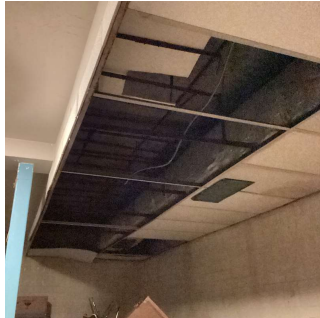
Question	Response
EXTERIOR	
WINDOWS	
WINDOWS	
Quantity Uom	EACH
Potential Action	MAINTENANCE
Urgency of Action	PRIORITY 3
Purpose of Action	LEVEL 2
Deficiency Photo1	No photo recorded
Violations	No violations recorded.
INTERIOR	
	Inspected
POOLS	
	Inspected
Instance on Basement	Inspected
CEILING	
Instance on Basement	Inspected
Condition	4 - Between Fair and Poor
Deficiency	ACOUSTIC TILE: MISSING/WATER DAMAGED/BROKEN TILES
Deficiency Location/Instance	Pool Area
Deficiency Quantity	300
Quantity Uom	S.F.
Potential Action	REPLACE
Urgency of Action	PRIORITY 4
Purpose of Action	LEVEL 2
Deficiency Photo1

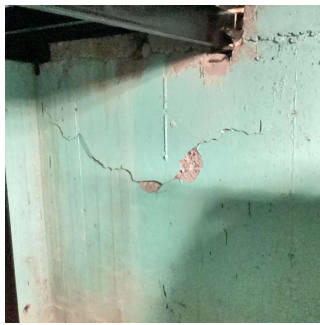
Question	Response
INTERIOR	
POOLS	
POOL STRUCTURE	
Deficiency Photo1

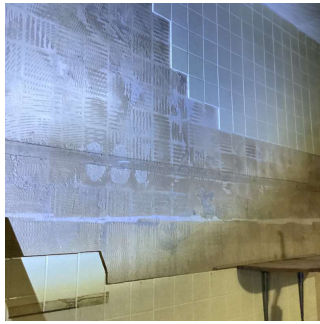
Equipment Room
Violations	No violations recorded.
SEATING	
Instance on Basement	Does not Exist
WALLS	
Instance on Basement	Inspected
Condition	4 - Between Fair and Poor
Deficiency	CERAMIC TILES: BROKEN/MISSING TILES
Deficiency Location/Instance	Pool Area
Deficiency Quantity	100
Quantity Uom	S.F.
Potential Action	REPLACE
Urgency of Action	PRIORITY 4
Purpose of Action	LEVEL 2
Deficiency Photo1

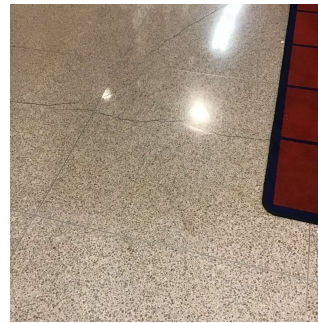
Corridor near Multi Purpose

Question	Response
INTERIOR	
CLASSROOMS/CORRIDORS/ADMIN SPACES	
Door(s)	Inspected
	Room 304
Violations	No violations recorded.
Floor Finish	Inspected
Condition	2 - Between Good and Fair
Deficiency	VINYL TILES: DETERIORATED SUBSTRATE
Deficiency Location/Instance	Corridor near room B18, 20
Deficiency Quantity	20
Quantity Uom	S.F.
Potential Action	REPLACE
Urgency of Action	PRIORITY 3
Purpose of Action	LEVEL 2
Deficiency Photo1	 
	Corridor near room B18
Violations	No violations recorded.
Deficiency	VINYL TILES: BROKEN/DETERIORATED/MISSING TILES
Deficiency Location/Instance	Corridor near to 2nd Floor Girls Restroom, Room B10
Deficiency Quantity	25
Quantity Uom	S.F.
Potential Action	REPLACE
Urgency of Action	PRIORITY 3
Purpose of Action	LEVEL 2
Deficiency Photo1	 
	Room B10
Violations	No violations recorded.
Deficiency	TERRAZZO: CRACKS
Deficiency Location/Instance	Corridor near Multi Purpose, near room 101, Main Office
Deficiency Quantity	120

Quantity Uom	S.F.
Potential Action	REPLACE
Urgency of Action	PRIORITY 3
Purpose of Action	LEVEL 2

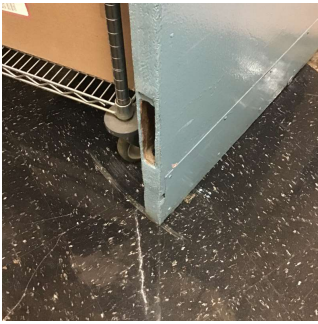
Main Entrance
Violations	No violations recorded.

Question	Response
INTERIOR	
KITCHEN	
Door(s)	
Deficiency Photo1

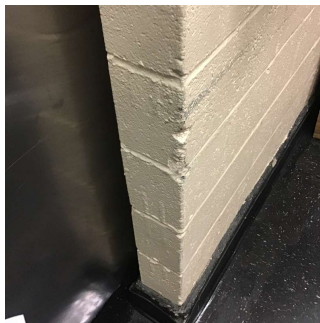
Instance on 1st Floor	Inspected
Condition	2 - Between Good and Fair
Deficiency	MASONRY: CRACKS/SPALLING
Deficiency Location/Instance	Near Main Entrance
Deficiency Quantity	15
Quantity Uom	S.F.
Potential Action	REPLACE
Urgency of Action	PRIORITY 3
Purpose of Action	LEVEL 2

Question	Response
INTERIOR	
KITCHEN	
Walls	
Deficiency Photo1

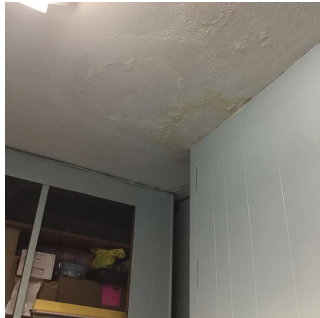
Violations	Near Main Entrance No violations recorded.
LIBRARY	Does not Exist
LOCKER ROOM	Does not Exist
MULTI-PURPOSE ROOM	Inspected
Instance on 1st Floor	Inspected
Ceiling	
Instance on 1st Floor	Inspected
Condition	2 - Between Good and Fair
Deficiency	PLASTER: CRACKS/SPALLING - ACTIVE LEAK
Deficiency Location/Instance	Multipurpose room office, Stage,
Deficiency Quantity	40
Quantity Uom	S.F.
Potential Action	REPLACE
Urgency of Action	PRIORITY 5
Purpose of Action	LEVEL 2
Deficiency Photo1

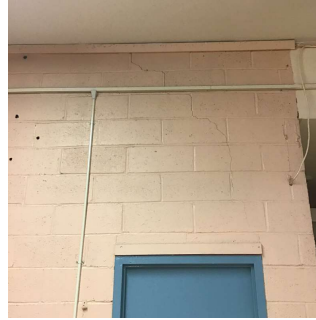
Question	Response
INTERIOR	
MULTI-PURPOSE ROOM	
Floor Finish	
Deficiency Photo1	 
Violations	Near Entrance No violations recorded.
Sliding-folding Partition	
Instance on 1st Floor	Does not Exist
Stage	
Instance on 1st Floor	Inspected
Stage	Inspected
Instance on 1st Floor	Inspected
Condition	2 - Between Good and Fair
Deficiency	DAMAGED FLOOR
Deficiency Location/Instance	Rear
Deficiency Quantity	15
Quantity Uom	S.F.
Potential Action	REPLACE
Urgency of Action	PRIORITY 3
Purpose of Action	LEVEL 2
Deficiency Photo1	 
Violations	Rear No violations recorded.
Stage Curtain Rigging	Does not Exist
Instance on 1st Floor	Does not Exist
Stage Curtains	Does not Exist
Instance on 1st Floor	Does not Exist
Walls	
Instance on 1st Floor	Inspected
Condition	2 - Between Good and Fair
Deficiency	MASONRY: CRACKS/SPALLING
Deficiency Location/Instance	Stage Left
Deficiency Quantity	20
Quantity Uom	S.F.

Potential Action	REPLACE
Urgency of Action	PRIORITY 3
Purpose of Action	LEVEL 2
Deficiency Photo1

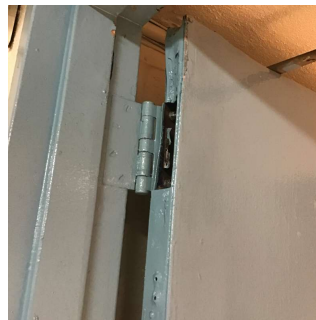
Stair B/Basement

Condition	4 - Between Fair and Poor
-----------	---------------------------

Deficiency	METAL: DETERIORATED DOOR
------------	--------------------------

Deficiency Location/Instance	Stair B/Basement, A/2
------------------------------	-----------------------

Deficiency Quantity	2
---------------------	---

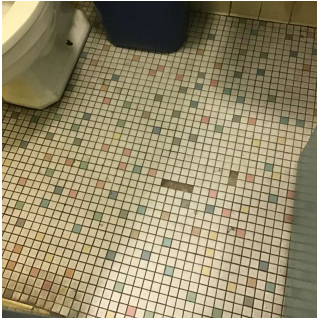
Question	Response
INTERIOR	
TOILET ROOMS - STAFF	
Ceiling	Inspected
Condition	2 - Between Good and Fair
Deficiency	No deficiencies recorded
Door(s)	Inspected
Condition	2 - Between Good and Fair
Deficiency	No deficiencies recorded
Floor Finish	Inspected
Condition	5 - Poor
Deficiency	CERAMIC TILE: BROKEN/MISSING TILES
Deficiency Location/Instance	2nd Floor Staff, Womens Basement, Principals
Deficiency Quantity	20
Quantity Uom	S.F.
Potential Action	REPLACE
Urgency of Action	PRIORITY 3
Purpose of Action	LEVEL 2
Deficiency Photo1

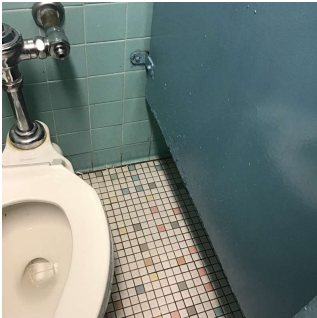
Violations	2nd Floor Staff No violations recorded.
Stalls	Inspected
Condition	5 - Poor
Deficiency	RUST - MAJOR
Deficiency Location/Instance	Mens Basement
Deficiency Quantity	1
Quantity Uom	EACH
Potential Action	REPLACE
Urgency of Action	PRIORITY 3
Purpose of Action	LEVEL 2
Deficiency Photo1

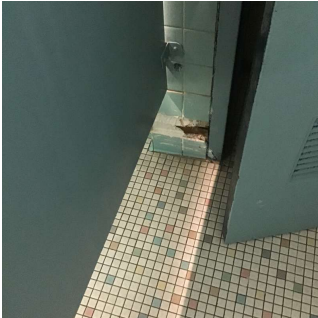
Question	Response
INTERIOR	
TOILET ROOMS - STAFF	
Walls	
Deficiency	CERAMIC TILE: BROKEN/ MISSING
Deficiency Location/Instance	2nd Floor Staff, Mens Basement
Deficiency Quantity	20
Quantity Uom	S.F.
Potential Action	REPLACE
Urgency of Action	PRIORITY 3
Purpose of Action	LEVEL 2
Deficiency Photo1

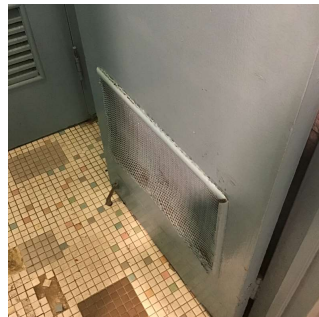
Violations	Mens Basement No violations recorded.
TOILET ROOMS - STUDENTS	
Ceiling	
Condition	Inspected 2 - Between Good and Fair
Deficiency	PLASTER: CRACKS/SPALLING
Deficiency Location/Instance	3rd Floor Boys
Deficiency Quantity	15
Quantity Uom	S.F.
Potential Action	REPLACE
Urgency of Action	PRIORITY 3
Purpose of Action	LEVEL 2
Deficiency Photo1	 
Violations	3rd Floor Boys No violations recorded.
Door(s)	
Condition	Inspected 5 - Poor
Deficiency	WOOD: DAMAGED LOUVER
Deficiency Location/Instance	Room 102
Deficiency Quantity	1
Quantity Uom	EACH
Potential Action	MAINTENANCE
Urgency of Action	PRIORITY 3

Question	Response
INTERIOR	
TOILET ROOMS - STUDENTS	
Door(s)	
Purpose of Action	LEVEL 2
Deficiency Photo1

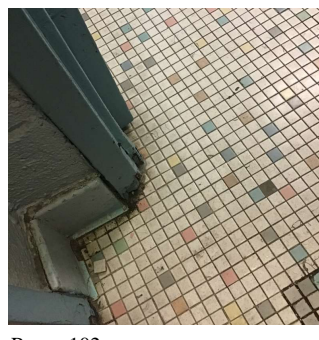
Room 102
Violations	No violations recorded.
Deficiency	WOOD: DETERIORATED DOOR AND FRAME
Deficiency Location/Instance	Room 102
Deficiency Quantity	1
Quantity Uom	EACH
Potential Action	MAINTENANCE
Urgency of Action	PRIORITY 3
Purpose of Action	LEVEL 2
Deficiency Photo1

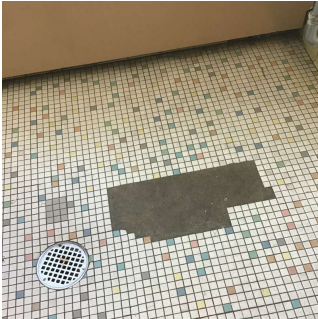
Question	Response
INTERIOR	
TOILET ROOMS - STUDENTS	
Door(s)	Inspected
Violations	No violations recorded.
Floor Finish	Inspected
Condition	3 - Fair
Deficiency	CERAMIC TILE: BROKEN/MISSING TILES
Deficiency Location/Instance	3rd Floor Girls, 3rd Floor Boys, 2nd Floor Boys, 2nd Floor Boys, 102
Deficiency Quantity	60
Quantity Uom	S.F.
Potential Action	REPLACE
Urgency of Action	PRIORITY 3
Purpose of Action	LEVEL 2
Deficiency Photo1

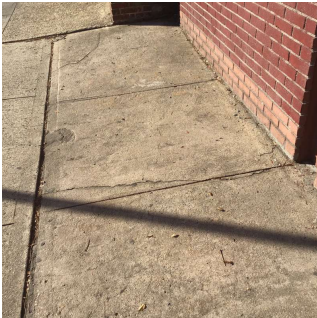
Violations	Courtyard No violations recorded.
IRRIGATION SYSTEM	Does not Exist
PAVING	Inspected
Student Non-Use	Inspected
Gravel Exists?	No
Asphalt	Does not Exist
Concrete	Inspected
Condition	2 - Between Good and Fair
Deficiency	No deficiencies recorded
Pavers	Does not Exist
Student Use	Does not Exist
Site Sidewalks & Walkways	Inspected
Asphalt	Does not Exist
Concrete	Inspected
Condition	3 - Fair
Deficiency	CRACKS - MAJOR
Deficiency Location/Instance	Avenue J
Deficiency Quantity	100
Quantity Uom	S.F.
Potential Action	REPLACE
Urgency of Action	PRIORITY 3
Purpose of Action	LEVEL 2
Deficiency Photo1

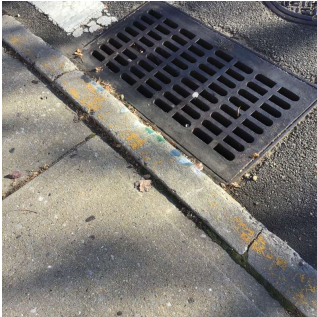
Question	Response
SITE	
PAVING	
Site Sidewalks & Walkways	Inspected
Concrete	Inspected
Violations	No violations recorded.
Pavers	Does not Exist
DOT Sidewalk	Inspected
Asphalt	Does not Exist
Concrete	Inspected
Condition	4 - Between Fair and Poor
Deficiency	DAMAGED CURBS
Deficiency Location/Instance	Avenue J
Deficiency Quantity	25
Quantity Uom	L.F.
Potential Action	REPLACE
Urgency of Action	PRIORITY 3
Purpose of Action	LEVEL 2
Deficiency Photo1

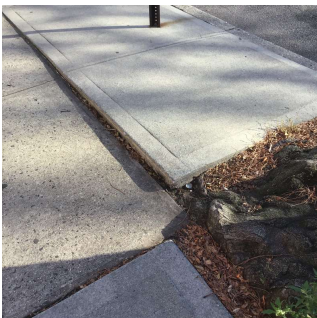
Violations	Avenue J No violations recorded.
Deficiency	HEAVING
Deficiency Location/Instance	Avenue J
Deficiency Quantity	75
Quantity Uom	S.F.
Potential Action	REPLACE
Urgency of Action	PRIORITY 5
Purpose of Action	LEVEL 6
Deficiency Photo1

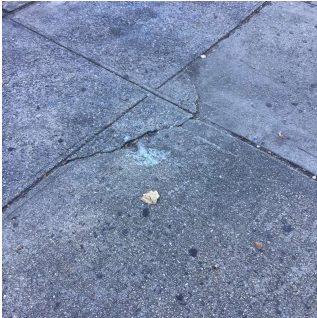
Utica Avenue
Violations	No violations recorded.
Pavers	Does not Exist
PLAYGROUNDS	Does not Exist
PLAYING SURFACE	Does not Exist
RETAINING WALLS	Does not Exist
SEATING	Does not Exist
SITE WALLS (NOT RETAINING WALLS)	Does not Exist
STAIRS/RAMPS: EXTERIOR	Does not Exist
ARTWORK	Does not Exist

Violations	Avenue J No violations recorded.
Deficiency	DAMAGED/DETERIORATED/MISSING SECTIONS
Deficiency Location/Instance	Utica Avenue, Avenue J
Deficiency Quantity	500

Question	Response
SITE	
PAVING	
DOT Sidewalk	Inspected
Concrete	
Quantity Uom	S.F.
Potential Action	REPLACE
Urgency of Action	PRIORITY 3
Purpose of Action	LEVEL 2
Deficiency Photo1
