**NYC Department of Education**  
**Building Condition Assessment Survey 2023 - 2024**

Architectural Inspection

**K855**

**Asset:** P.S. 135/P.S. 235 ANNEX - K, 5811 DITMAS AVENUE, New York, 11218

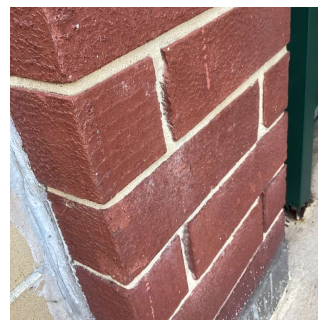
**BRICK: DETERIORATED JOINTS**

20  
S.F.  
REPOINT  
PRIORITY 4  
LEVEL 2

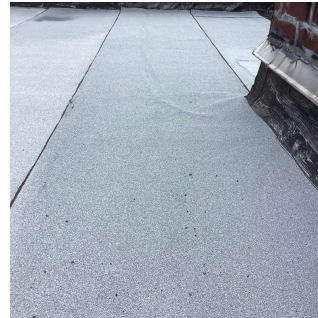
Roof 1

**MODIFIED BITUMEN: ROOFING: DELAMINATION**

50  
S.F.  
REPLACE ROOFING WITHOUT MAJOR EQUIPMENT  
REMOVAL  
PRIORITY 4  
LEVEL 2

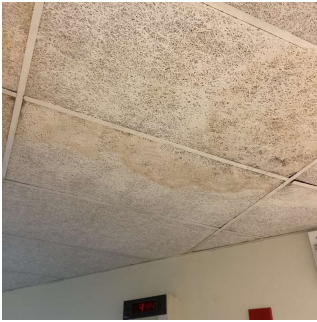
Near Entrance
Violations	No violations recorded.
<b>Door(s)</b>	
Instance on Basement - Staff (600SF)	Inspected
Condition	2 - Between Good and Fair

Basement - Water and Gas Main Room
Violations	No violations recorded.
<b>ROOF STRUCTURE</b>	
Condition	Inspected
	2 - Between Good and Fair
Deficiency	No deficiencies recorded
<b>VAULTS-BUNKERS</b>	
	Does not Exist
<b>AUDITORIUM</b>	
	Does not Exist
<b>CAFETERIA</b>	
	Inspected
Instance on Basement - Staff (600SF)	Inspected
Instance on Basement - Students	Inspected
<b>Ceiling</b>	
Instance on Basement - Staff (600SF)	Inspected
Condition	4 - Between Fair and Poor
Deficiency	TECTUM: DAMAGED/MISSING
Deficiency Location/Instance	Near Entrance, Serving Area
Deficiency Quantity	50
Quantity Uom	S.F.
Potential Action	REPLACE
Urgency of Action	PRIORITY 3
Purpose of Action	LEVEL 2
Deficiency Photo1

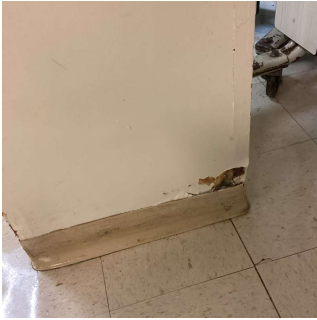
Question	Response
<b>INTERIOR</b>	
<b>CAFETERIA</b>	
<b>Stage</b>	
Instance on Basement - Staff (600SF)	Does not Exist
Instance on Basement - Students	Does not Exist
<b>Walls</b>	
Instance on Basement - Staff (600SF)	Inspected
Condition	2 - Between Good and Fair
Deficiency	PLASTER: CRACKS/SPALLING
Deficiency Location/Instance	Near center
Deficiency Quantity	10
Quantity Uom	S.F.
Potential Action	REPLACE
Urgency of Action	PRIORITY 3
Purpose of Action	LEVEL 2
Deficiency Photo1

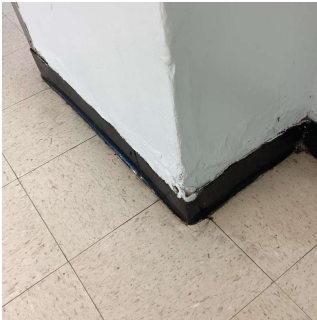
Columns
Violations	No violations recorded.
<b>Window Curtains/Shades/Blinds</b>	
Instance on Basement - Students	Does not Exist

Near center
Violations	No violations recorded.
Instance on Basement - Students	Inspected
Condition	2 - Between Good and Fair
Deficiency	GYPSUM BOARD: DETERIORATED
Deficiency Location/Instance	Columns
Deficiency Quantity	10
Quantity Uom	S.F.
Potential Action	REPLACE
Urgency of Action	PRIORITY 3
Purpose of Action	LEVEL 2
Deficiency Photo1

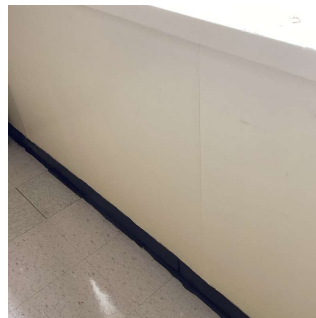
GYPSON BOARD: DETERIORATED

REPLACE

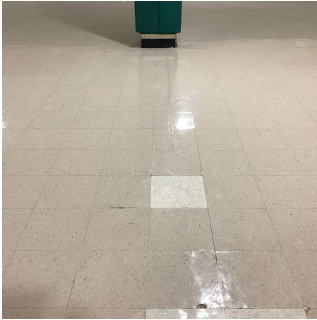
Question	Response
<b>INTERIOR</b>	
<b>MULTI-PURPOSE ROOM</b>	
<b>Ceiling</b>	
Deficiency Photo1	 
Violations	Near Entrance No violations recorded.
<b>Door(s)</b>	
Instance on Basement	Inspected
Condition	2 - Between Good and Fair
Deficiency	No deficiencies recorded
<b>Fixed Equipment</b>	
Instance on Basement	Does not Exist
<b>Floor Finish</b>	
Instance on Basement	Inspected
Condition	3 - Fair
Deficiency	VINYL TILES: DETERIORATED SUBSTRATE
Deficiency Location/Instance	Near center
Deficiency Quantity	120
Quantity Uom	S.F.
Potential Action	REPLACE
Urgency of Action	PRIORITY 3
Purpose of Action	LEVEL 2
Deficiency Photo1

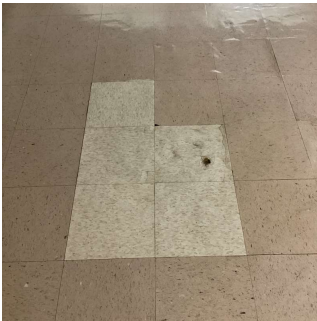
Violations	Near center No violations recorded.
Deficiency	VINYL TILES: BROKEN/DETERIORATED/MISSING TILES
Deficiency Location/Instance	Near Entrances, Windows
Deficiency Quantity	100
Quantity Uom	S.F.
Potential Action	REPLACE
Urgency of Action	PRIORITY 3
Purpose of Action	LEVEL 2

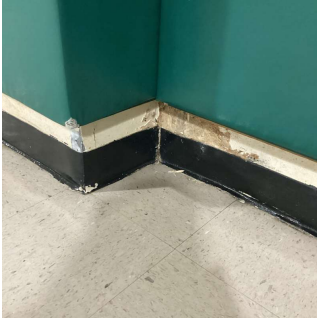
Near center
Violations	No violations recorded.
Deficiency	WALL PADDING: DETERIORATED
Deficiency Location/Instance	Near center, Columns
Deficiency Quantity	80
Quantity Uom	S.F.
Potential Action	REPLACE
Urgency of Action	PRIORITY 3
Purpose of Action	LEVEL 2

Near Entrance
Violations	No violations recorded.
<b>Sliding-folding Partition</b>	
Instance on Basement	Does not Exist
<b>Stage</b>	
Instance on Basement	Does not Exist
<b>Walls</b>	
Instance on Basement	Inspected
Condition	2 - Between Good and Fair
Deficiency	PLASTER: CRACKS/SPALLING
Deficiency Location/Instance	Near center
Deficiency Quantity	10
Quantity Uom	S.F.
Potential Action	REPLACE
Urgency of Action	PRIORITY 3
Purpose of Action	LEVEL 2
Deficiency Photo1

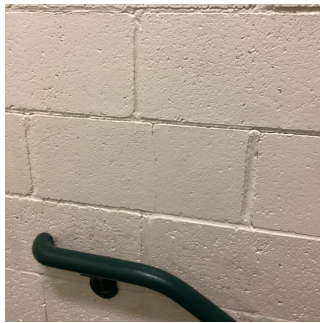
Question	Response
<b>INTERIOR</b>	
<b>STAIRS/RAMPS: INTERIOR</b>	
<b>Walls</b>	
Deficiency Photo1

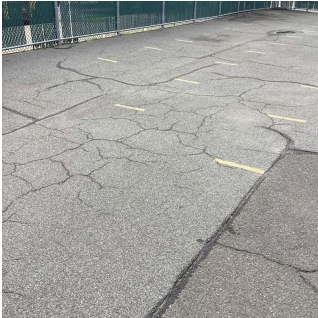
Question	Response
<b>SITE</b>	
<b>PAVING</b>	
<b>Student Non-Use</b>	Inspected
<b>Asphalt</b>	Inspected
Violations	No violations recorded.
<b>Concrete</b>	Does not Exist
<b>Pavers</b>	Does not Exist
<b>Student Use</b>	Inspected
Gravel Exists?	No
<b>Asphalt</b>	Inspected
Condition	4 - Between Fair and Poor
Deficiency	CRACKS - MAJOR
Deficiency Location/Instance	Near center, Playground
Deficiency Quantity	1,200
Quantity Uom	S.F.
Potential Action	REPLACE
Urgency of Action	PRIORITY 3
Purpose of Action	LEVEL 2
Deficiency Photo1

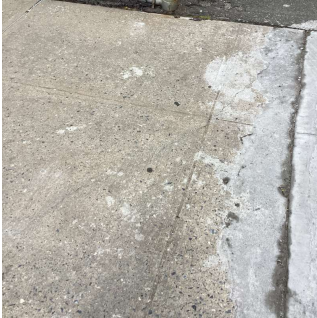
Question	Response
<b>SITE</b>	
<b>PAVING</b>	
<b>DOT Sidewalk</b>	
<b>Concrete</b>	
Deficiency Photo1

Violations	Ditmas Avenue No violations recorded.
<b>Pavers</b>	Does not Exist
<b>PLAYGROUNDS</b>	Does not Exist
<b>PLAYING SURFACE</b>	Does not Exist
<b>RETAINING WALLS</b>	Inspected
Are there any Retaining Walls 6' OR higher facing public street/sidewalk?	No
Condition	3 - Fair
Deficiency	CAST IN PLACE CONCRETE: CRACKS/SPALLING - MAJOR
Deficiency Location/Instance	Schoolyard Area, Along East 58th Street
Deficiency Quantity	80
Quantity Uom	S.F.
Potential Action	REPLACE
Urgency of Action	PRIORITY 3
Purpose of Action	LEVEL 2
Deficiency Photo1

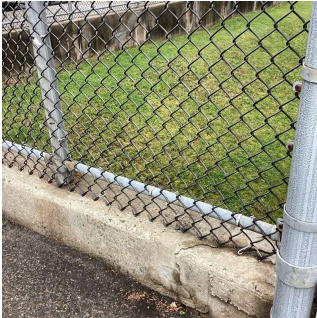
Violations	Schoolyard Area No violations recorded.
<b>SEATING</b>	Does not Exist
<b>SITE WALLS (NOT RETAINING WALLS)</b>	Does not Exist
<b>STAIRS/RAMPS: EXTERIOR</b>	Does not Exist
<b>ARTWORK</b>	Does not Exist
