NYC Department of Education
Building Condition Assessment Survey 2023 - 2024

Architectural Inspection

Asset: P.S. 36 ANNEX - BROOKLYN, 2045 LINDEN BLVD, New York, 11207

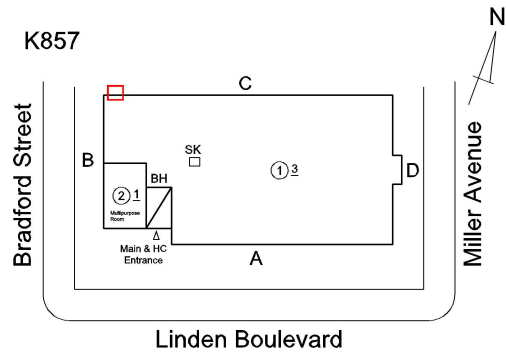
Question	Response
Architectural	
EXTERIOR	Inspected
AREAWAY	Does not Exist
AWNINGS AND CANOPIES	Does not Exist
CHIMNEY	Does not Exist
COPING	Inspected
Condition	2 - Between Good and Fair
Deficiency	No deficiencies recorded
CORNICE	Does not Exist
DOORS	Inspected
DOORS AND FRAMES	Inspected
Condition	4 - Between Fair and Poor
Deficiency	ROLL-UP DOOR: DETERIORATED DOOR AND FRAME - MAJOR DETERIORATION

300
S.F.
REPLACE
PRIORITY 4
LEVEL 2

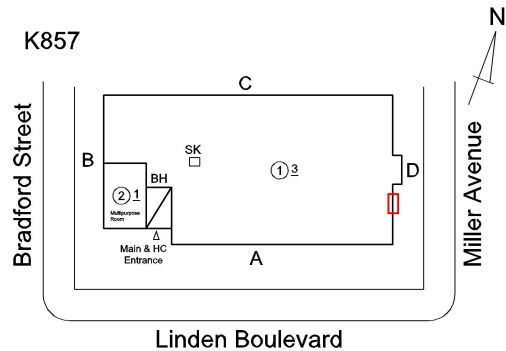
METAL CLAD: DETERIORATED DOOR AND FRAME - MAJOR DETERIORATION

1
EACH
REPLACE
PRIORITY 4
LEVEL 2

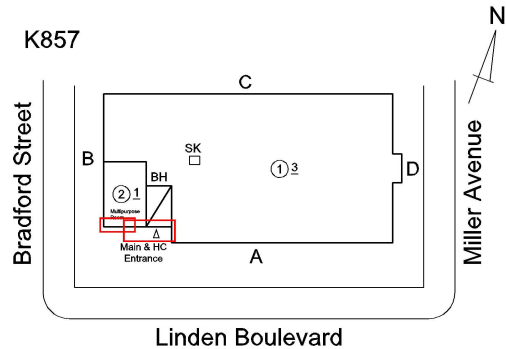
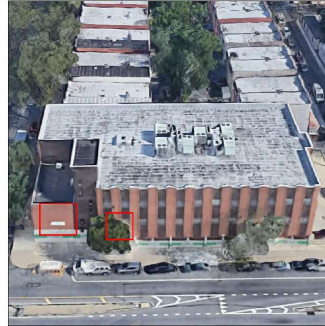
BRICK: DETERIORATED JOINTS

140

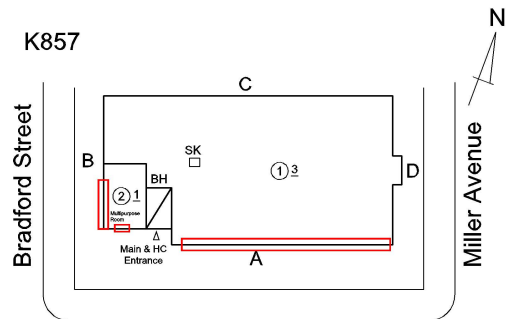
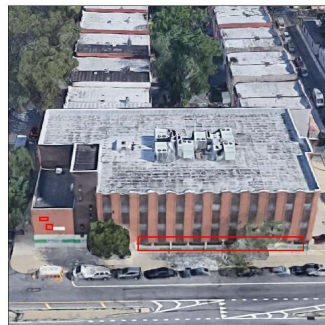
Linden Boulevard

BRICK: DETERIORATED JOINTS

100

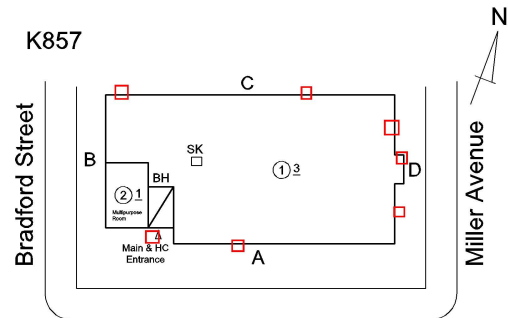
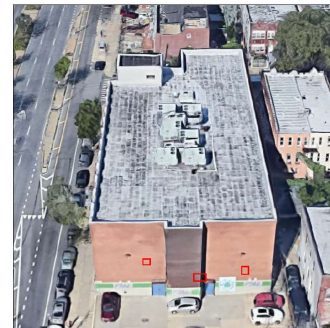
Linden Boulevard

BRICK: MINOR CRACKS AND SPALLING

70

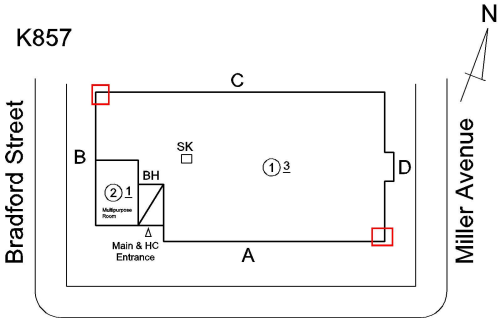
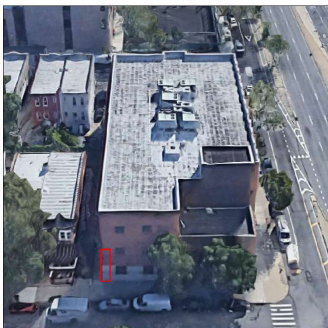
Question	Response
EXTERIOR	
EXTERIOR WALLS	
Violations	No violations recorded.
Deficiency	BRICK: CRACKS/DISPLACED/SPALLED BRICK AT BUILDING CORNERS
Roof Plan reference	<p align="center">K857</p>

Deficiency Quantity	80
Quantity Uom	S.F.
Potential Action	REMOVE AND REBUILD
Urgency of Action	PRIORITY 4
Purpose of Action	LEVEL 2
Deficiency Photo1

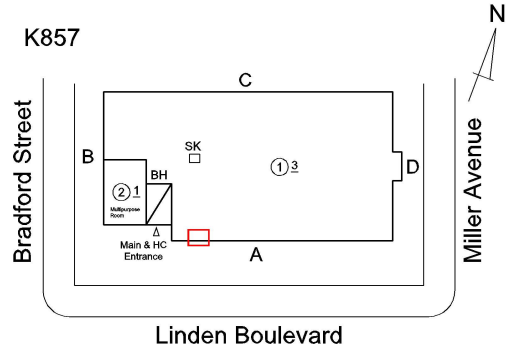
Instance Condition	2 - Between Good and Fair
Instance Quantity	4,000
Instance Quantity Uom	C.F.
Deficiency	METAL: RAILINGS: RUSTED
Roof Plan reference

Deficiency Quantity	25
Quantity Uom	S.F.
Potential Action	REPAIR AND REPAINT
Urgency of Action	PRIORITY 3
Purpose of Action	LEVEL 2
Deficiency Photo1

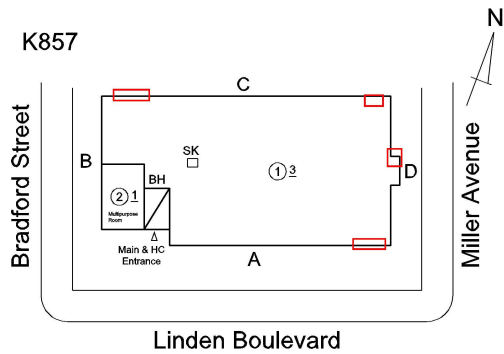
Deficiency	MODIFIED BITUMEN: FLASHING: BASE FLASHING DETERIORATED
------------	--

Deficiency Quantity	70
Quantity Uom	S.F.
Potential Action	REPAIR
Urgency of Action	PRIORITY 3
Purpose of Action	LEVEL 2
Deficiency Photo1

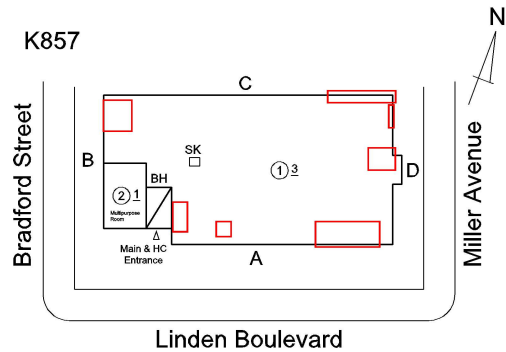
Violations	
Deficiency	MODIFIED BITUMEN: ROOFING: DELAMINATION

200
S.F.
REPLACE ROOFING WITH MAJOR EQUIPMENT REMOVAL
PRIORITY 4
LEVEL 2

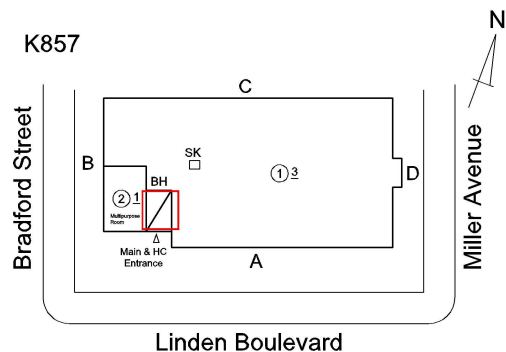
3 - Fair
BULKHEAD/PENTHOUSE CEILING: ACOUSTIC TILES DAMAGED/MISSING

20
S.F.
REPLACE

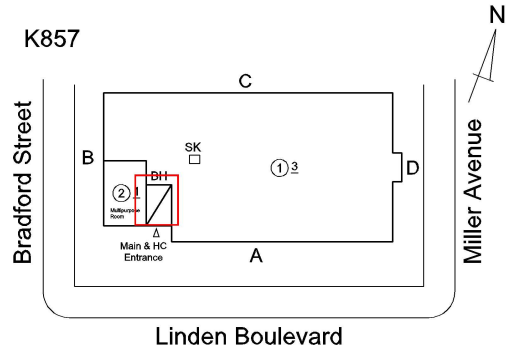
BULKHEAD/PENTHOUSE WALLS/INTERIOR: GYPSUM BOARD DAMAGED/DETERIORATED

30
S.F.
REPLACE
PRIORITY 4
LEVEL 2

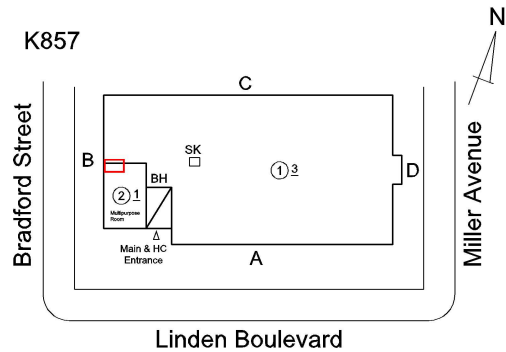
BULKHEAD/PENTHOUSE WALLS/EXTERIOR: CRACKS/SPALLING - MAJOR

35
 S.F.
 REPLACE
 PRIORITY 4
 LEVEL 2

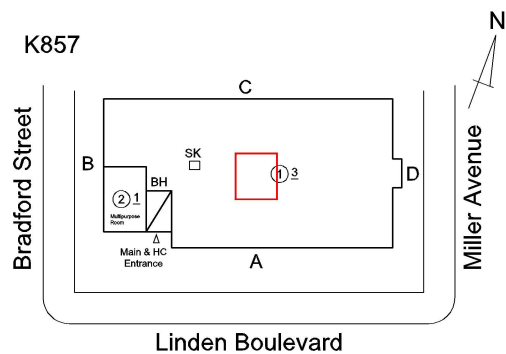
HEIGHT LESS THAN 18"

50
 L.F.
 REPLACE
 PRIORITY 3
 LEVEL 2

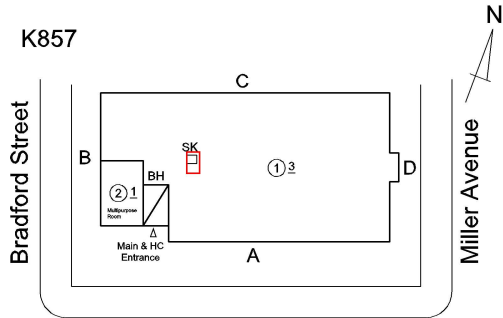
Violations	Roof 1 No violations recorded.
SKYLIGHT/ROOF VENT	Inspected
Material Type(s)	Glass
Condition	3 - Fair
Deficiency	BROKEN GLASS
Roof Plan reference

Deficiency Quantity	20
Quantity Uom	S.F.
Potential Action	MAINTENANCE
Urgency of Action	PRIORITY 3
Purpose of Action	LEVEL 2
Deficiency Photo1

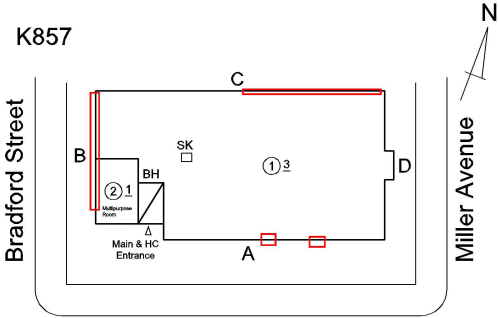
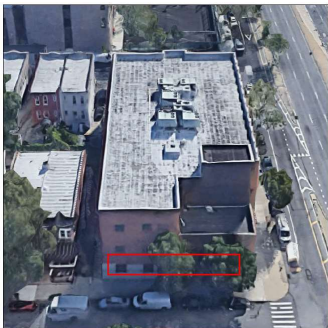
Question	Response
EXTERIOR	
WINDOWS	
EXTERIOR GUARDS	
Condition	Inspected 4 - Between Fair and Poor
Deficiency	DETERIORATED/TORN-OUT/MISSING
Roof Plan reference

Deficiency Quantity	300
Quantity Uom	S.F.
Potential Action	REPLACE
Urgency of Action	PRIORITY 4
Purpose of Action	LEVEL 2
Deficiency Photo1

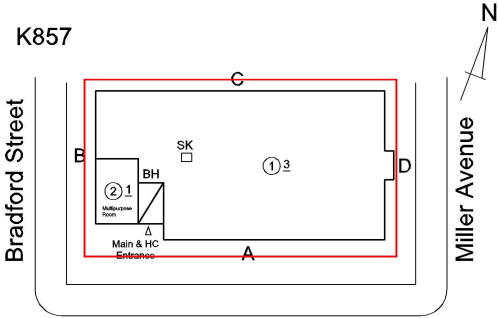
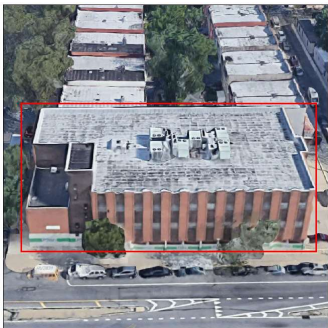
Question	Response
EXTERIOR	
WINDOWS	
WINDOWS	
Installation Year	1985
Source of Installation	Custodial Staff
Deficiency	ALUMINUM - OTHER: HARDWARE POOR CONDITION/MISSING
Roof Plan reference	<p align="center">K857</p>

Deficiency Quantity	60
Quantity Uom	EACH
Potential Action	MAINTENANCE
Urgency of Action	PRIORITY 3
Purpose of Action	LEVEL 2
Deficiency Photo1	No photo recorded
Violations	No violations recorded.
Instance on Steel: Facade C	Inspected
Instance Condition	3 - Fair
Instance Quantity	600
Instance Quantity Uom	S.F.
Are these windows insulated	No
Installation Year	1973
Source of Installation	Custodial Staff
Deficiency	STEEL: DETERIORATED

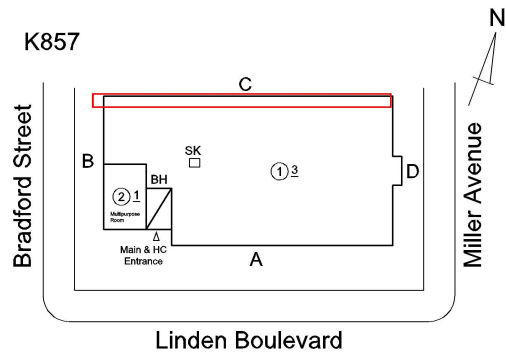
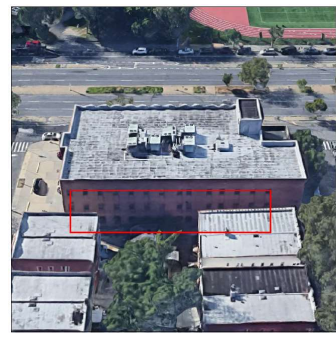
Deficiency Quantity	100
Quantity Uom	S.F.
Potential Action	REPLACE WINDOW
Urgency of Action	PRIORITY 4
Purpose of Action	LEVEL 2
Deficiency Photo1

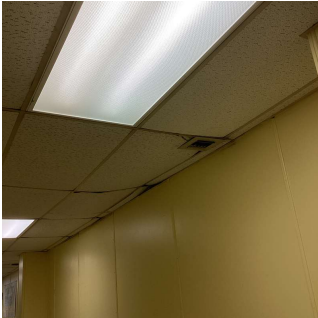
Question	Response
INTERIOR	
CLASSROOMS/CORRIDORS/ADMIN SPACES	
Ceiling	
Violations	No violations recorded.
Deficiency	ACOUSTIC TILES: DAMAGED/MISSING
Deficiency Location/Instance	Rooms 301, 303, Corridor near Rooms 103, 311, by Stair A/3 and others
Deficiency Quantity	520
Quantity Uom	S.F.
Potential Action	REPLACE
Urgency of Action	PRIORITY 3
Purpose of Action	LEVEL 2
Deficiency Photo1

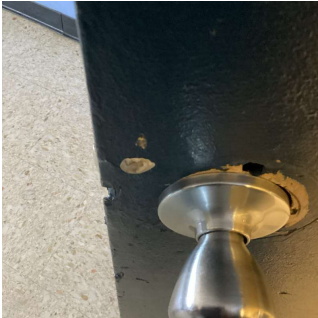
Violations	Corridor near Room 103 No violations recorded.
Door(s)	
Condition	Inspected 5 - Poor
Deficiency	WOOD: DETERIORATED DOOR
Deficiency Location/Instance	Rooms 201, 203, 223, 307
Deficiency Quantity	4
Quantity Uom	EACH
Potential Action	MAINTENANCE
Urgency of Action	PRIORITY 3
Purpose of Action	LEVEL 2
Deficiency Photo1

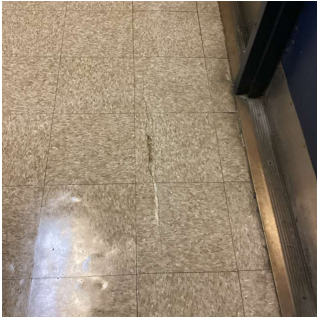
Violations	Room 101 No violations recorded.
Deficiency	VINYL TILES: DETERIORATED SUBSTRATE
Deficiency Location/Instance	Main Entrance - Vestibule, Corridor near Stair A/1
Deficiency Quantity	20
Quantity Uom	S.F.
Potential Action	REPLACE
Urgency of Action	PRIORITY 3
Purpose of Action	LEVEL 2
Deficiency Photo1

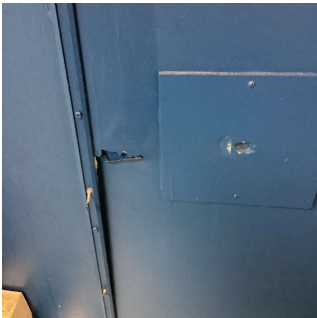
Violations	Near Windows No violations recorded.
Walls	
Instance on Room 311	Inspected
Condition	2 - Between Good and Fair
Deficiency	GYPSUM BOARD: DETERIORATED
Deficiency Location/Instance	Near Main Entrance
Deficiency Quantity	10
Quantity Uom	S.F.
Potential Action	REPLACE
Urgency of Action	PRIORITY 3
Purpose of Action	LEVEL 2
Deficiency Photo1

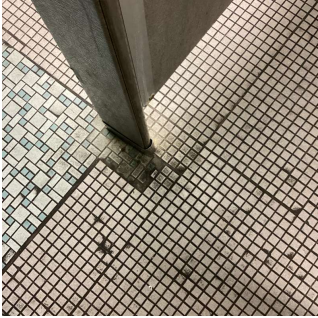
Question	Response
INTERIOR	
TOILET ROOMS - STUDENTS	
Door(s)	Inspected
	Room 114
Violations	No violations recorded.
Floor Finish	Inspected
Condition	2 - Between Good and Fair
Deficiency	CERAMIC TILE: BROKEN/MISSING TILES
Deficiency Location/Instance	Rooms 114, 225
Deficiency Quantity	30
Quantity Uom	S.F.
Potential Action	REPLACE
Urgency of Action	PRIORITY 3
Purpose of Action	LEVEL 2
Deficiency Photo1

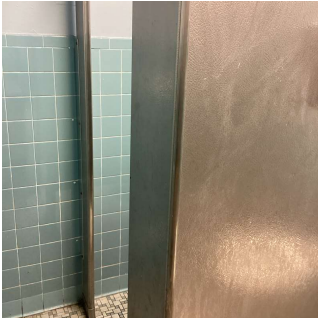
Room 225
Violations	No violations recorded.
Stalls	Inspected
Condition	4 - Between Fair and Poor
Deficiency	BROKEN/MISSING
Deficiency Location/Instance	Room 225
Deficiency Quantity	2
Quantity Uom	EACH
Potential Action	REPLACE
Urgency of Action	PRIORITY 3
Purpose of Action	LEVEL 2
Deficiency Photo1

Room 225
Violations	No violations recorded.
Walls	Inspected
Condition	2 - Between Good and Fair
Deficiency	GYPNUM BOARD: DETERIORATED
Deficiency Location/Instance	Rooms 114, 115
Deficiency Quantity	20

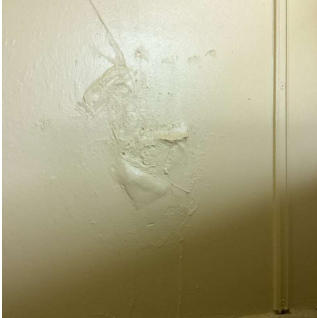
Question	Response
INTERIOR	
TOILET ROOMS - STUDENTS	
Walls	
Quantity Uom	S.F.
Potential Action	REPLACE
Urgency of Action	PRIORITY 3
Purpose of Action	LEVEL 2
Deficiency Photo1

Room 115
Violations	No violations recorded.
Deficiency	CERAMIC TILE: BROKEN/ MISSING
Deficiency Location/Instance	Rooms 114, 226
Deficiency Quantity	20
Quantity Uom	S.F.
Potential Action	REPLACE
Urgency of Action	PRIORITY 3
Purpose of Action	LEVEL 2
Deficiency Photo1

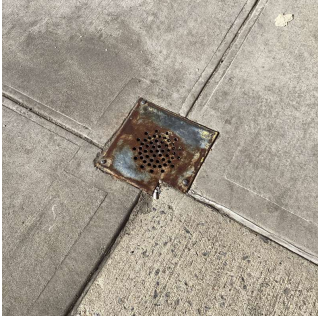
Room 114
Violations	No violations recorded.
LIFE SAFETY	
	Inspected
F.D. HOLDING AREA	
	Does not Exist
STEEL STAIRS	
	Does not Exist
SITE	
	Inspected
CONTAINERIZATION	
	Does not Exist
Drainage System for Asphalt	
	Does not Exist
Drainage System for Concrete	
	Inspected
Catch Basins/Manhole - Surrounded by concrete	
	Inspected
Condition	4 - Between Fair and Poor
Deficiency	DAMAGED COVER
Deficiency Location/Instance	Miller Avenue, Back Side of Building
Deficiency Quantity	2
Quantity Uom	EACH

Question	Response
SITE	
Drainage System for Concrete	
Catch Basins/Manhole - Surrounded by concrete	
Potential Action	REPLACE
Urgency of Action	PRIORITY 3
Purpose of Action	LEVEL 2
Deficiency Photo1

Violations	Miller Avenue No violations recorded.
Culverts - Concrete Covering	Does not Exist
Drainage System for Soil	Does not Exist
DRINKING FOUNTAINS	Does not Exist
FENCES	Inspected
Condition	4 - Between Fair and Poor
Deficiency	CONCRETE CURB: DAMAGED/DETERIORATED
Deficiency Location/Instance	Back Side of the Building
Deficiency Quantity	30
Quantity Uom	S.F.
Potential Action	REPLACE
Urgency of Action	PRIORITY 3
Purpose of Action	LEVEL 2
Deficiency Photo1	 
Violations	Back Side of the Building No violations recorded.
Deficiency	CHAIN LINK: RUST - MAJOR
Deficiency Location/Instance	Miller Avenue, Back side of Building
Deficiency Quantity	1,100
Quantity Uom	S.F.
Potential Action	REPLACE
Urgency of Action	PRIORITY 3
Purpose of Action	LEVEL 2

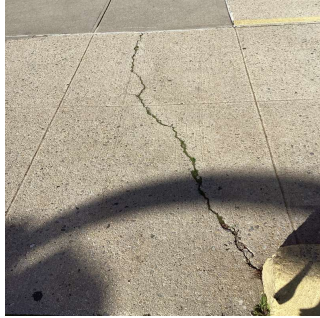
Question	Response
SITE	
FENCES	
Deficiency Photo1	 
Violations	Miller Avenue No violations recorded.
IRRIGATION SYSTEM	Does not Exist
PAVING	Inspected
Student Non-Use	Inspected
Gravel Exists?	No
Asphalt	Does not Exist
Concrete	Inspected
Condition	4 - Between Fair and Poor
Deficiency	DAMAGED/DETERIORATED/MISSING SECTIONS
Deficiency Location/Instance	Miller Avenue, Linden Boulevard, Bradford Street
Deficiency Quantity	700
Quantity Uom	S.F.
Potential Action	REPLACE
Urgency of Action	PRIORITY 3
Purpose of Action	LEVEL 2
Deficiency Photo1	 
Violations	Miller Avenue No violations recorded.
Pavers	Does not Exist
Student Use	Does not Exist
Site Sidewalks & Walkways	Inspected
Asphalt	Does not Exist
Concrete	Inspected
Condition	3 - Fair
Deficiency	DAMAGED/DETERIORATED/MISSING SECTIONS
Deficiency Location/Instance	Miller Avenue, Back of the building
Deficiency Quantity	100
Quantity Uom	S.F.
Potential Action	REPLACE

Question	Response
SITE	
PAVING	
Site Sidewalks & Walkways	
Concrete	
Urgency of Action	PRIORITY 3
Purpose of Action	LEVEL 2
Deficiency Photo1

Miller Avenue
Violations	No violations recorded.
Pavers	Does not Exist
DOT Sidewalk	Inspected
Asphalt	Does not Exist
Concrete	Inspected
Condition	4 - Between Fair and Poor
Deficiency	DAMAGED/DETERIORATED/MISSING SECTIONS
Deficiency Location/Instance	Miller Avenue, Linden Boulevard, Bradford Street
Deficiency Quantity	2,250
Quantity Uom	S.F.
Potential Action	REPLACE
Urgency of Action	PRIORITY 3
Purpose of Action	LEVEL 2
Deficiency Photo1

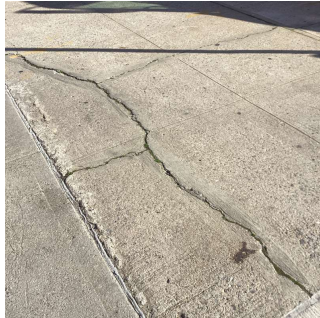
Miller Avenue
Violations	No violations recorded.
Deficiency	DAMAGED CURBS
Deficiency Location/Instance	Miller Avenue, Linden Boulevard, Bradford Street
Deficiency Quantity	210
Quantity Uom	L.F.
Potential Action	REPLACE
Urgency of Action	PRIORITY 3
Purpose of Action	LEVEL 2

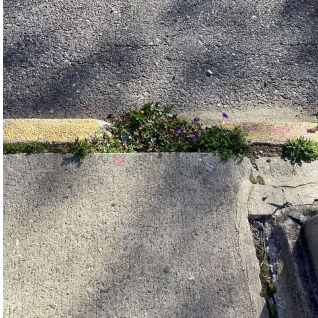
Question	Response
SITE	
PAVING	
DOT Sidewalk	
Concrete	
Deficiency Photo1	
<p align="center">Violations</p>

<p align="center">Miller Avenue No violations recorded.</p>
Pavers	Does not Exist
PLAYGROUNDS	Does not Exist
PLAYING SURFACE	Does not Exist
RETAINING WALLS	Does not Exist
SEATING	Does not Exist
SITE WALLS (NOT RETAINING WALLS)	Does not Exist
STAIRS/RAMPS: EXTERIOR	Does not Exist
ARTWORK	Does not Exist
