NYC Department of Education
Building Condition Assessment Survey 2023 - 2024

Architectural Inspection

Asset: **I.S. 364 AX (POOL&GYM)-BROOKLYN, 1540 VAN SICLEN AVE, New York, 11239**

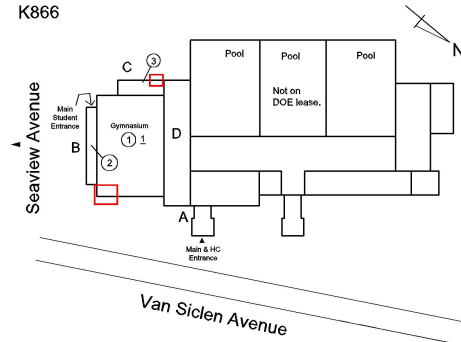
Question	Response
Architectural	
EXTERIOR	Inspected
AREAWAY	Not Required
AWNINGS AND CANOPIES	Not Required
CHIMNEY	Not Required
COPING	Inspected
Condition	2 - Between Good and Fair
Deficiency	No deficiencies recorded
CORNICE	Does not Exist
DOORS	Inspected
DOORS AND FRAMES	Inspected
Condition	3 - Fair
Deficiency	METAL: DETERIORATED DOOR - MINOR DETERIORATION
Roof Plan reference	K866

Deficiency Quantity	2
Quantity Uom	EACH
Potential Action	MAINTENANCE
Urgency of Action	PRIORITY 3
Purpose of Action	LEVEL 2

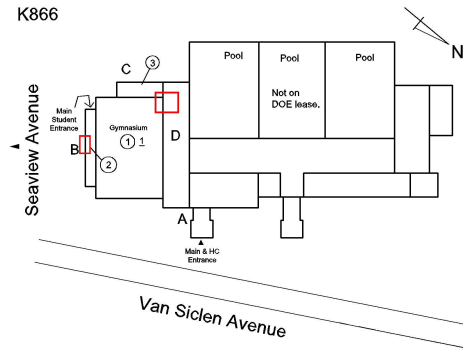
Violations	Facade C No violations recorded.
DOOR HARDWARE	Inspected
Condition	2 - Between Good and Fair
Deficiency	No deficiencies recorded
LINTELS	Inspected
Condition	2 - Between Good and Fair
Deficiency	No deficiencies recorded
TRANSOM/SIDE LIGHT	Inspected
Condition	2 - Between Good and Fair
Deficiency	No deficiencies recorded
EXTERIOR WALLS	Inspected
Material Type(s)	Masonry
Replacement Quantity	11,000
Replacement Uom	S.F.
Instance on All Facades	Inspected
Instance Condition	2 - Between Good and Fair
Instance Quantity	11,000
Instance Quantity Uom	S.F.
Deficiency	No deficiencies recorded
EXTERIOR SOFFITS	Not Required
LOADING DOCK	Not Required
LOUVER	Inspected
Condition	3 - Fair
Deficiency	BROKEN/ DENTED BLADES
Roof Plan reference	K866

Question	Response
EXTERIOR	
LOUVER	
Elevation	 
Deficiency Quantity	10
Quantity Uom	S.F.
Potential Action	REPLACE
Urgency of Action	PRIORITY 4
Purpose of Action	LEVEL 2
Deficiency Photo1	 
Violations	Facade B No violations recorded.
PARAPETS	Inspected
Material Type(s)	Masonry, Metal, Other
Replacement Quantity	1,000
Replacement Uom	C.F.
Instance on All Roofs	Inspected
Instance Condition	2 - Between Good and Fair
Instance Quantity	1,000
Instance Quantity Uom	C.F.
Deficiency	No deficiencies recorded
PLAZA DECK	Does not Exist
ROOF	Inspected
Roofing	Inspected
Replacement Quantity	5,500
Replacement Uom	S.F.
ROOF HATCH/SMOKE HATCH	Not Required
LEADERS, GUTTERS, DOWNSPOUTS, SCUPPERS	Not Required
ROOF BARRIER/FENCE	Inspected
Condition	3 - Fair
Deficiency	RAILINGS/PANELS: DETERIORATED, MAJOR RUSTING

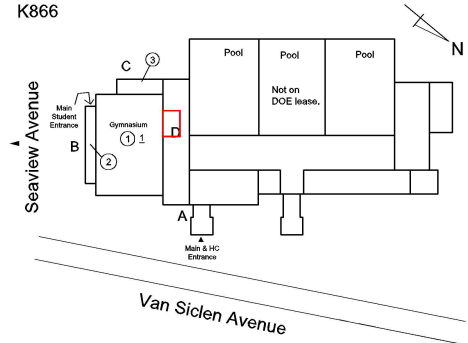
Roof 4
Instance Quantity	500
Instance Quantity Uom	S.F.
Does the roof have major mechanical equipment sitting on Dunnage Steel less than 18" above the Roofing?	No
Does this roof instance have a Sustainable Roof System?	Yes
Sustainable Roof Type	White Roof
Sustainable Roof Location (Roof Number)	Roof 4
Do solar panels exist on these roofs?	No
Is/Are the roof(s) suitable for Solar Panel installation?	No
Installation Year	1978
Source of Installation	Inspector Estimate
Deficiency	MODIFIED BITUMEN: ROOFING: DELAMINATION
Roof Plan reference	K866

Deficiency Quantity	100
Quantity Uom	S.F.
Potential Action	REPLACE ROOFING WITHOUT MAJOR EQUIPMENT REMOVAL
Urgency of Action	PRIORITY 4
Purpose of Action	LEVEL 2
Deficiency Photo1
