**NYC Department of Education**  
**Building Condition Assessment Survey 2023 - 2024**

Architectural Inspection

**Asset: P.S. 361 MINISCHOOL - BROOKLYN, 3109 NEWKIRK AVENUE, New York, 11210**

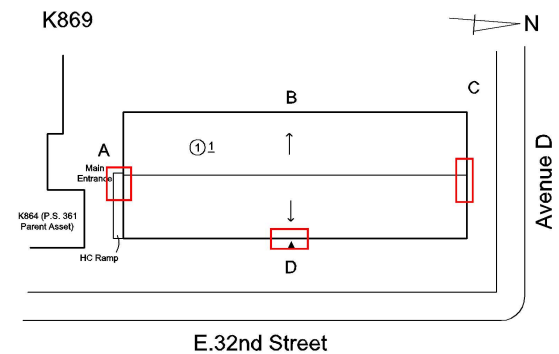
Roof Plan reference

Deficiency METAL: DETERIORATED DOOR AND FRAME - MAJOR DETERIORATION

6

REPLACE

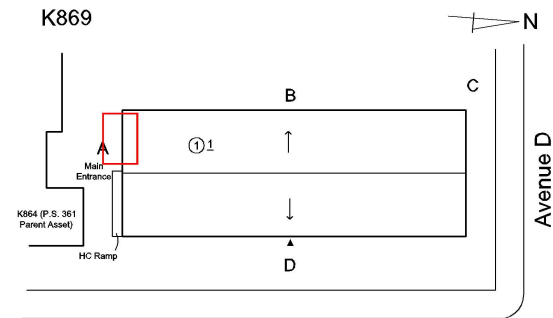
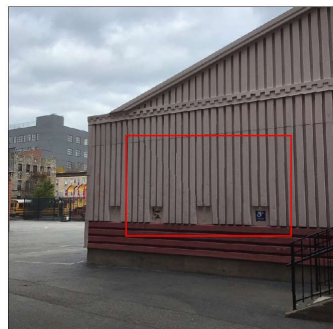
Violations	Facade D No violations recorded.
<b>DOOR HARDWARE</b>	Inspected
Condition	3 - Fair
Deficiency	No deficiencies recorded
<b>LINTELS</b>	Does not Exist
<b>TRANSOM/SIDE LIGHT</b>	Does not Exist
<b>EXTERIOR WALLS</b>	Inspected
Material Type(s)	Masonry, Steel
Replacement Quantity	6,000
Replacement Uom	S.F.
Instance on All Facades	Inspected
Instance Condition	5 - Poor
Instance Quantity	6,000
Instance Quantity Uom	S.F.
Deficiency	METAL PANEL: SEVERE DENTS
Roof Plan reference

Deficiency Quantity	80
Quantity Uom	S.F.
Potential Action	REPLACE

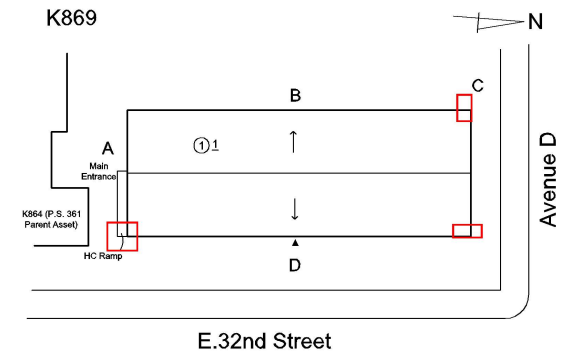
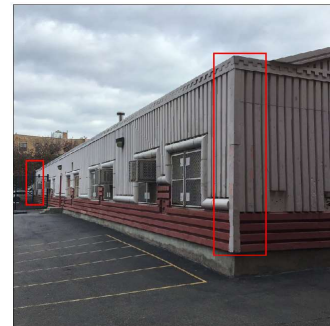
Roof Plan reference

METAL PANEL: DAMAGED TRIM

30

REPLACE

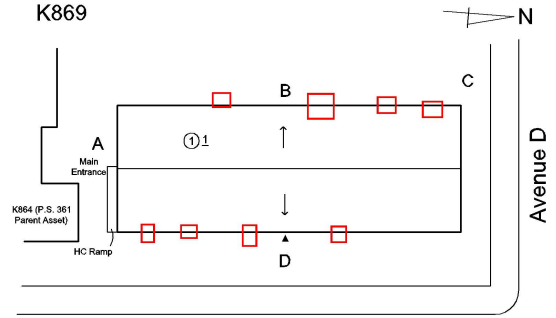
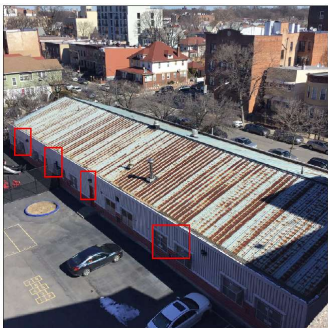
Question	Response
<b>EXTERIOR</b>	
<b>EXTERIOR WALLS</b>	
Violations	No violations recorded.
Deficiency	METAL PANEL: WATER INFILTRATION IN INSTRUCTIONAL SPACE
Roof Plan reference

Deficiency Quantity	800
Quantity Uom	S.F.
Potential Action	REPAIR
Urgency of Action	PRIORITY 5
Purpose of Action	LEVEL 2
Deficiency Photo1

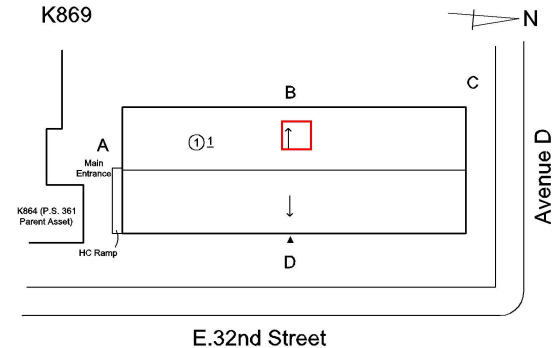
Roof Plan reference

Roof 1
Instance Quantity	10,000
Instance Quantity Uom	S.F.
Does the roof have major mechanical equipment sitting on Dunnage Steel less than 18" above the Roofing?	No
Does this roof instance have a Sustainable Roof System?	No
Do solar panels exist on these roofs?	No
Is/Are the roof(s) suitable for Solar Panel installation?	No
Installation Year	1989
Source of Installation	Custodial Staff
Deficiency	METAL: ROOFING: MAJOR ACTIVE ROOF LEAKS IN NON-INSTRUCTIONAL SPACE

Deficiency Quantity	100
Quantity Uom	S.F.
Potential Action	REPLACE
Urgency of Action	PRIORITY 5
Purpose of Action	LEVEL 2

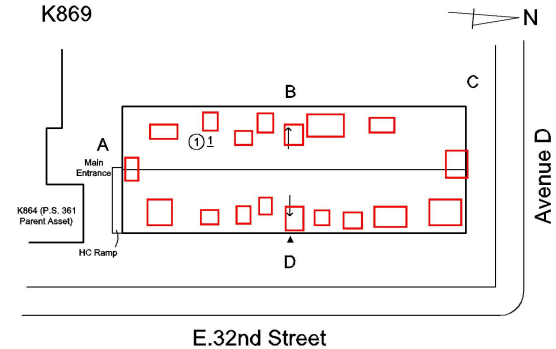
Violations	Roof 1 - Mechanical Room 5 No violations recorded.
Deficiency	<b>METAL: ROOFING: MAJOR ACTIVE ROOF LEAKS IN INSTRUCTIONAL SPACE</b>
Roof Plan reference

<p>K869</p> <p>Main Entrance</p> <p>HC Ramp</p> <p>K864 (P.S. 361 Parent Asset)</p> <p>E.32nd Street</p> <p>Avenue D</p> <p>A, B, C, D</p>
Deficiency Quantity	1,800
Quantity Uom	S.F.
Potential Action	REPLACE
Urgency of Action	PRIORITY 5
Purpose of Action	LEVEL 2
Deficiency Photo1

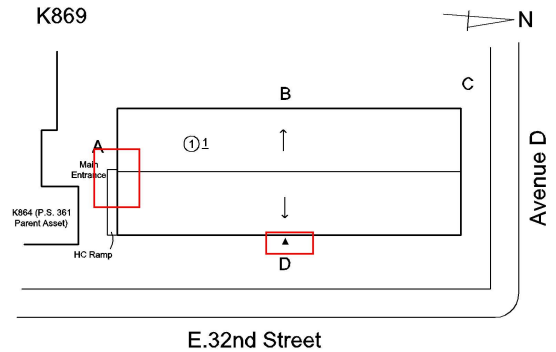
Roof Plan reference

Violations	Roof 1 - Rooms 1, 2, 3, 4, 6, 7, 10, 11, 13, Office, Staff, Exits A, B (Shown), C - Vestibules, In Rooms 1/3, 2/4, 7/13, 10/12 No violations recorded.
<b>ROOFING DRAINS</b>	Does not Exist
<b>Specialties</b>	Does not Exist
<b>STAIRS/RAMPS: EXTERIOR</b>	Inspected
<b>BUILDING CHEEK/FLANK WALLS</b>	Inspected
Condition	4 - Between Fair and Poor
Deficiency	CAST IN PLACE CONCRETE: CRACKS/SPALLING - MAJOR

**BUILDING CHEEK/FLANK WALLS**

20  
S.F.  
REPLACE  
PRIORITY 4  
LEVEL 2

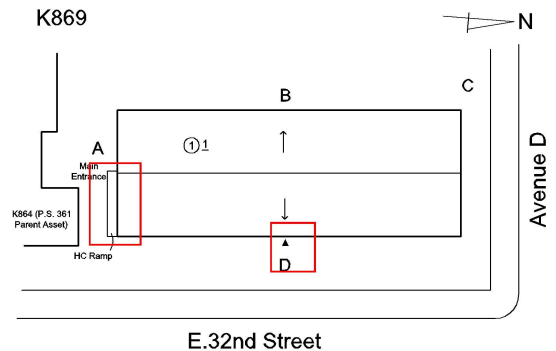
Roof Plan reference

CONCRETE: CRACKS/SPALLING - MAJOR

30  
S.F.  
REPLACE  
PRIORITY 4  
LEVEL 2

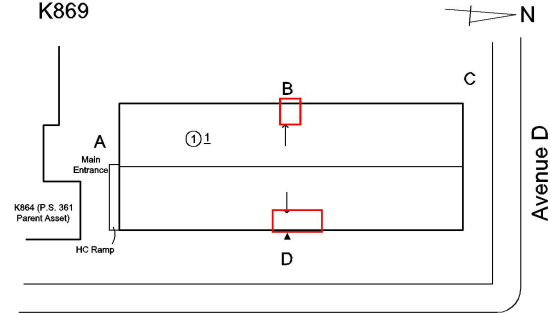
Violations	Facade A No violations recorded.
Deficiency	<b>CONCRETE: CRACKS/SPALLING - MINOR</b>
Roof Plan reference	<p>K869</p>

<p>E.32nd Street</p>
Deficiency Quantity	20
Quantity Uom	S.F.
Potential Action	REPAIR
Urgency of Action	PRIORITY 3
Purpose of Action	LEVEL 2
Deficiency Photo1

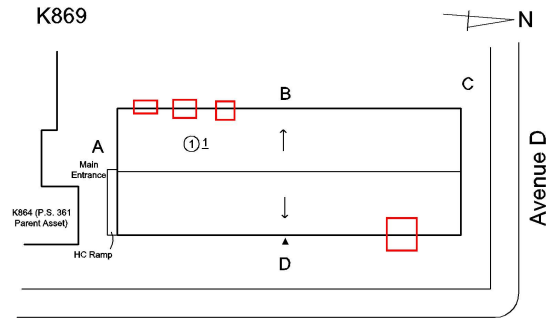
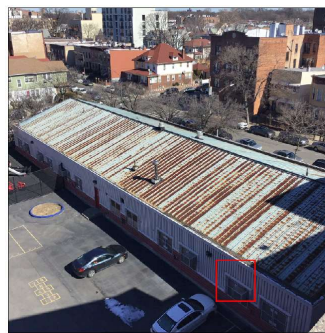
Roof Plan reference

Violations	Facade A No violations recorded.
<b>WINDOWS</b>	Inspected
Replacement Quantity	720
Replacement Uom	S.F.
<b>EXTERIOR GUARDS</b>	Inspected
Condition	3 - Fair
Deficiency	RUST - MAJOR

**EXTERIOR GUARDS**

120  
S.F.  
REPLACE  
PRIORITY 4  
LEVEL 2
