NYC Department of Education
Building Condition Assessment Survey 2023 - 2024

Architectural Inspection

Asset: I.S. 364 ANNEX - BROOKLYN, 1461 GENEVA LOOP, New York, 11239

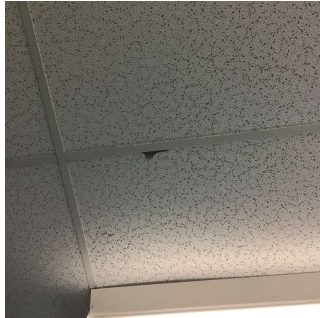
Facade C
Violations	No violations recorded.
ROOF STRUCTURE	
	Inspected
Condition	2 - Between Good and Fair
Deficiency	No deficiencies recorded
VAULTS-BUNKERS	
	Does not Exist
AUDITORIUM	
	Does not Exist
CAFETERIA	
	Inspected
Instance on 1st Floor - Staff (900 SF)	Inspected
Instance on 1st Floor - Students (1,700 SF)	Inspected
Ceiling	
Instance on 1st Floor - Staff (900 SF)	Inspected
Condition	2 - Between Good and Fair
Deficiency	ACOUSTIC TILES: DAMAGED/MISSING
Deficiency Location/Instance	Near center, rear
Deficiency Quantity	10
Quantity Uom	S.F.
Potential Action	REPLACE
Urgency of Action	PRIORITY 3
Purpose of Action	LEVEL 2
Deficiency Photo1

Near center
Violations	No violations recorded.
Instance on 1st Floor - Students (1,700 SF)	Inspected

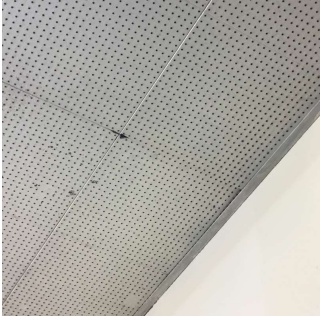
Question	Response
INTERIOR	
INTERIOR GUARDS	Does not Exist
KITCHEN	Inspected
Instance on 1st Floor (500 SF)	Inspected
Ceiling	
Instance on 1st Floor (500 SF)	Inspected
Condition	3 - Fair
Deficiency	METAL PAN: DAMAGED/MISSING
Deficiency Location/Instance	Near Storage, Servery
Deficiency Quantity	20
Quantity Uom	S.F.
Potential Action	REPLACE
Urgency of Action	PRIORITY 3
Purpose of Action	LEVEL 2
Deficiency Photo1

Violations	Near Storage No violations recorded.
Deficiency	GYPSUM BOARD: DAMAGED/DETERIORATED
Deficiency Location/Instance	Storage
Deficiency Quantity	10
Quantity Uom	S.F.
Potential Action	REPLACE
Urgency of Action	PRIORITY 3
Purpose of Action	LEVEL 2
Deficiency Photo1

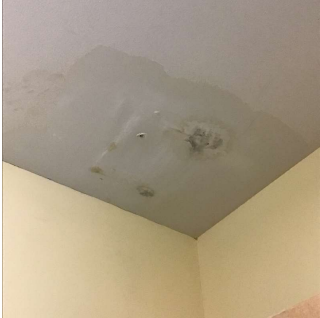
Violations	Storage No violations recorded.
Door(s)	
Instance on 1st Floor (500 SF)	Inspected
Condition	2 - Between Good and Fair
Deficiency	No deficiencies recorded
Floor Finish	
Instance on 1st Floor (500 SF)	Inspected
Condition	2 - Between Good and Fair

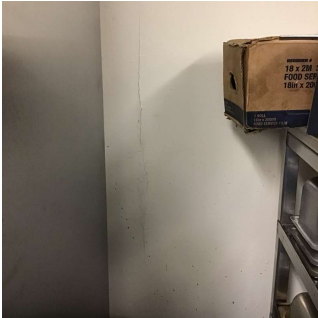
Question	Response
INTERIOR	
KITCHEN	
Floor Finish	
Deficiency	No deficiencies recorded
Walls	
Instance on 1st Floor (500 SF)	Inspected
Condition	2 - Between Good and Fair
Deficiency	PLASTER: CRACKS/SPALLING
Deficiency Location/Instance	Near Storage
Deficiency Quantity	10
Quantity Uom	S.F.
Potential Action	REPLACE
Urgency of Action	PRIORITY 3
Purpose of Action	LEVEL 2
Deficiency Photo1

Near Storage
Violations	No violations recorded.
LIBRARY	Does not Exist
LOCKER ROOM	Does not Exist
MULTI-PURPOSE ROOM	Does not Exist
SCIENCE DEMO ROOM	Does not Exist
SCIENCE LAB	Does not Exist
SCIENCE PREP ROOM	Does not Exist
SHOWER ROOM	Does not Exist
STAIRS/RAMPS: INTERIOR	Inspected
Do Letter Stair Signs Exist?	Partially
Ceiling	Not Required
Door(s)	Does not Exist
Partition	Does not Exist
Railings	Inspected
Condition	2 - Between Good and Fair
Deficiency	No deficiencies recorded
Stairs and Landings	Inspected
Condition	5 - Poor
Deficiency	STONE: BROKEN/MISSING

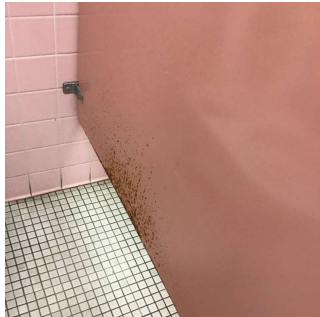
Question	Response
INTERIOR	
STAIRS/RAMPS: INTERIOR	
Stairs and Landings	
Deficiency Photo1	 
Violations	Main Entrance Steps No violations recorded.
Walls	Not Required
TOILET ROOMS - STAFF	
Ceiling	Inspected
Condition	2 - Between Good and Fair
Deficiency	No deficiencies recorded
Door(s)	Inspected
Condition	2 - Between Good and Fair
Deficiency	No deficiencies recorded
Floor Finish	Inspected
Condition	5 - Poor
Deficiency	CERAMIC TILE: BROKEN/MISSING TILES
Deficiency Location/Instance	1st Floor - womens, Mens, kitchen, life safety
Deficiency Quantity	50
Quantity Uom	S.F.
Potential Action	REPLACE
Urgency of Action	PRIORITY 3
Purpose of Action	LEVEL 2
Deficiency Photo1	 
Violations	1st Floor - life safety No violations recorded.
Stalls	Inspected
Condition	5 - Poor
Deficiency	RUST - MAJOR
Deficiency Location/Instance	1st Floor - womens, Mens, kitchen
Deficiency Quantity	3
Quantity Uom	EACH
Potential Action	REPLACE
Urgency of Action	PRIORITY 3

Question	Response
INTERIOR	
TOILET ROOMS - STAFF	
Stalls	
Purpose of Action	LEVEL 2
Deficiency Photo1

Violations	1st Floor - womens No violations recorded.
Walls	Inspected
Condition	2 - Between Good and Fair
Deficiency	CERAMIC TILE: BROKEN/ MISSING
Deficiency Location/Instance	1st Floor - life safety, Mens, womens
Deficiency Quantity	20
Quantity Uom	S.F.
Potential Action	REPLACE
Urgency of Action	PRIORITY 3
Purpose of Action	LEVEL 2
Deficiency Photo1

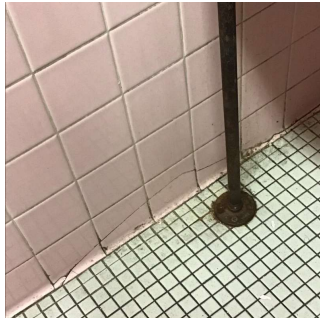
Violations	1st Floor - life safety No violations recorded.
TOILET ROOMS - STUDENTS	
Ceiling	Inspected
Condition	2 - Between Good and Fair
Deficiency	No deficiencies recorded
Door(s)	Inspected
Condition	2 - Between Good and Fair
Deficiency	No deficiencies recorded
Floor Finish	Inspected
Condition	3 - Fair
Deficiency	CERAMIC TILE: BROKEN/MISSING TILES
Deficiency Location/Instance	1st Floor - Gender Neutral, boys, girls
Deficiency Quantity	30
Quantity Uom	S.F.
Potential Action	REPLACE

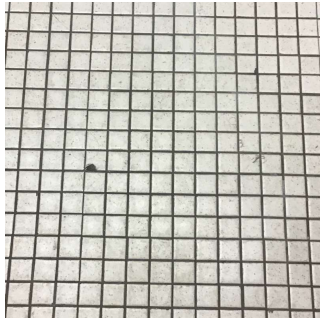
Question	Response
INTERIOR	
TOILET ROOMS - STUDENTS	
Floor Finish	
Purpose of Action	LEVEL 2
Deficiency Photo1

Violations	1st Floor - Gender Neutral No violations recorded.
Stalls	Inspected
Condition	2 - Between Good and Fair
Deficiency	No deficiencies recorded
Walls	Inspected
Condition	2 - Between Good and Fair
Deficiency	CERAMIC TILE: BROKEN/ MISSING
Deficiency Location/Instance	1st Floor - Gender Neutral, girls, boys
Deficiency Quantity	30
Quantity Uom	S.F.
Potential Action	REPLACE
Urgency of Action	PRIORITY 3
Purpose of Action	LEVEL 2
Deficiency Photo1

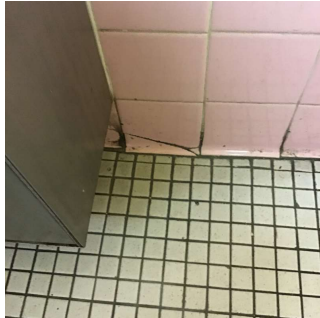
Violations	1st Floor - Gender Neutral No violations recorded.
LIFE SAFETY	Inspected
F.D. HOLDING AREA	Does not Exist
STEEL STAIRS	Does not Exist
SITE	Inspected
CONTAINERIZATION	Does not Exist
Drainage System for Asphalt	Does not Exist
Drainage System for Concrete	Inspected
Catch Basins/Manhole - Surrounded by concrete	Inspected
Condition	2 - Between Good and Fair

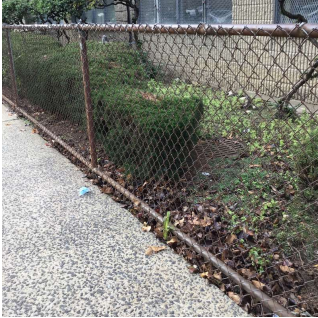
Question	Response
SITE	
Drainage System for Soil	Inspected
Catch Basins/Manhole - Surrounded by Soil	Inspected
Condition	2 - Between Good and Fair
Deficiency	No deficiencies recorded
Culverts - Soil Covering	Does not Exist
DRINKING FOUNTAINS	Does not Exist
FENCES	Inspected
Condition	4 - Between Fair and Poor
Deficiency	CHAIN LINK: RUST - MAJOR
Deficiency Location/Instance	Along Geneva Loop
Deficiency Quantity	1,100
Quantity Uom	S.F.
Potential Action	REPLACE
Urgency of Action	PRIORITY 3
Purpose of Action	LEVEL 2
Deficiency Photo1

Violations	Along Geneva Loop No violations recorded.
IRRIGATION SYSTEM	Does not Exist
PAVING	Inspected
Student Non-Use	Does not Exist
Student Use	Does not Exist
Site Sidewalks & Walkways	Inspected
Asphalt	Does not Exist
Concrete	Inspected
Condition	3 - Fair
Deficiency	DAMAGED/DETERIORATED/MISSING SECTIONS
Deficiency Location/Instance	Along Geneva Loop
Deficiency Quantity	75
Quantity Uom	S.F.

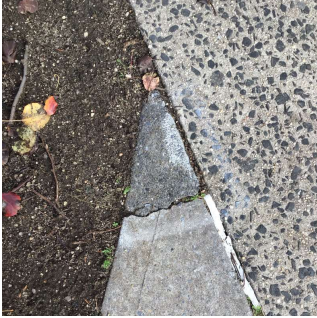
Potential Action	REPLACE
Urgency of Action	PRIORITY 3
Purpose of Action	LEVEL 2

Along Geneva Loop
Violations	No violations recorded.
Pavers	Does not Exist
DOT Sidewalk	Inspected
Asphalt	Does not Exist
Concrete	Inspected
Condition	4 - Between Fair and Poor
Deficiency	DAMAGED/DETERIORATED/MISSING SECTIONS
Deficiency Location/Instance	Along Geneva Loop, Pennsylvania Avenue
Deficiency Quantity	1,000
Quantity Uom	S.F.
Potential Action	REPLACE
Urgency of Action	PRIORITY 3
Purpose of Action	LEVEL 2
Deficiency Photo1

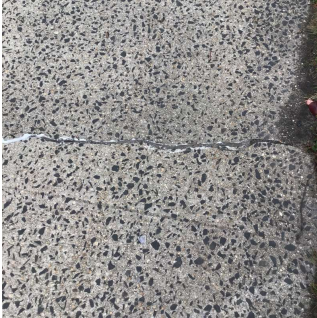
Along Geneva Loop
Violations	No violations recorded.
Deficiency	DAMAGED CURBS
Deficiency Location/Instance	Along Geneva Loop, Pennsylvania Avenue
Deficiency Quantity	165
Quantity Uom	L.F.
Potential Action	REPLACE
Urgency of Action	PRIORITY 3
Purpose of Action	LEVEL 2
