**NYC Department of Education**  
**Building Condition Assessment Survey 2023 - 2024**

Architectural Inspection

**Asset: P.S. 1 MINISCHOOL - BROOKLYN, 309 47 STREET, New York, 11220**

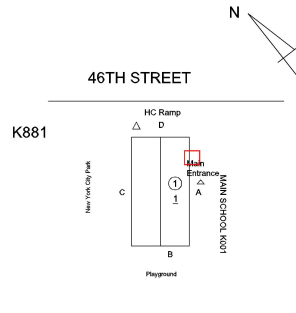
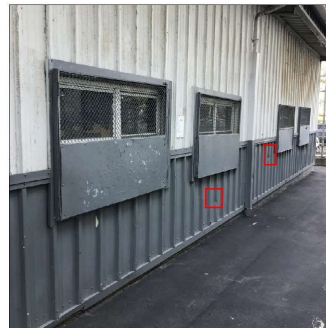
Material Type(s)	Steel
Replacement Quantity	6,200
Replacement Uom	S.F.
Instance on All Facades	Inspected
Instance Condition	3 - Fair
Instance Quantity	6,200
Instance Quantity Uom	S.F.
Deficiency	METAL PANEL: SEVERE DENTS
Roof Plan reference

Deficiency Quantity	20
Quantity Uom	S.F.
Potential Action	REPLACE
Urgency of Action	PRIORITY 4
Purpose of Action	LEVEL 2
Deficiency Photo1

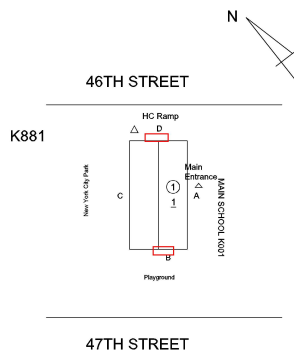
Roof Plan reference

Condition	3 - Fair
Deficiency	CONCRETE: CRACKS/SPALLING - MAJOR

Deficiency Quantity	15
Quantity Uom	S.F.
Potential Action	REPLACE
Urgency of Action	PRIORITY 4
Purpose of Action	LEVEL 2

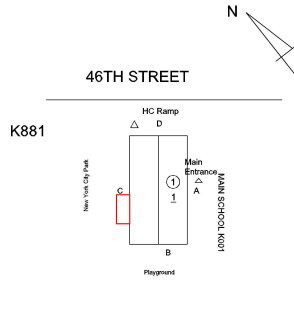
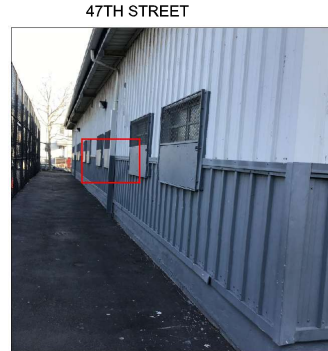
DETERIORATED/TORN-OUT/MISSING

Deficiency Quantity

30

REPLACE
