**NYC Department of Education**  
**Building Condition Assessment Survey 2023 - 2024**

Architectural Inspection

**K891**

**Asset: P.S. 91 MINISCHOOL - BROOKLYN, 532 ALBANY AVENUE, New York, 11213**

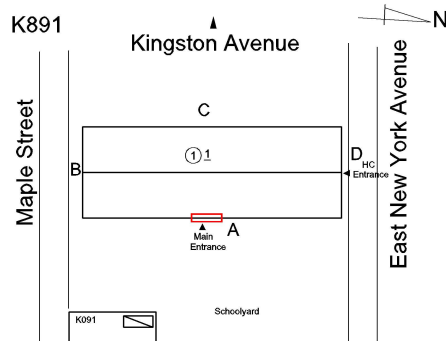
Roof Plan reference

Question	Response
<b>Architectural</b>	
<b>EXTERIOR</b>	Inspected
<b>AREAWAY</b>	Does not Exist
<b>AWNINGS AND CANOPIES</b>	Does not Exist
<b>CHIMNEY</b>	Does not Exist
<b>COPING</b>	Does not Exist
<b>CORNICE</b>	Does not Exist
<b>DOORS</b>	Inspected
<b>DOORS AND FRAMES</b>	Inspected
Condition	5 - Poor

Deficiency METAL: DETERIORATED DOOR AND FRAME - MAJOR DETERIORATION

Deficiency Quantity

2

Quantity Uom

EACH

Potential Action

REPLACE

Urgency of Action

PRIORITY 4

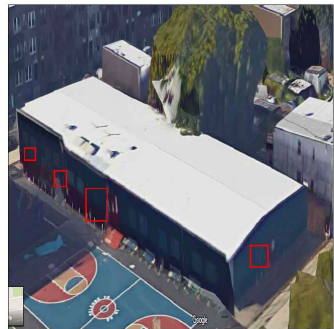
Violations	Facade A No violations recorded.
<b>DOOR HARDWARE</b>	Inspected
Condition	3 - Fair
Deficiency	No deficiencies recorded
<b>LINTELS</b>	Does not Exist
<b>TRANSOM/SIDE LIGHT</b>	Does not Exist
<b>EXTERIOR WALLS</b>	Inspected
Material Type(s)	Steel
Replacement Quantity	5,000
Replacement Uom	S.F.
Instance on All Facades	Inspected
Instance Condition	3 - Fair
Instance Quantity	5,000
Instance Quantity Uom	S.F.
Deficiency	METAL PANEL: SEVERE DENTS
Roof Plan reference	 
Elevation

Deficiency Quantity	40
Quantity Uom	S.F.
Potential Action	REPLACE

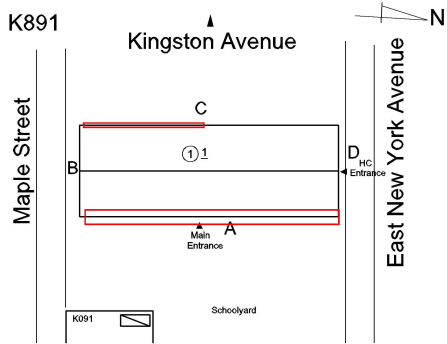
Facade A
Violations	No violations recorded.
<b>EXTERIOR SOFFITS</b>	
Condition	Inspected
Deficiency	2 - Between Good and Fair
	No deficiencies recorded
<b>LOADING DOCK</b>	
	Does not Exist
<b>LOUVER</b>	
Condition	Inspected
Deficiency	2 - Between Good and Fair
	No deficiencies recorded
<b>PARAPETS</b>	
	Does not Exist
<b>PLAZA DECK</b>	
	Does not Exist
<b>ROOF</b>	
<b>Roofing</b>	
Condition	Inspected
Replacement Quantity	11,000
Replacement Uom	S.F.
<b>ROOF HATCH/SMOKE HATCH</b>	
	Does not Exist
<b>LEADERS, GUTTERS, DOWNSPOUTS, SCUPPERS</b>	
Condition	Inspected
Deficiency	4 - Between Fair and Poor
Deficiency	DAMAGED/MISSING
Roof Plan reference

Deficiency Quantity	100
Quantity Uom	L.F.
Potential Action	REPLACE
Urgency of Action	PRIORITY 4
Purpose of Action	LEVEL 2

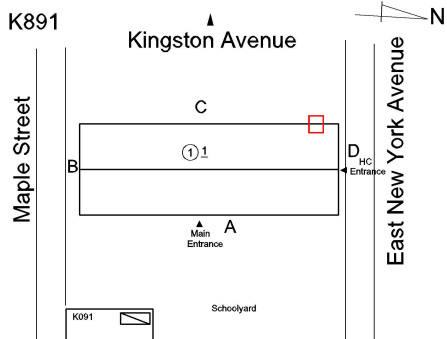
Violations	Roof 1 - Facade A No violations recorded.
Deficiency	DAMAGED/MISSING
Roof Plan reference	K891

Deficiency Quantity	20
Quantity Uom	L.F.
Potential Action	REPLACE
Urgency of Action	PRIORITY 5
Purpose of Action	LEVEL 6
Deficiency Photo1

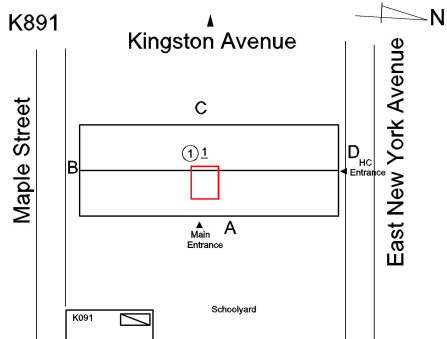
Roof 1
Instance Quantity	11,000
Instance Quantity Uom	S.F.
Does the roof have major mechanical equipment sitting on Dunnage Steel less than 18" above the Roofing?	No
Does this roof instance have a Sustainable Roof System?	No
Do solar panels exist on these roofs?	No
Is/Are the roof(s) suitable for Solar Panel installation?	No
Installation Year	1996
Source of Installation	Custodial Staff
Deficiency	METAL: ROOFING: MAJOR ACTIVE ROOF LEAKS IN NON-INSTRUCTIONAL SPACE
Roof Plan reference

Deficiency Quantity	100
Quantity Uom	S.F.
Potential Action	REPLACE
Urgency of Action	PRIORITY 5
Purpose of Action	LEVEL 2
Deficiency Photo1

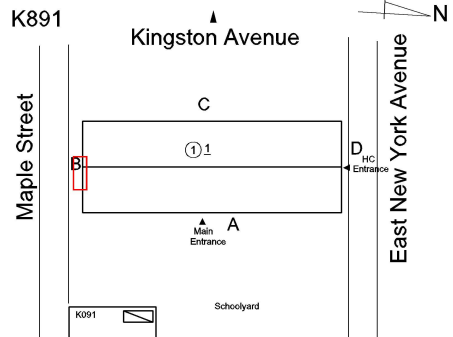
Roof Plan reference

Inspected	
Condition	3 - Fair

CONCRETE: CRACKS/SPALLING - MAJOR

REPLACE

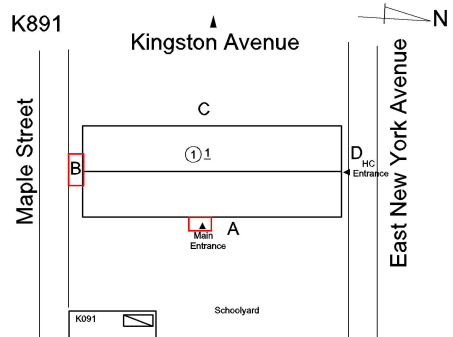
Roof Plan reference

CONCRETE: CRACKS/SPALLING - MINOR

REPAIR

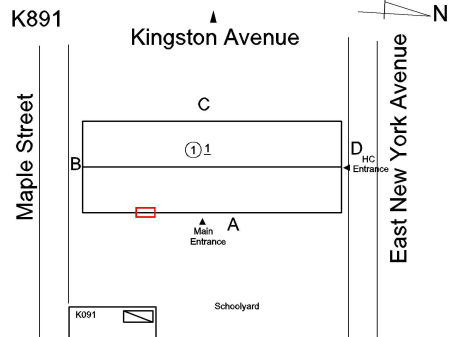
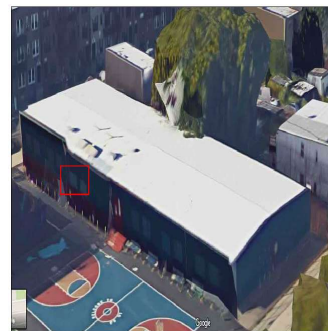
Roof Plan reference

DETERIORATED/TORN-OUT/MISSING

20  
S.F.  
REPLACE  
PRIORITY 4  
LEVEL 2
