**NYC Department of Education  
Building Condition Assessment Survey 2023 - 2024**

Architectural Inspection

**K892**

**Asset:** P.S. 221 MINISCHOOL - BROOKLYN, 791 EMPIRE BLVD, New York, 11213

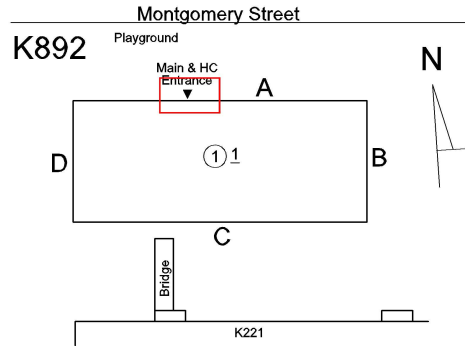
Roof Plan reference

METAL: DETERIORATED DOOR AND FRAME - MAJOR DETERIORATION

2

REPLACE

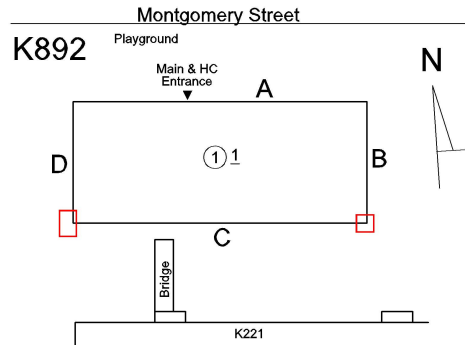
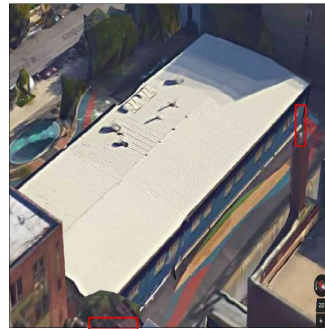
Roof Plan reference

METAL PANEL: DAMAGED TRIM

20

REPLACE

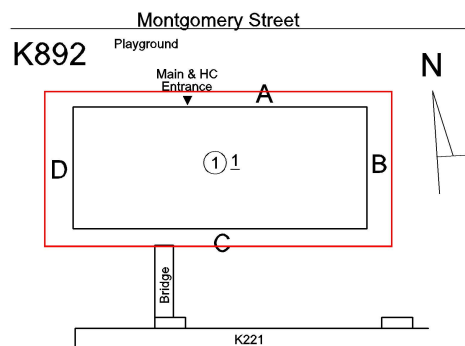
Roof Plan reference

METAL PANEL: SEVERE DENTS

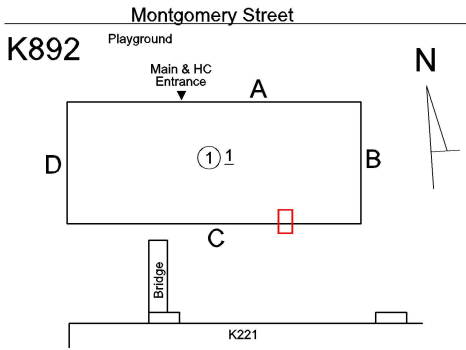
Question	Response
<b>EXTERIOR</b>	
<b>ROOF</b>	
<b>Roofing</b>	
<b>LEADERS, GUTTERS, DOWNSPOUTS, SCUPPERS</b>	
Roof Plan reference

Deficiency Quantity	10
Quantity Uom	L.F.
Potential Action	REPLACE
Urgency of Action	PRIORITY 4
Purpose of Action	LEVEL 2
Deficiency Photo1

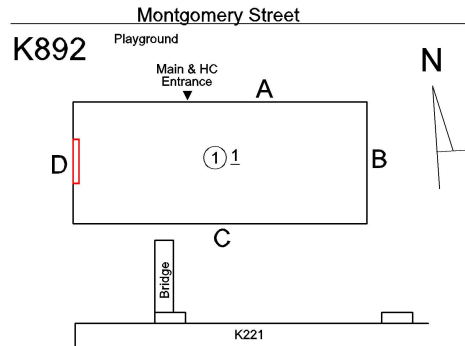
Question	Response
<b>EXTERIOR</b>	
<b>ROOF</b>	
<b>Roofing</b>	
<b>ROOFING</b>	
Deficiency	METAL: ROOFING: MAJOR ACTIVE ROOF LEAKS IN INSTRUCTIONAL SPACE
Roof Plan reference	
Deficiency Quantity	400
Quantity Uom	S.F.
Potential Action	REPLACE
Urgency of Action	PRIORITY 5
Purpose of Action	LEVEL 2
Deficiency Photo1	
Violations	Roof 1 - Corridor near Rooms 015, 018 (Shown) and Staff Bathroom, Staff Toilet Room near Room 016 No violations recorded.
<b>ROOFING DRAINS</b>	Does not Exist
<b>Specialties</b>	Does not Exist
<b>STAIRS/RAMPS: EXTERIOR</b>	Inspected
<b>BUILDING CHEEK/FLANK WALLS</b>	Does not Exist
<b>RAILINGS</b>	Inspected
Condition	2 - Between Good and Fair
Deficiency	No deficiencies recorded
<b>STAIRS/RAMPS</b>	Inspected
Condition	5 - Poor
Deficiency	CONCRETE: WORN-OUT TREAD/RISER/NOSING

20  
S.F.  
REPLACE  
PRIORITY 4  
LEVEL 2

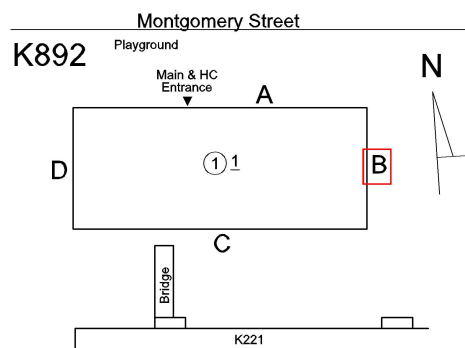
Roof Plan reference

CONCRETE: CRACKS/SPALLING - MINOR

10  
S.F.  
REPAIR  
PRIORITY 3  
LEVEL 2

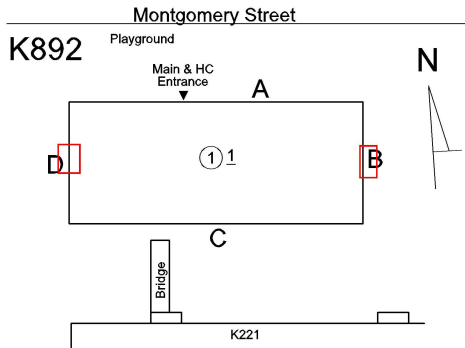
Violations	Facade B No violations recorded.
Deficiency	<b>CONCRETE: CRACKS/SPALLING - MAJOR</b>
Roof Plan reference	<p align="center">Montgomery Street</p>

Deficiency Quantity	30
Quantity Uom	S.F.
Potential Action	REPLACE
Urgency of Action	PRIORITY 4
Purpose of Action	LEVEL 2
Deficiency Photo1
